Vehicle Inspection Report

Date Inspected: 24/04/2025 10:40

Reg: DN12AHX

VIN: W0L0SDL68C4187643

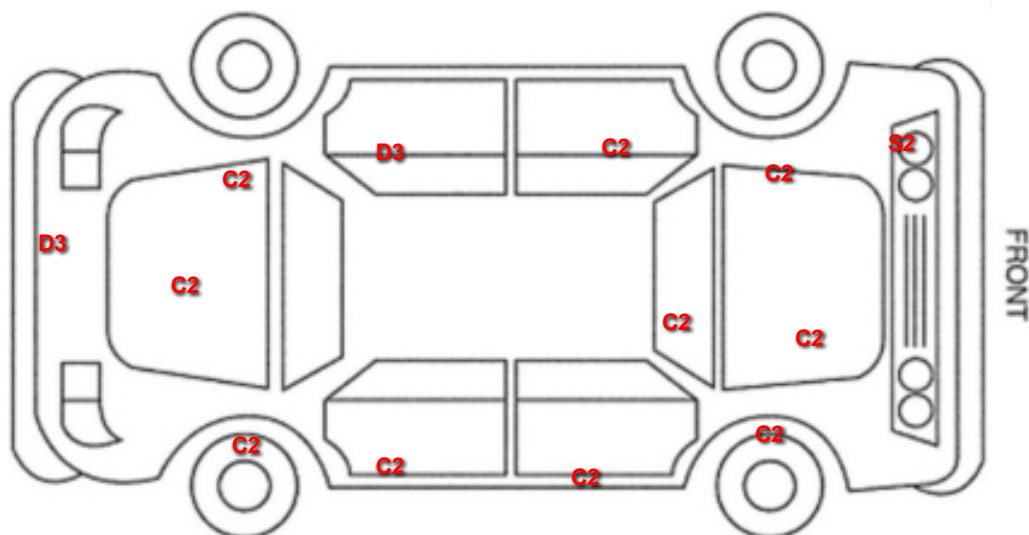
Vehicle Splat

Component	Condition	Severity	Repair
Bumper Rear	Dented	With Paint Damage	Repair and Refinish
Boot Lid	Scratched	Over 25mm Not Thru Paint	Machine Polish
Boot Lid	Chipped	1 To 5	Smart Repair
Qtr Panel nsr	Scratched	Over 25mm Not Thru Paint	Machine Polish
Qtr Panel nsr	Chipped	1 To 5	Smart Repair
Door nsr	Dented	With Paint Damage	Repair and Refinish
Door nsf	Chipped	Multiple Chips	Refinish
Wing nsf	Scratched	Over 25mm Not Thru Paint	Machine Polish
Wing nsf	Chipped	1 To 5	Smart Repair
Door Mirror Assy nsf	Scratched (Painted)	UpTo 25mm Thru Paint	Smart Repair
Bonnet	Chipped	Multiple Chips	Refinish
Bumper Front	Scratched	Over 25mm Not Thru Paint	Machine Polish
Bumper Front	Scratched	25 to 100mm Thru Paint	Smart Repair
Wing osf	Chipped	1 To 5	Smart Repair
Wing osf	Scratched	Over 25mm Not Thru Paint	Machine Polish
Screen Front	Chipped	UpTo 10mm	Smart Repair
Door osf	Chipped	Multiple Chips	Refinish
Door osr	Chipped	Multiple Chips	Refinish

Qtr Panel osr	Chipped	1 To 5	Smart Repair
Qtr Panel osr	Scratched	Over 25mm Not Thru Paint	Machine Polish
Roof	Scratched	Over 25mm Not Thru Paint	Machine Polish
Seat Base Cover osf	Torn	Over 3mm	Replace
