Vehicle Inspection Report

Date Inspected: 28/03/2025 13:16

Reg: NV08FPG

VIN: YV1MW214282421301

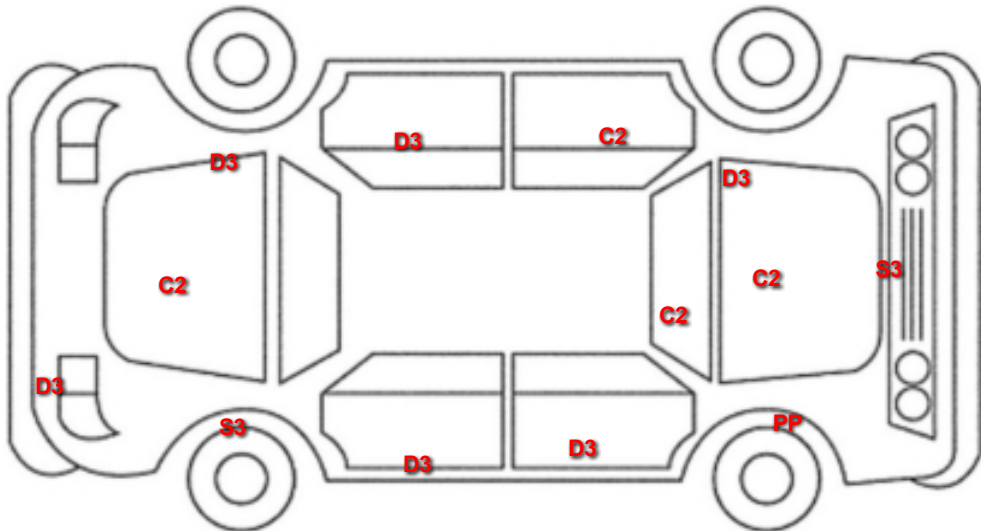
Vehicle Splat

front bumper misaligned and noisy engine
