Vehicle Inspection Report

Reg: GN72PXH

Make	MAZDA	Body Type	Estate	Doors	5
Model	CX-5 SPORT - 1998cc	Fuel Type	Petrol	Colour	Blue
Mileage	27028 miles	Transmission	Manual	Year of MFR	2022
		Gears	6	Date First Reg	01/09/2022

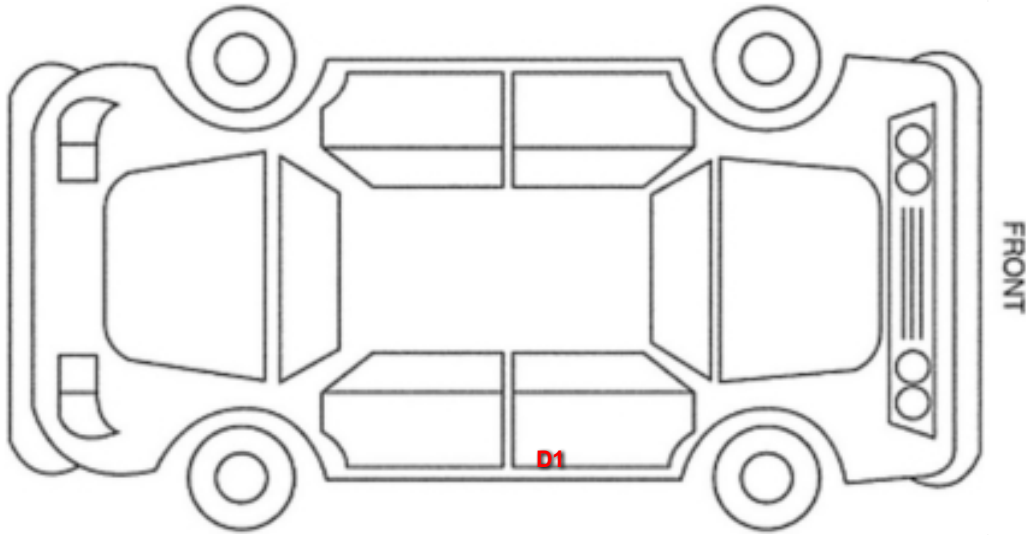
Vehicle Splat

Damage Assessment			
	Bumper Rear Scratched Over 25mm Not Thru Paint Machine Polish	Door nsr Scratched Over 25mm Not Thru Paint Machine Polish	Qtr Panel osr Scratched Over 25mm Not Thru Paint Machine Polish
	Door nsf Scratched Over 25mm Not Thru Paint Machine Polish	Wing nsf Scratched Over 25mm Not Thru Paint Machine Polish

Bumper Front Moulding Broken Needs Replaced Replace
	Bumper Front Scratched Over 25mm Not Thru Paint Machine Polish

Screen Front Chipped UpTo 10mm Smart Repair	Roof Scratched Over 25mm Not Thru Paint Machine Polish
	Door osf Dented 2 Or Less UpTo 10mm Smart Repair

Sill Panel Trim os Scuffed (Unpainted) UpTo 100mm Smart Repair
