### Vehicle Inspection Report

**Reg:** LD63KPX

**VIN:** VF7SC8HR4DW639952

<b>Make</b>	CITROEN	<b>Body Type</b>	Hatchback	<b>Doors</b>	5
<b>Model</b>	C3 VTR + HDI - 1398cc	<b>Fuel Type</b>	Diesel	<b>Colour</b>	Silver
<b>Mileage</b>	58115 miles	<b>Transmission</b>	Manual	<b>Year of MFR</b>	2013
		<b>Gears</b>	5	<b>Date First Reg</b>	02/12/2013

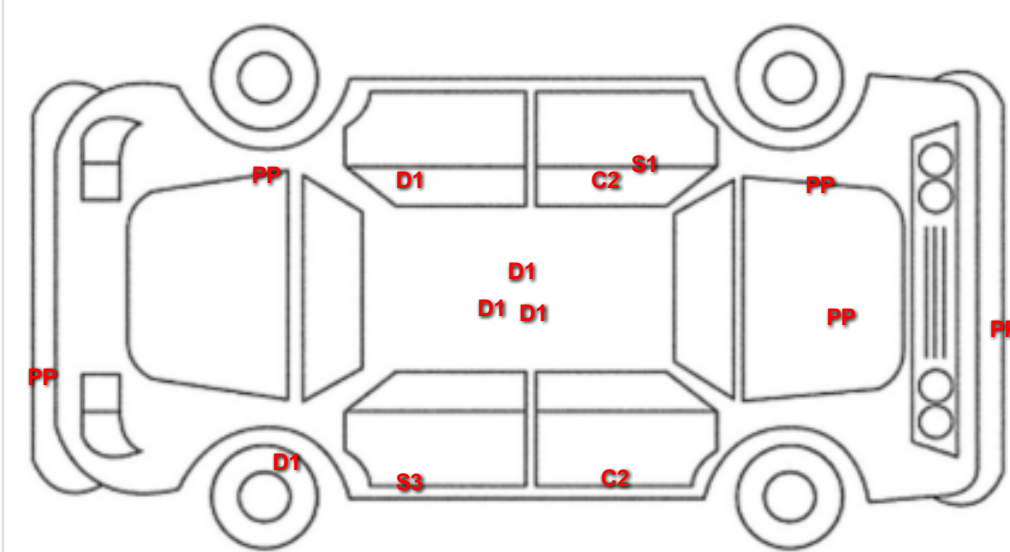
Vehicle Splat

Damage Lines			
Component	Condition	Severity	Repair
Door osf	Chipped	1 To 5	Smart Repair
Door osr	Scratched	Over 25mm Thru Paint	Refinish
Qtr Panel osr	Dented	Between 10mm + 30mm	Smart Repair
Bumper Rear	Poor Previous Repair	Paint Flake	Refinish
Qtr Panel nsr	Poor Previous Repair	Poor Paint	Refinish
Door nsr	Dented	2 Or Less UpTo 10mm	Smart Repair
Door nsr	Scratched	Over 25mm Not Thru Paint	Machine Polish
Door nsf	Scratched	UpTo 25mm Thru Paint	Smart Repair
Door nsf	Scratched	Over 25mm Not Thru Paint	Machine Polish
Door nsf	Chipped	1 To 5	Smart Repair
Door Mirror Assy nsf	Scratched (Painted)	Over 25mm Thru Paint	Smart Repair
Wing nsf	Poor Previous Repair	Poor Paint	Refinish
Bumper Front	Poor Previous Repair	Poor Paint	Refinish
Bonnet	Poor Previous Repair	Poor Paint	Refinish
Roof	Dented	Over 2 UpTo 10mm	Smart Repair
A Post ns	Scratched	Over 25mm Not Thru Paint	Machine Polish
