Vehicle Inspection Report

Reg: GU62NUH

VIN: TMBKC75L9C6086082

Make	SKODA	Body Type	Hatchback	Doors	5
Model	YETI ELEGANCE TDI	Fuel Type	Diesel	Colour	Grey
	CR - 1968cc	Transmission	Manual	Year of MFR	2012
Mileage	183208 miles	Gears	5	Date First Reg	04/09/2012

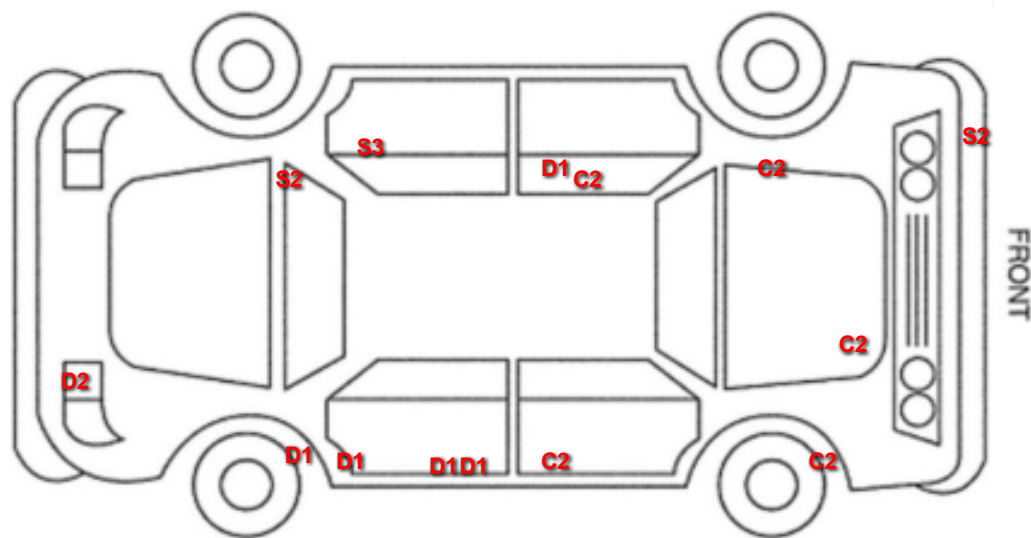
Vehicle Splat

Component	Condition	Severity	Repair
Wing osf	Chipped	1 To 5	Smart Repair
Wing osf	Scratched	Over 25mm Not Thru Paint	Machine Polish
Door osf	Scratched	Over 25mm Not Thru Paint	Machine Polish
Door osf	Chipped	Edge Chip	Smart Repair
Door osf	Chipped	1 To 5	Smart Repair
Door osr	Dented	Between 10mm + 30mm	Smart Repair
Door osr	Scratched	Over 25mm Not Thru Paint	Machine Polish
Qtr Panel osr	Dented	Between 10mm + 30mm	Smart Repair
Qtr Panel osr	Scratched	Over 25mm Not Thru Paint	Machine Polish
Tailgate	Dented	Over 30mm	Repair and Refinish
Badgedecal Rear	Missing	Replace	Replace
Qtr Panel nsr	Scratched	Over 25mm Thru Paint	Refinish
Door nsr	Scratched	Over 25mm Thru Paint	Refinish
Door nsf	Scratched	Over 25mm Not Thru Paint	Machine Polish
Door nsf	Chipped	1 To 5	Smart Repair
Door nsf	Dented	2 Or Less UpTo 10mm	Smart Repair
Wing nsf	Chipped	1 To 5	Smart Repair
Wing nsf	Scratched	Over 25mm Not Thru Paint	Machine Polish

Bumper Front	Scratched	25 to 100mm Thru Paint	Smart Repair
Bumper Front	Scratched	Over 25mm Not Thru Paint	Machine Polish
Bonnet	Chipped	1 To 5	Smart Repair
Bonnet	Scratched	Over 25mm Not Thru Paint	Machine Polish

low clutch,vibration when pulling away
