Vehicle Inspection Report

Reg: GV71WSN

Make	HYUNDAI	Body Type	Estate	Doors	5
Model	IONIQ 5 ULTIMATE EV 4X4 - 0cc	Transmission	Auto	Colour	Green
Mileage	22,295 miles			Year of MFR	2022
				Date First Reg	12/02/2022

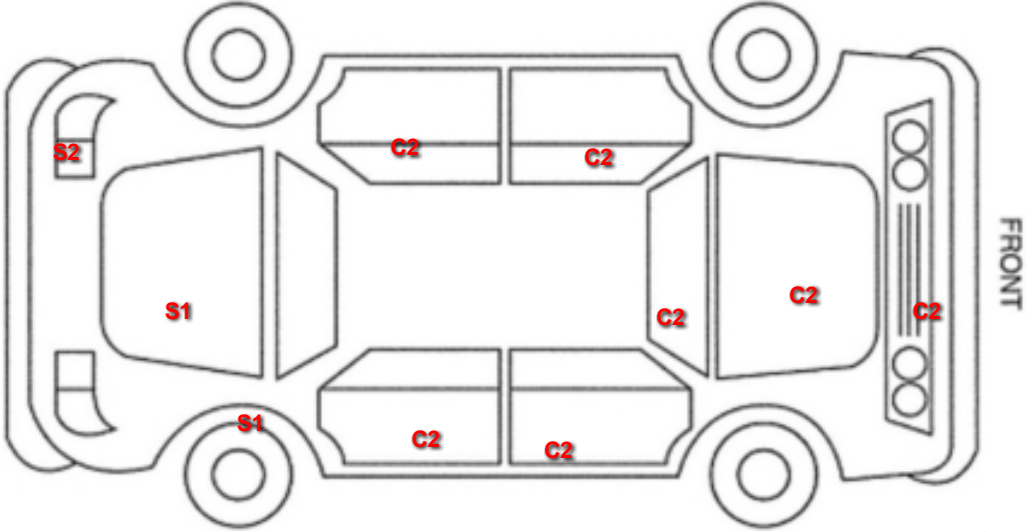
Vehicle Splat

Damage Lines			
Component	Condition	Severity	Repair
Bonnet	Chipped	1 To 5	Smart Repair
Bumper Front	Chipped	Multiple Chips	Smart Repair
Bumper Front	Scratched	Over 25mm Not Thru Paint	Machine Polish
Screen Front	Chipped	UpTo 10mm	Smart Repair
Door osf	Scratched	Over 25mm Not Thru Paint	Machine Polish
Door osf	Chipped	1 To 5	Smart Repair
Door osr	Scratched	Over 25mm Not Thru Paint	Machine Polish
Door osr	Chipped	1 To 5	Smart Repair
Qtr Panel osr	Scratched	Over 25mm Not Thru Paint	Machine Polish
Qtr Panel osr	Scratched	UpTo 25mm Thru Paint	Smart Repair
Qtr Panel Arch Extension os	Scratched (Painted)	Over 25mm Thru Paint	Smart Repair
Bumper Rear	Scratched	25 to 100mm Thru Paint	Smart Repair
Bumper Rear Moulding	Scratched (Painted)	Over 25mm Thru Paint	Smart Repair
Boot Lid	Scratched	UpTo 25mm Thru Paint	Smart Repair
Qtr Panel nsr	Scratched	Over 25mm Not Thru Paint	Machine Polish
Door nsr	Scratched	Over 25mm Not Thru Paint	Machine Polish

Door nsr	Chipped	1 To 5	Smart Repair
Door nsf	Scratched	Over 25mm Not Thru Paint	Machine Polish
Door nsf	Chipped	1 To 5	Smart Repair
