VEHICLE INSPECTION REPORT

Bentley Arnage Arnage RL [450] 4dr Auto

nama
GRADE
2

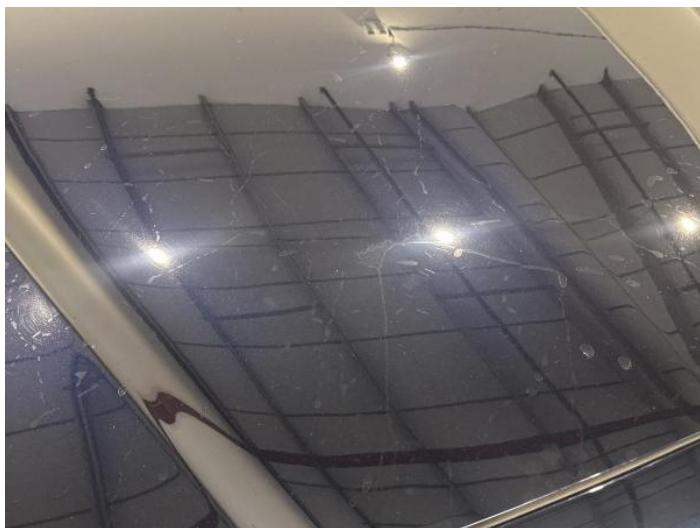
1: Bonnet
Chipped
1 To 5

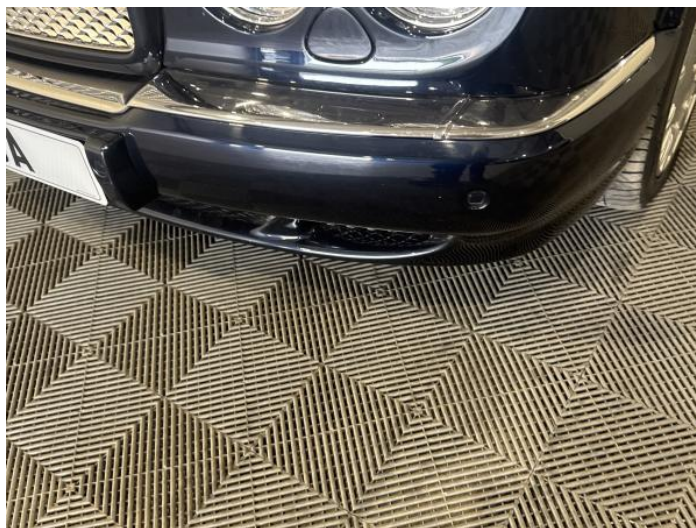
2: Bumper Front
Chipped
Multiple Chips

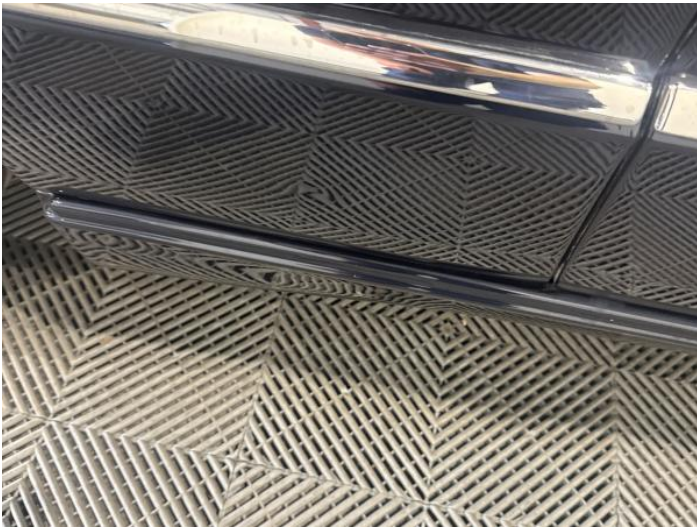
5: Wing nsf
Dented
Between 10mm + 30mm

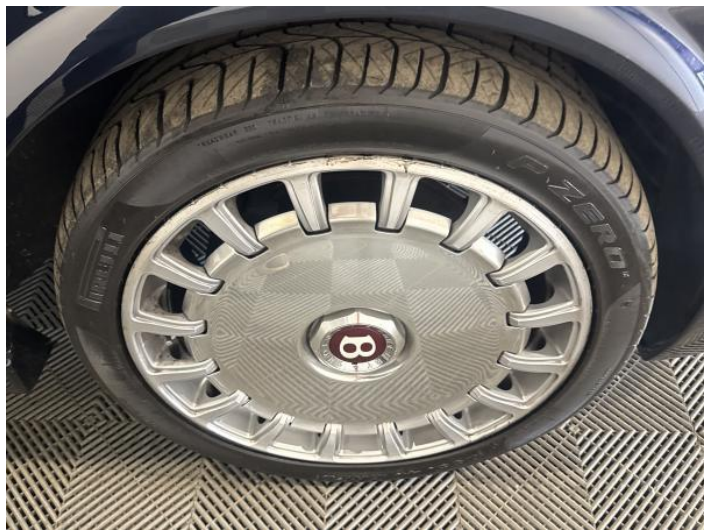
18: Wheel osf
Scratched
Over 50mm

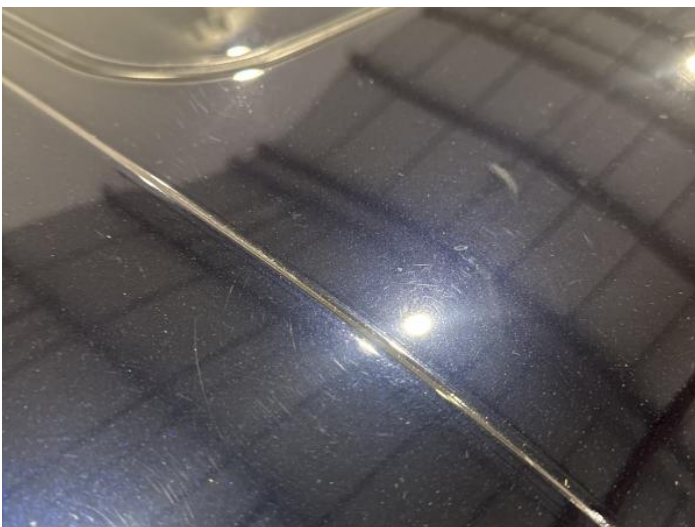
19: Roof
Dented
Between 10mm + 30mm
