### Vehicle Inspection Report

**Reg:** EN59FBL

Appraised By: Eastbourne Car Auctions

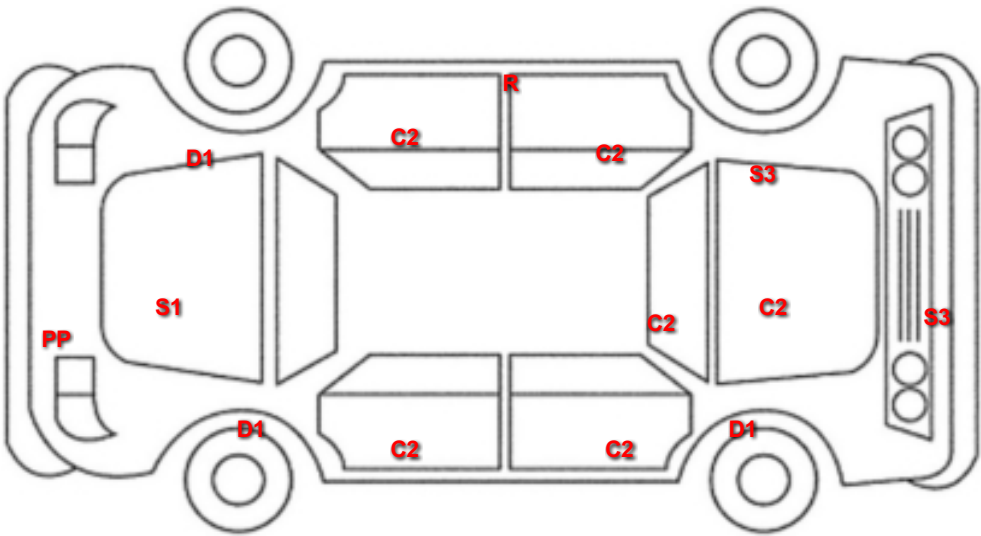
Vehicle Splat

Component	Condition	Severity	Repair
Bonnet	Chipped	1 To 5	Smart Repair
Bumper Front	Scratched	25 to 100mm Thru Paint	Smart Repair
Bumper Front	Scratched	Over 25mm Not Thru Paint	Machine Polish
Wing osf	Scratched	Over 25mm Not Thru Paint	Machine Polish
Wing osf	Dented	Between 10mm + 30mm	Smart Repair
Screen Front	Chipped	UpTo 10mm	Smart Repair
Door osf	Scratched	Over 25mm Not Thru Paint	Machine Polish
Door osf	Chipped	1 To 5	Smart Repair
Door osr	Scratched	Over 25mm Not Thru Paint	Machine Polish
Door osr	Chipped	1 To 5	Smart Repair
Qtr Panel osr	Scratched	Over 25mm Not Thru Paint	Machine Polish
Qtr Panel osr	Dented	Between 10mm + 30mm	Smart Repair
Fuel Flap	Missing	Replace	Replace
Bumper Rear	Poor Previous Repair	Poor Paint	Refinish
Boot Lid	Scratched	Over 25mm Not Thru Paint	Machine Polish
Qtr Panel nsr	Scratched	Over 25mm Not Thru Paint	Machine Polish
Qtr Panel nsr	Dented	Between 10mm + 30mm	Smart Repair

Door nsr	Scratched	Over 25mm Not Thru Paint	Machine Polish
Door nsr	Chipped	1 To 5	Smart Repair
Door nsf	Scratched	Over 25mm Not Thru Paint	Machine Polish
Door nsf	Chipped	1 To 5	Smart Repair
Wing nsf	Scratched	Over 25mm Thru Paint	Refinish
Boot Lid	Scratched	UpTo 25mm Thru Paint	Smart Repair
Sill ns	Rusted	Over 5mm	Refinish
