Vehicle Inspection Report

Reg: GP07VHR

Appraised By: Eastbourne Car Auctions

Make FORD Model FOCUS CLIMAT Mileage 86,499	E - 1596cc	Body Type Fuel Type Transmission Gears	Hatchback Petrol Manual 5	Doors Colour Year of MFR Date First Reg	5 Silver 2007 29/06/2007	V5 Location No. Keys	2
yres & Wheels				Interior Condit	ion	Service History	
OSF Depth NSF Depth OSR Depth NSR Depth	3 mm 3 mm 4 mm 4 mm	Alloys Alloys That Need Refurb Tools Spare	Yes 4 No Space Saver	Carpets Upholstery Seats Parcel Shelf Odour	Average Average Average Yes No	Service No History Stamps	
Extras							
Metallic Paint Air Conditioning Stereo	Yes y Yes Radio	Central Locking Sun Roof Sat Nav	Yes No No	Interior Elec Windows Cruise	Cloth 2 No	Electric Seats Heated Seats Xenons	No No No

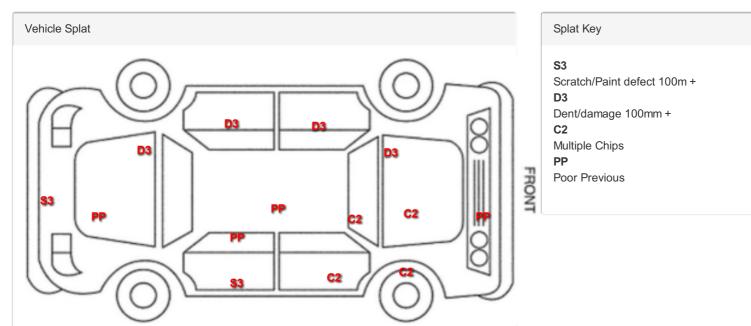
Damage Lines

Component
Bonnet
Bumper Front
Wing osf
Wing osf
Screen Front
Door Mirror Assy osf
Door osf
Door osf
Roof
D Post os
Door osr
Qtr Panel osr
Bumper Rear
Boot Lid
Qtr Panel nsr
Door nsr
Door nsr
Wing nsf
Door Mirror Assy nsf

Condition Poor Previous Repair Scratched Scratched (Painted) Scratched Poor Previous Repair

Multiple Chips Paint Flake Over 25mm Not Thru Paint 1 To 5 UpTo 10mm Over 25mm Not Thru Paint Over 25mm Not Thru Paint 1 To 5 Poor Paint Poor Paint Over 25mm Thru Paint Over 25mm Not Thru Paint Over 100mm Thru Paint Poor Paint With Paint Damage With Paint Damage With Paint Damage With Paint Damage Replace

water leak in boot

Refinish Refinish Machine Polish Smart Repair Smart Repair Machine Polish Machine Polish Smart Repair Refinish Refinish Refinish Machine Polish Refinish Refinish Repair and Refinish Repair and Refinish Repair and Refinish Repair and Refinish Replace
