Vehicle Inspection Report

Date Inspected: 08/04/2025 11:15

Reg: NJ60NCO

Make	FORD	Body Type	Hatchback	Doors	5
Model	FIESTA ZETEC - 1242cc	Fuel Type	Petrol	Colour	Red
Mileage	117483 miles	Transmission	Manual	Year of MFR	2010
		Gears	5	Date First Reg	23/09/2010

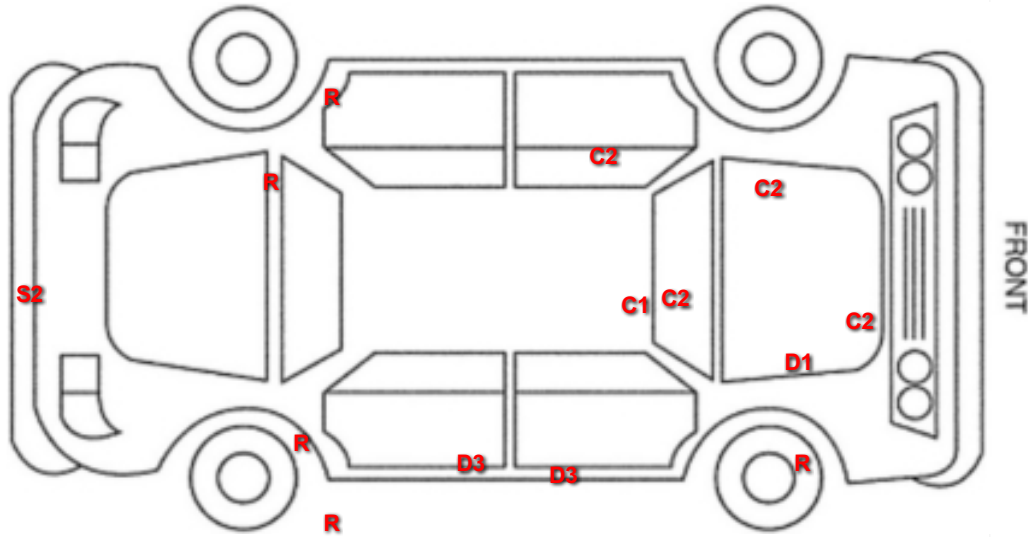
Vehicle Splat

Damage Lines			
Component	Condition	Severity	Repair
Seat Back Cover nsf	Holed	UpTo 3mm	Smart Repair
Wing osf	Rusted	Over 5mm	Refinish
Door Mirror Assy osf	Broken	Replace	Replace
Door osf	Dented	With Paint Damage	Repair and Refinish
Door osr	Dented	With Paint Damage	Repair and Refinish
Qtr Panel osr	Rusted	Over 5mm	Refinish
Sill os	Rusted	Over 5mm	Refinish
Bumper Rear	Scratched	25 to 100mm Thru Paint	Smart Repair
Tailgate	Scratched	Over 25mm Not Thru Paint	Machine Polish
Qtr Panel nsr	Rusted	Over 5mm	Refinish
Sill ns	Rusted	Over 5mm	Refinish
Door nsr	Scratched	Over 25mm Not Thru Paint	Machine Polish
Door nsf	Chipped	1 To 5	Smart Repair
Door nsf	Scratched	Over 25mm Not Thru Paint	Machine Polish
Door Mirror Assy nsf	Scratched (Painted)	Over 25mm Thru Paint	Smart Repair
Wing nsf	Chipped	1 To 5	Smart Repair
Wing nsf	Scratched	Over 25mm Not Thru Paint	Machine Polish
Bumper Front	Scratched	Over 25mm Not Thru Paint	Machine Polish

Bumper Front	Chipped	Multiple Chips	Smart Repair
Bonnet	Chipped	1 To 5	Smart Repair
Bonnet	Dented	2 Or Less UpTo 10mm	Smart Repair
Roof	Chipped	1 To 5	Smart Repair
Screen Front	Chipped	UpTo 10mm	Smart Repair
Seat Back Cover osf	Holed	Over 3mm	Replace
Seat Base Cover osf	Torn	Over 3mm	Replace
