VEHICLE INSPECTION REPORT

HV62GCU

Hyundai I20 1.2 Style 5dr

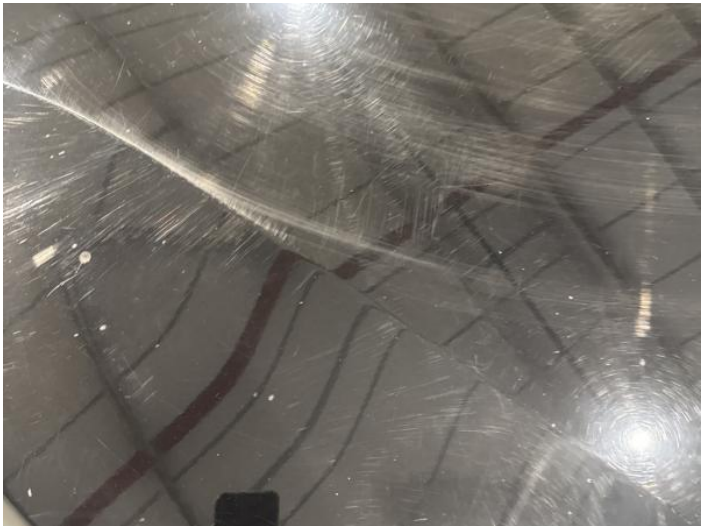
2: Bonnet
Poor Previous Repair
Poor Paint

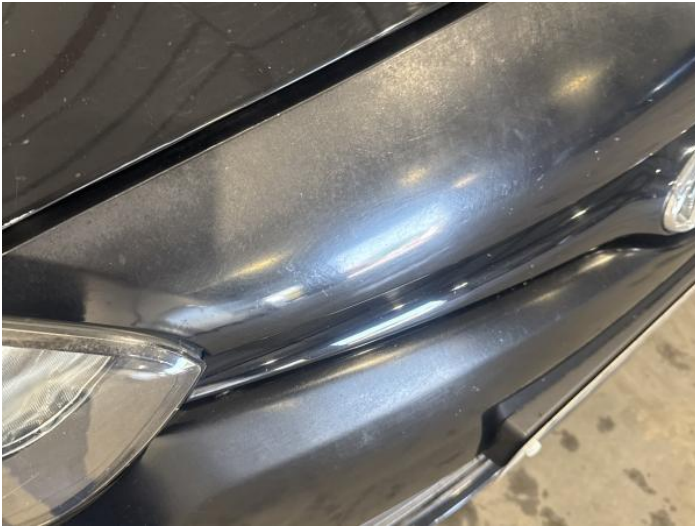
3: Bumper Front
Poor Previous Repair
Poor Paint

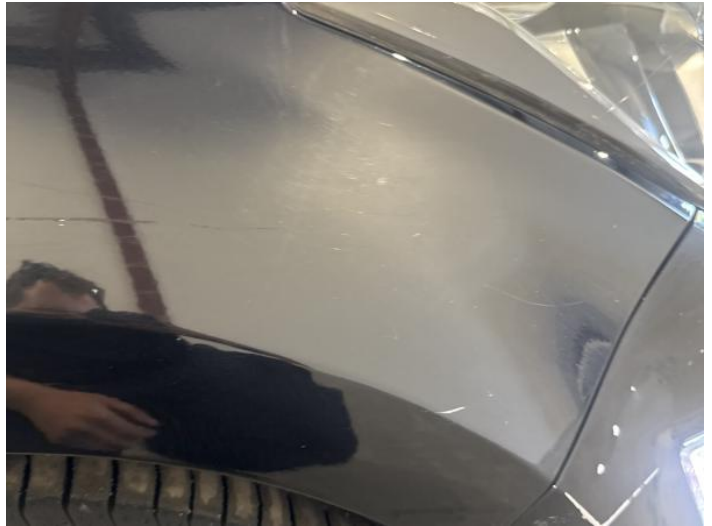
4: Wing osf
Scratched
Over 25mm Thru Paint

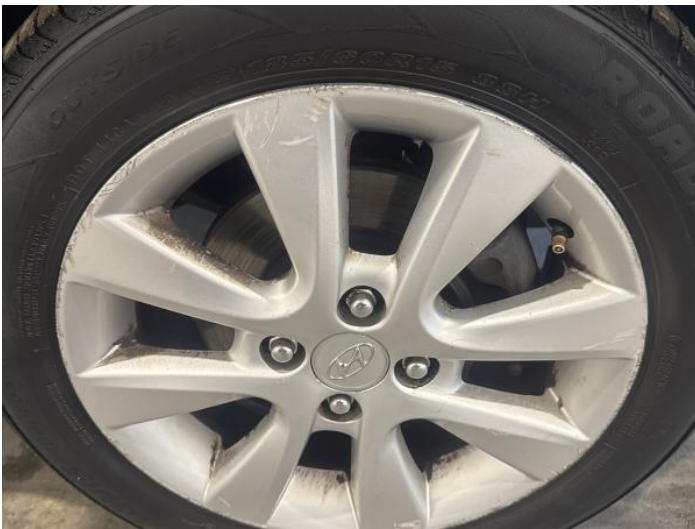
5: Wheel osf
Scratched
Over 50mm

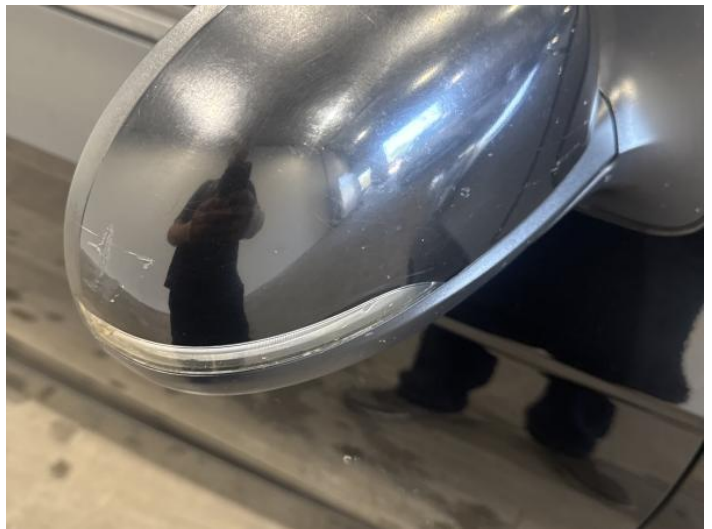
6: Door Mirror Assy osf
Scratched (Painted)
Over 25mm Thru Paint

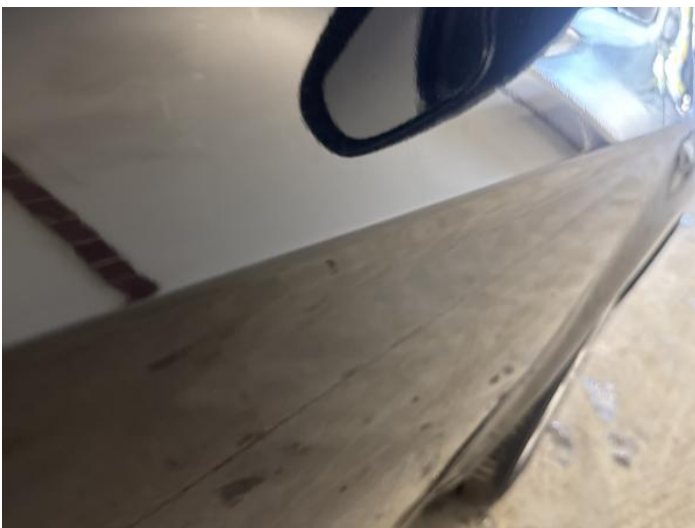
7: Door osf
Dented
Between 10mm + 30mm

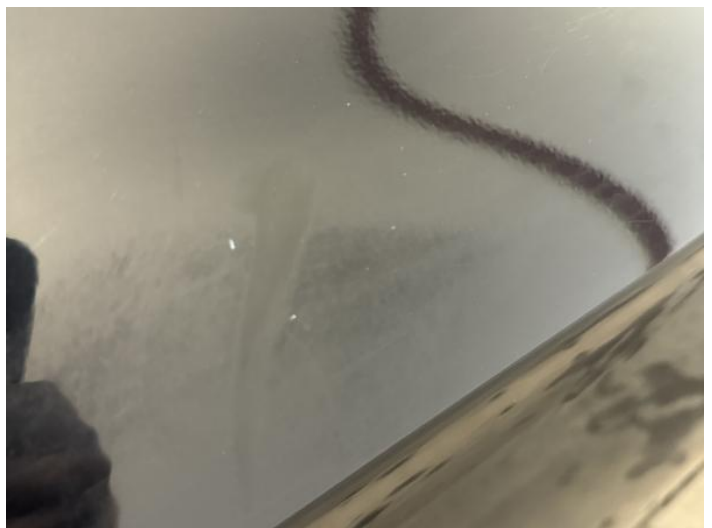
8: Door osr
Poor Previous Repair
Poor Paint

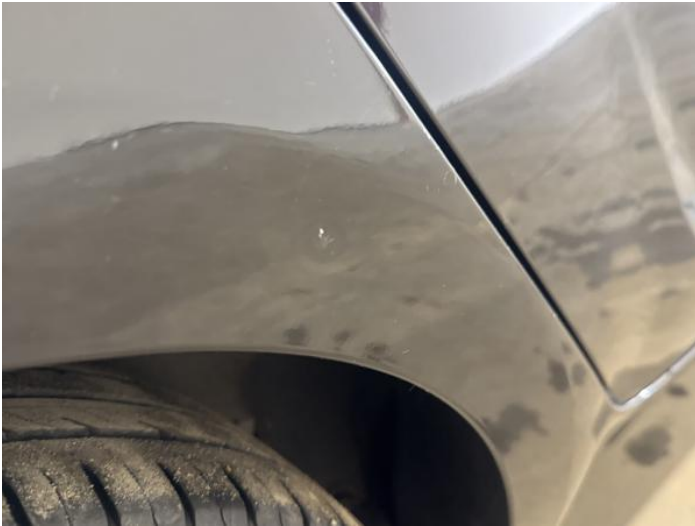
9: Qtr Panel osr
Dented
With Paint Damage

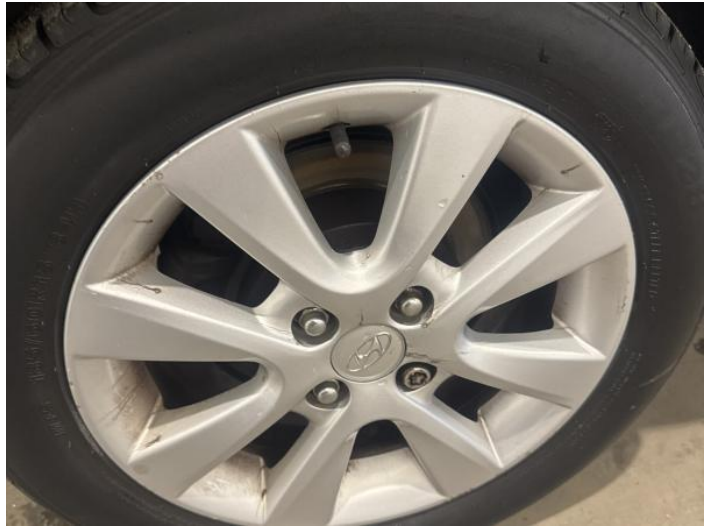
10: Wheel osr
Scratched
Over 50mm

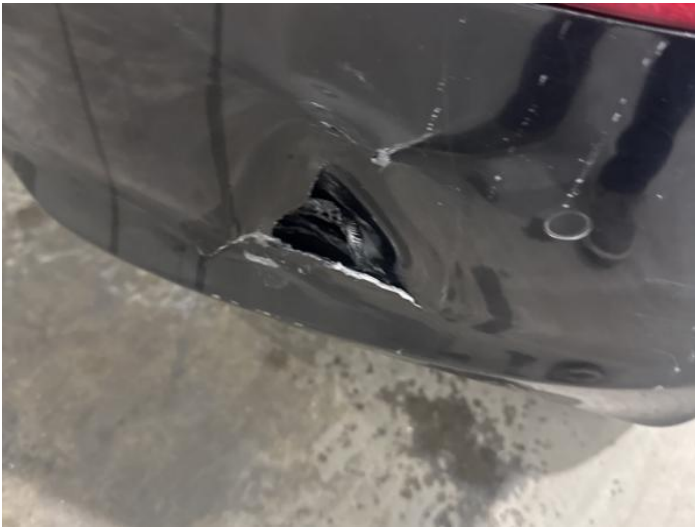
11: Bumper Rear
Hole
Over 25mm

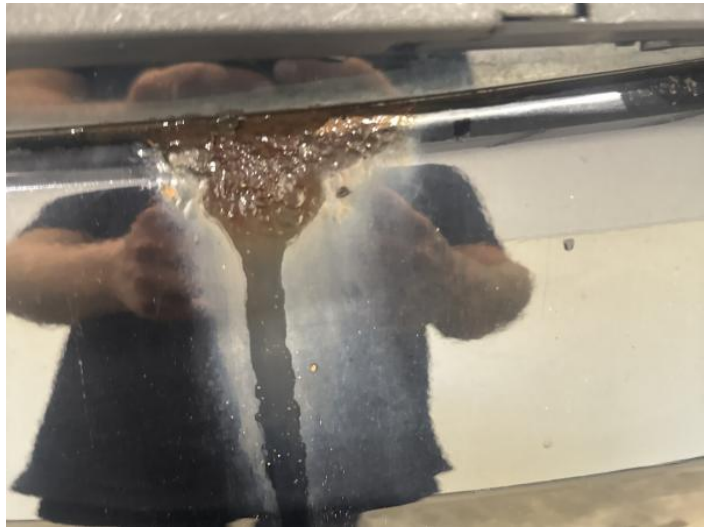
12: Boot Lid
Rusted
Over 5mm

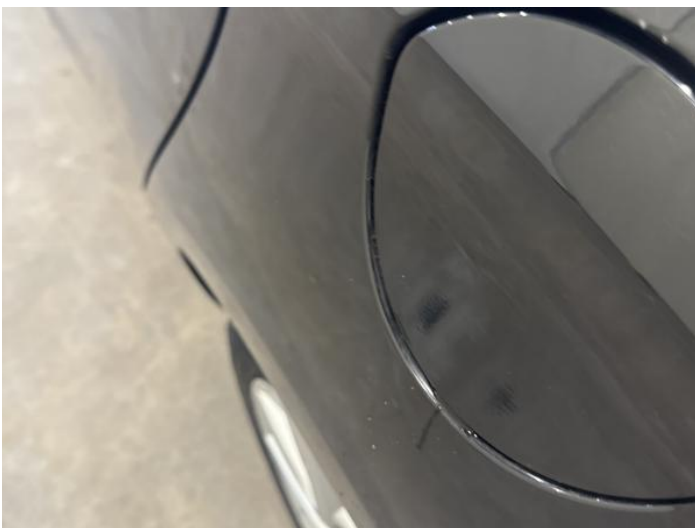
13: Qtr Panel nsr
Dented
With Paint Damage

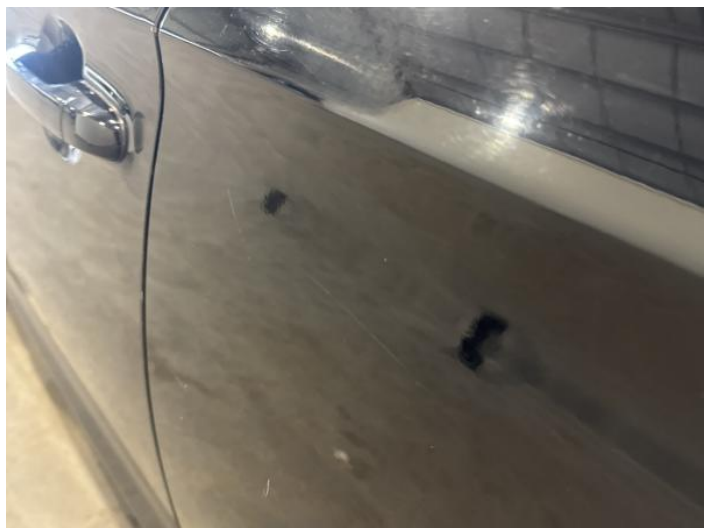
14: Door nsr
Dented
With Paint Damage

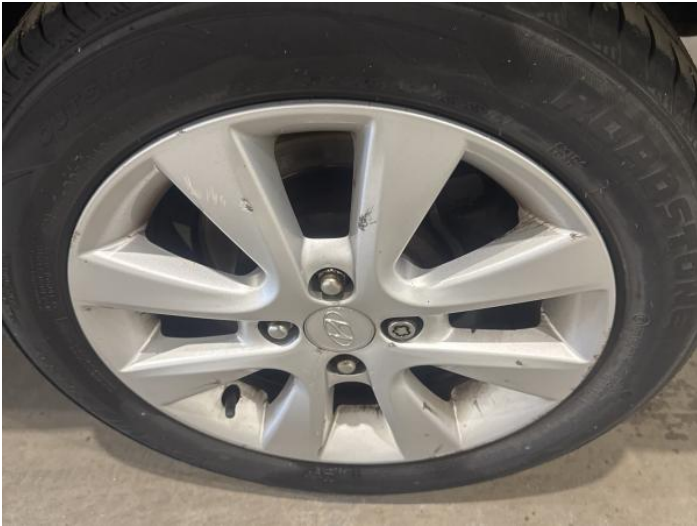
15: Wheel nsf
Scratched
Over 50mm

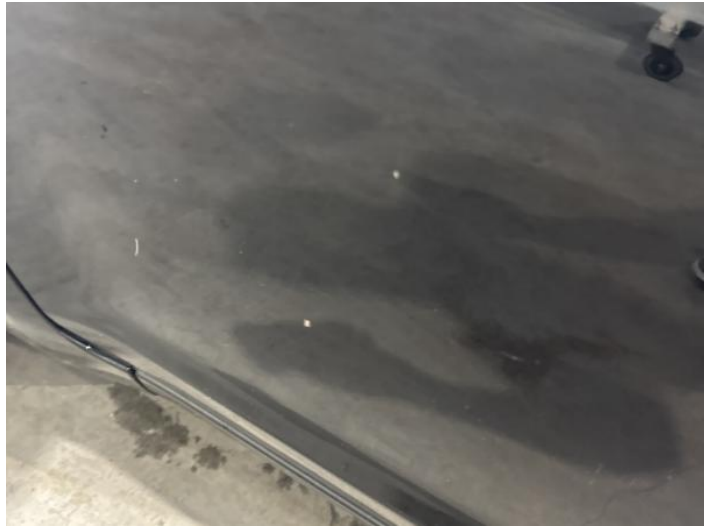
16: Door nsf
Chipped
Multiple Chips

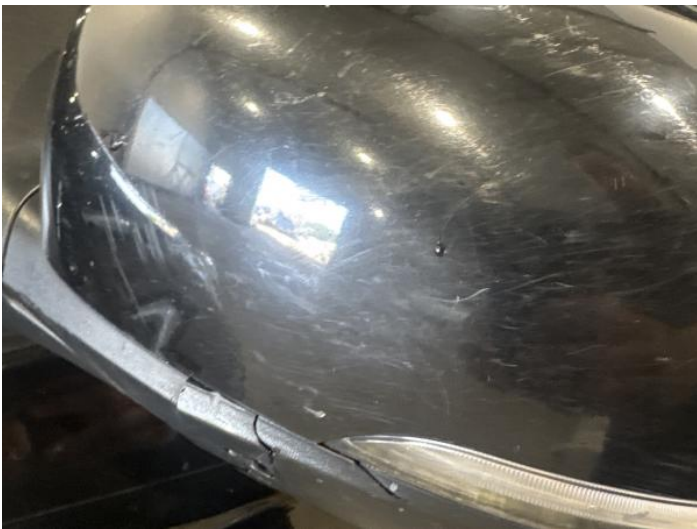
17: Door Mirror Assy nsf
Broken
Replace

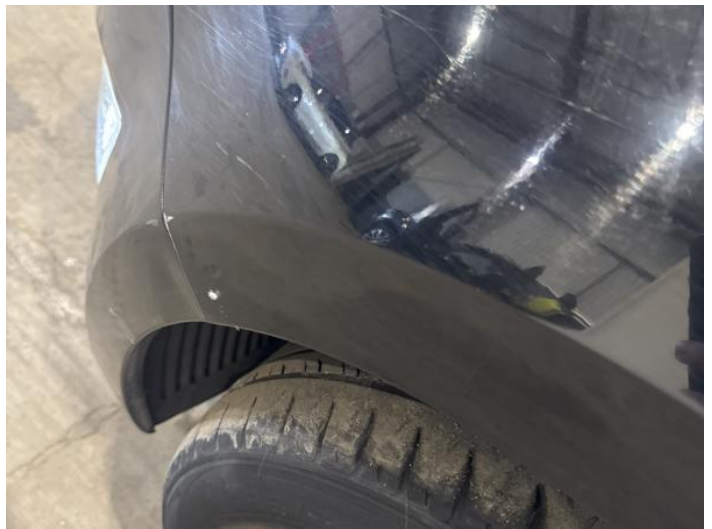
18: Wing nsf
Scratched
Over 25mm Thru Paint

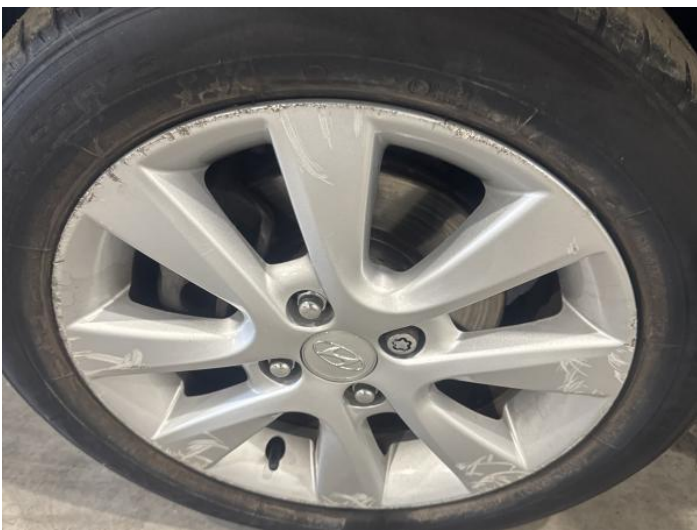
19: Wheel nsf
Scratched
Over 50mm
