VEHICLE INSPECTION REPORT

VN59NZO

Skoda Octavia 2.0 TDI PD Laurin + Klement 5dr DSG

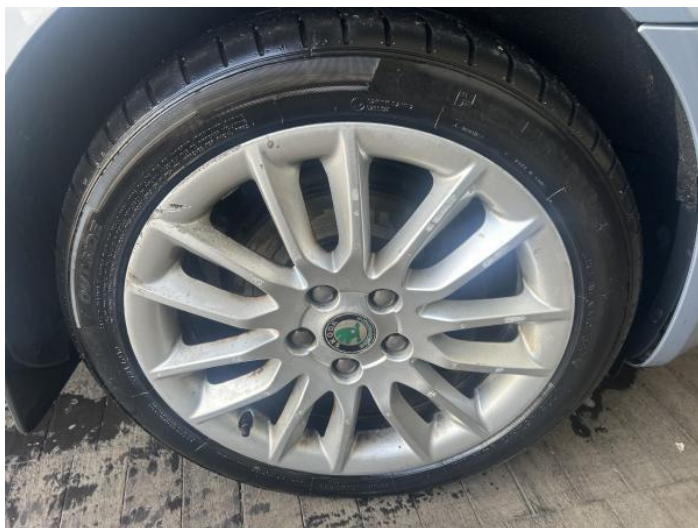
1: Wheel osf
Scratched
Over 50mm

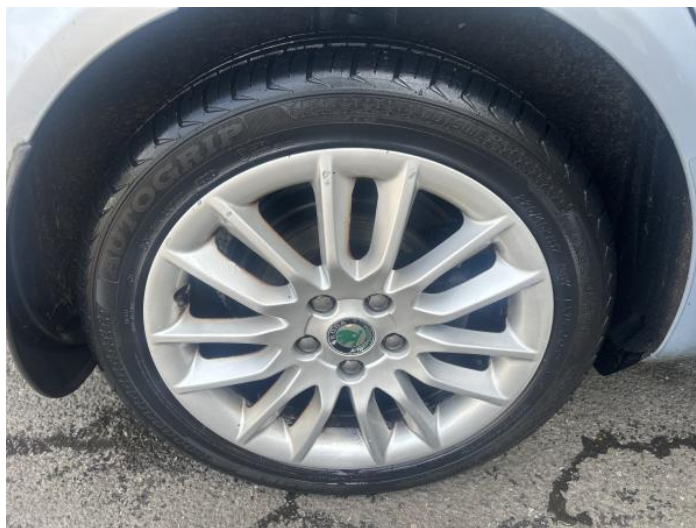
2: Wheel osr
Scratched
Over 50mm

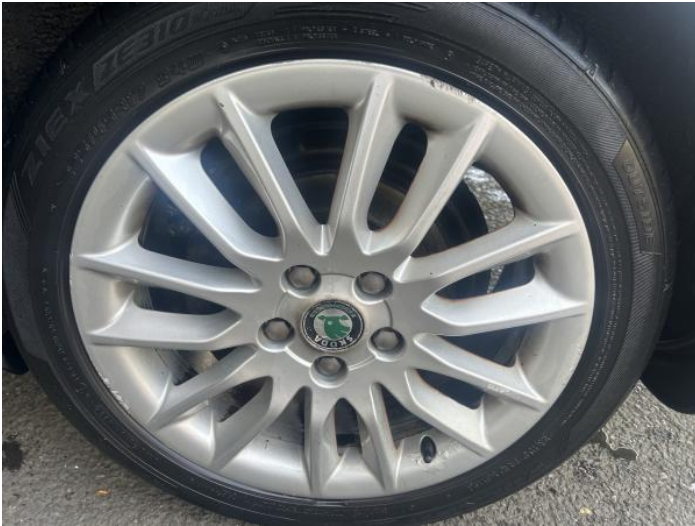
3: Wheel nsr
Scratched
Over 50mm

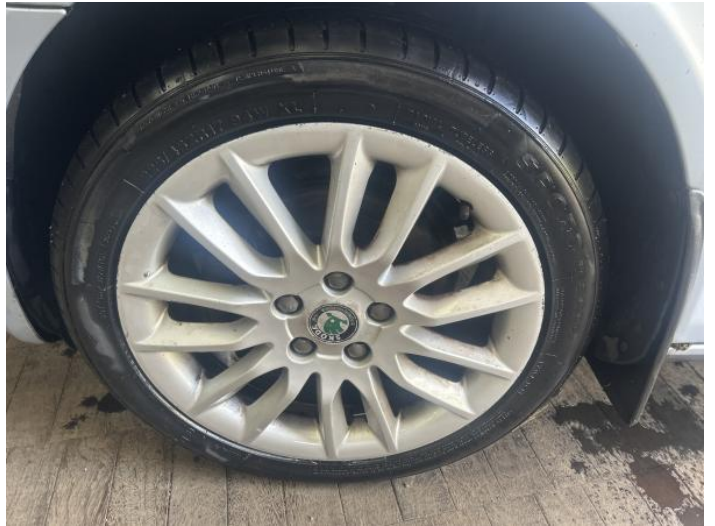
4: Wheel nsf
Scratched
Over 50mm

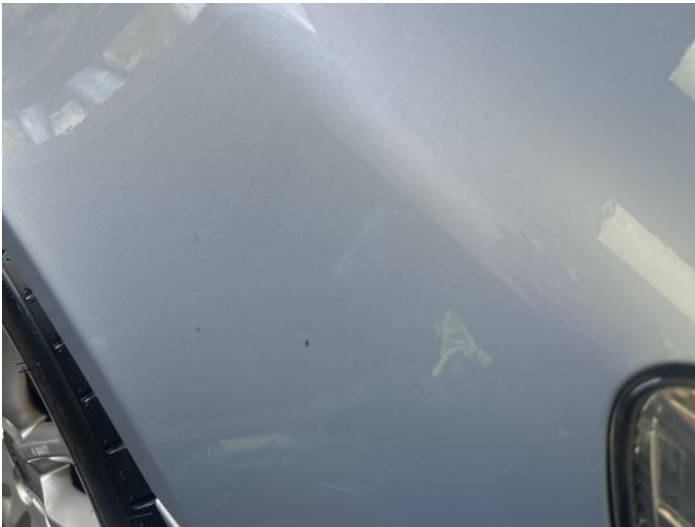
5: Wing osf
Chipped
1 To 5

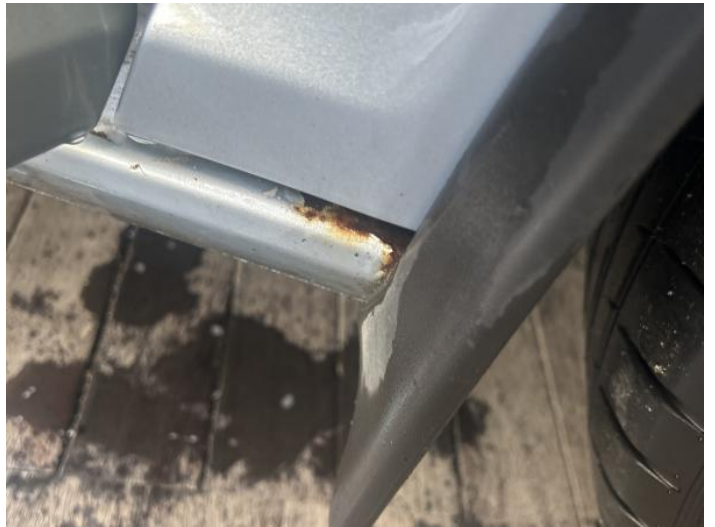
6: Sill os
Rusted
Over 5mm

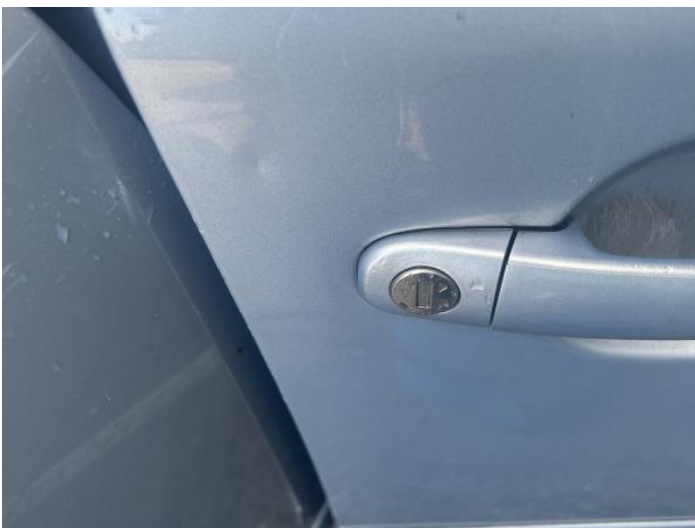
7: Door osf
Dented
2 Or Less UpTo 10mm

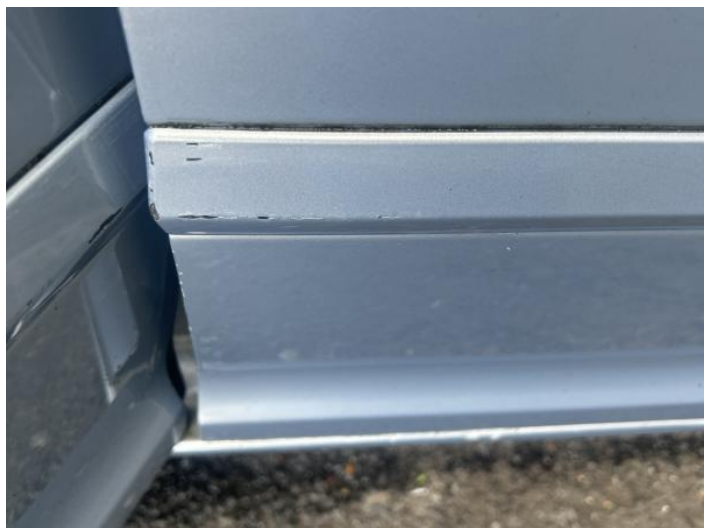
8: Door Moulding osf
Scratched (Painted)
Over 25mm Thru Paint

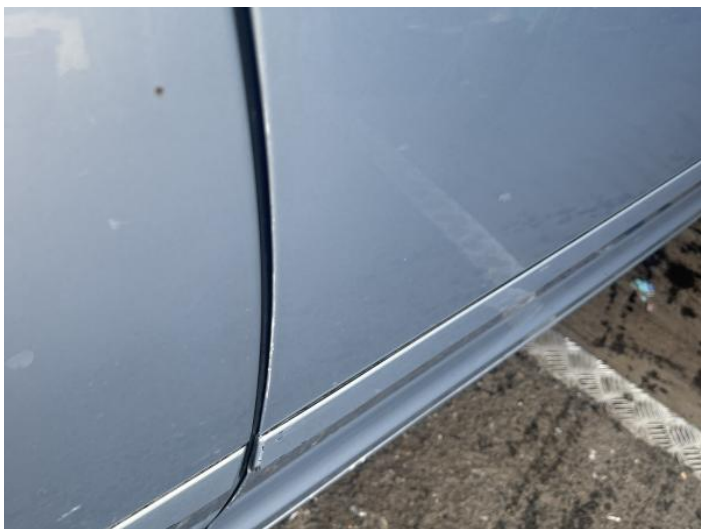
9: Door osf
Chipped
Edge Chip

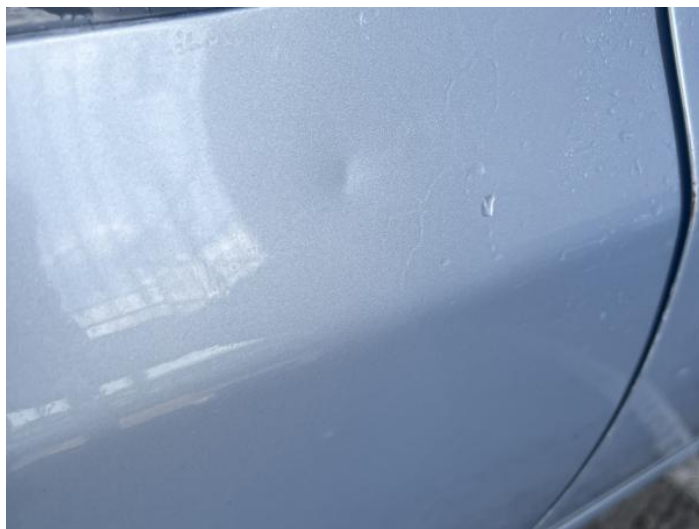
10: Door osr
Dented
2 Or Less UpTo 10mm

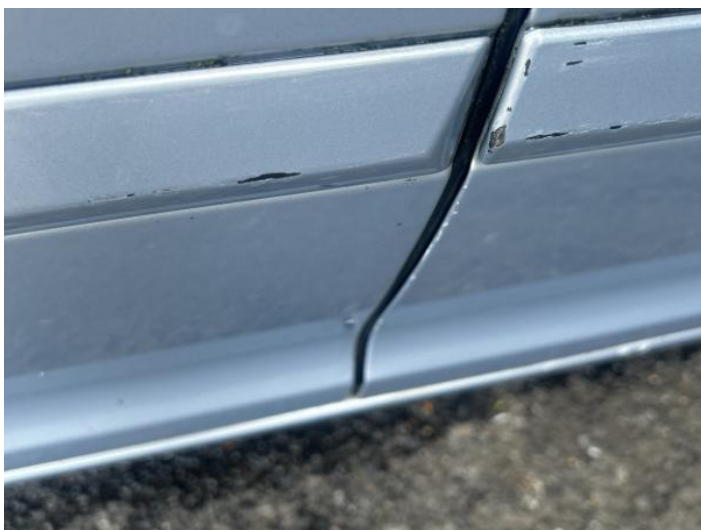
11: Door Moulding osr
Scratched (Painted)
UpTo 25mm Thru Paint

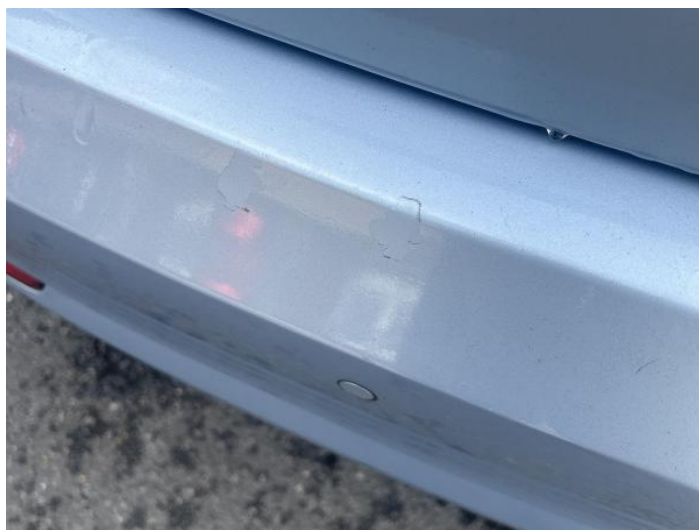
12: Bumper Rear
Poor Previous Repair
Paint Flake

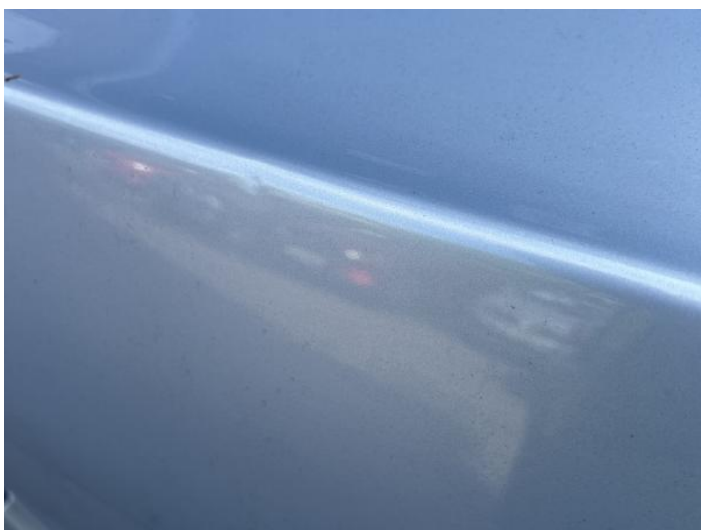
13: Tailgate
Dented
2 Or Less UpTo 10mm

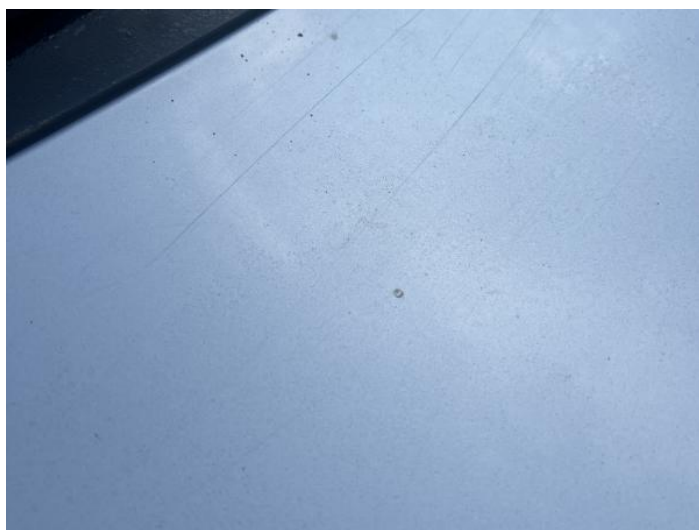
14: Tailgate
Scratched
Over 25mm Not Thru Paint

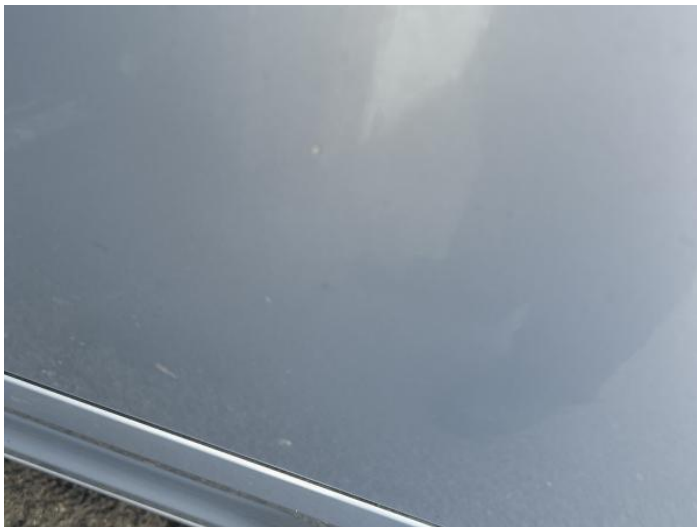
15: Door nsr
Chipped
1 To 5

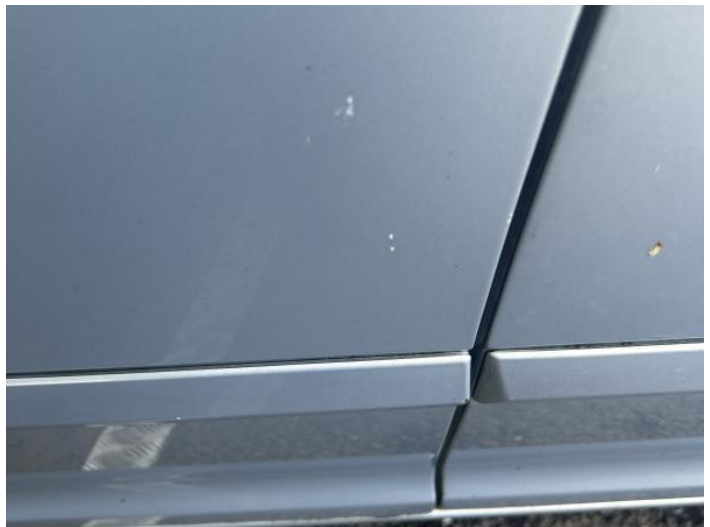
16: Door nsf
Chipped
1 To 5

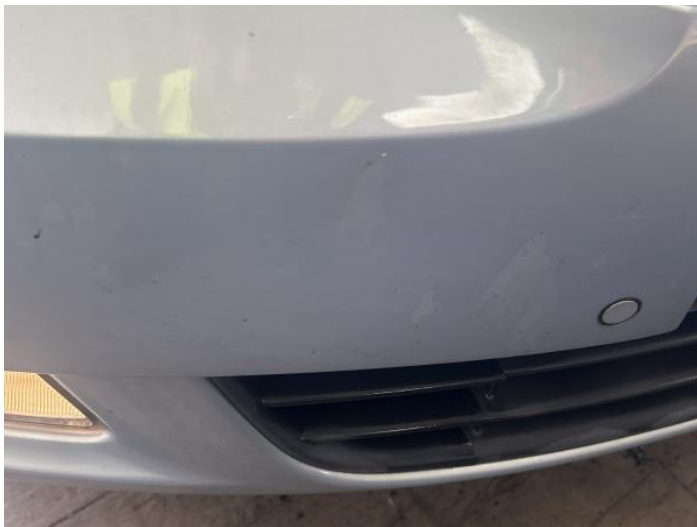
17: Bumper Front
Poor Previous Repair
Paint Flake

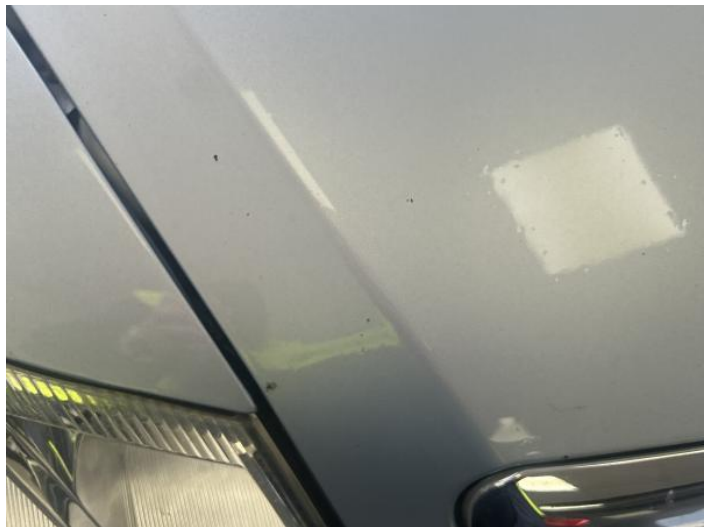
18: Bonnet
Chipped
1 To 5

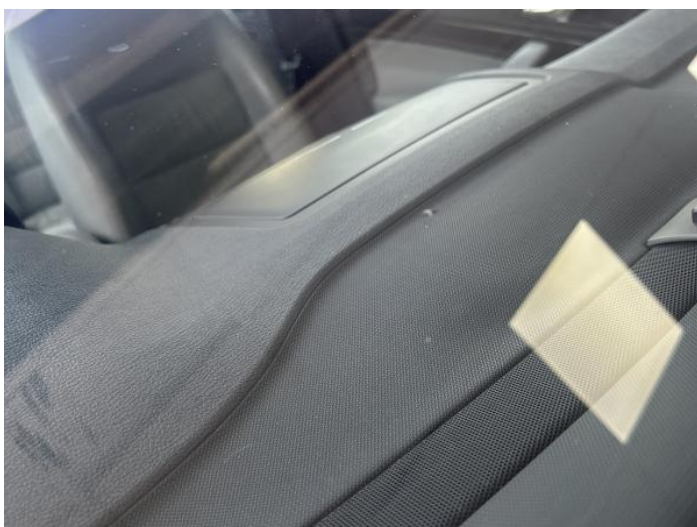
19: Screen Front
Chipped
UpTo 10mm
