### Vehicle Inspection Report

Date Inspected: 08/04/2025 13:28

**Reg:** GF65SNN

**VIN:** TMBKF75L1G6025371

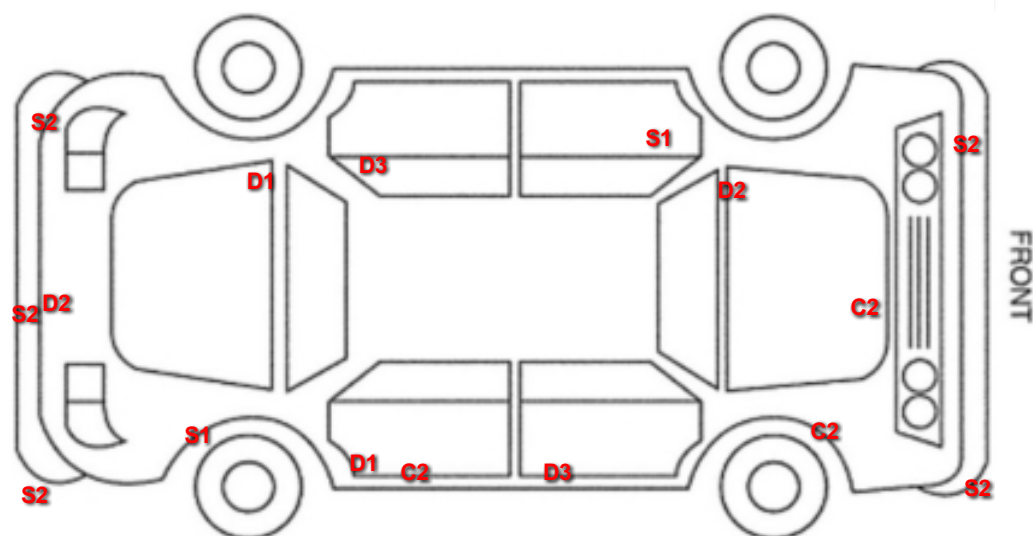
## Vehicle Splat

**Wing osf**  
Chipped  
1 To 5  
Smart  
Repair

**Wing osf**  
Scratched

Over  
25mm Not  
Thru Paint

**Door osf**  
Dented

With Paint  
Damage

**Door osr**  
Dented

Over 2  
UpTo  
10mm

**Door osr**  
Chipped

1 To 5

**Door osr**  
Scratched

**Qtr Panel  
osr**  
Scratched

UpTo  
25mm  
Thru Paint

**Bumper  
Rear**  
Scratched

Over  
100mm  
Thru Paint

**Bumper  
Rear  
Moulding**  
Scratched  
(Painted)

Over  
25mm  
Thru Paint

**Tailgate**  
Dented

**Qtr Panel  
nsr**  
Dented

**Door nsr**  
Dented

**Door nsf**  
Scratched

**Wing nsf**  
Dented

Over  
30mm

**Bumper  
Front**  
Scratched

**Bonnet**  
Chipped

Machine  
Polish

Repair  
and  
Refinish

Smart  
Repair

Refinish
