### Vehicle Inspection Report

**Reg:** GX71OYJ

**VIN:** JSAMFH91S00227763

<b>Make</b>	SUZUKI	<b>Body Type</b>	Hatchback	<b>Doors</b>	5
<b>Model</b>	IGNIS SZ3 DUALJET MHEV - 1197cc	<b>Fuel Type</b>	Hybrid	<b>Colour</b>	Green
<b>Mileage</b>	73617 miles	<b>Transmission</b>	Manual	<b>Year of MFR</b>	2021
		<b>Gears</b>	5	<b>Date First Reg</b>	17/09/2021

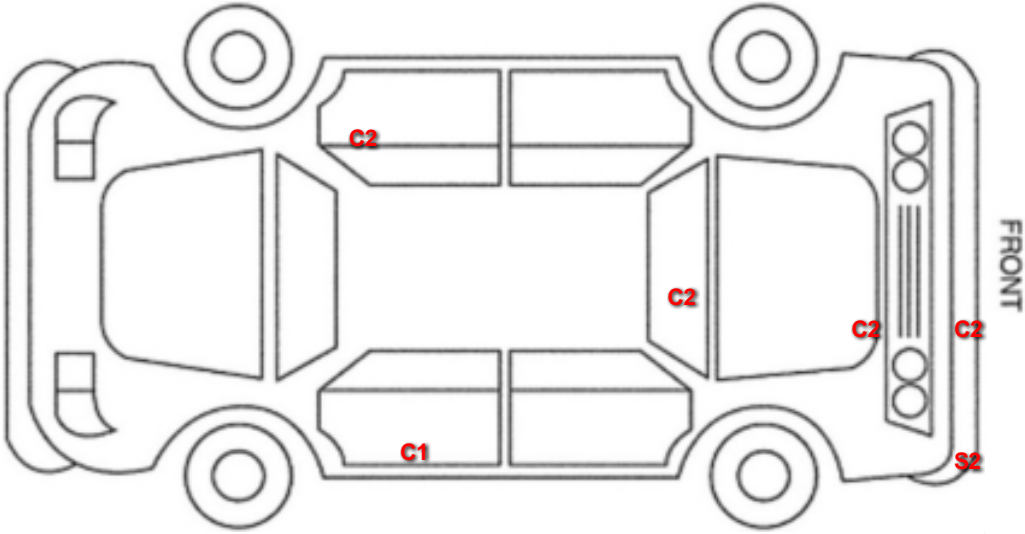
Vehicle Splat	Splat Key

<b>Door osr</b> Chipped 1 To 5 Smart Repair

<b>Door nsr</b> Chipped 1 To 5 Smart Repair

<b>Bumper Front</b> Scratched 25 to 100mm Thru Paint Smart Repair

<b>Bumper Front</b> Chipped Multiple Chips Smart Repair

<b>Bonnet</b> Chipped 1 To 5 Smart Repair

<b>Screen Front</b> Chipped UpTo 10mm Smart Repair
