Vehicle Inspection Report

Reg: GX72KTV

Damage Assessment

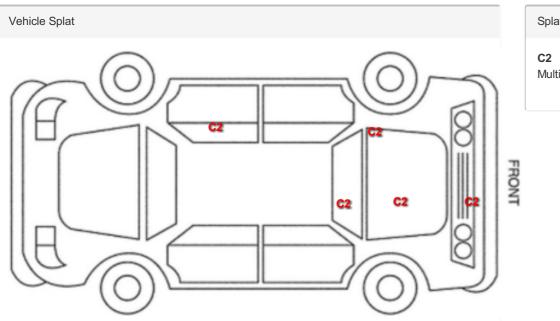
Component	Condition	Severity	Repair
Bumper Rear	Scratched	Over 25mm Not Thru Paint	Machine Polish
Qtr Panel nsr	Scratched	Over 25mm Not Thru Paint	Machine Polish
Door nsr	Scratched	Over 25mm Not Thru Paint	Machine Polish
Door nsr	Chipped	1 To 5	Smart Repair
Door nsf	Scratched	Over 25mm Not Thru Paint	Machine Polish
Wing nsf	Scratched	Over 25mm Not Thru Paint	Machine Polish
Wing nsf	Chipped	1 To 5	Smart Repair
Bumper Front	Scratched	Over 25mm Not Thru Paint	Machine Polish
Bumper Front	Chipped	Multiple Chips	Smart Repair
Bonnet	Chipped	1 To 5	Smart Repair
Screen Front	Chipped	UpTo 10mm	Smart Repair
Door osf	Scratched	Over 25mm Not Thru Paint	Machine Polish
Door osr	Scratched	Over 25mm Not Thru Paint	Machine Polish
