Vehicle Inspection Report

Reg: LD60KGZ

Make MINI Model

COOPER CLUBMAN -1598cc

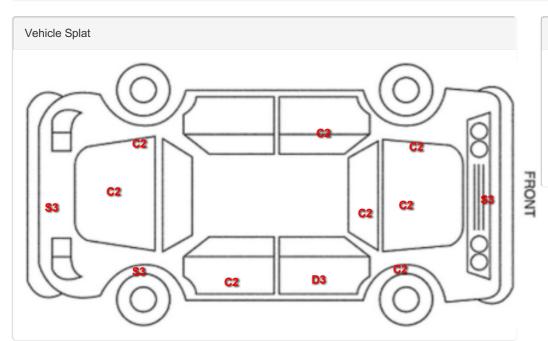
Component	Condition	Severity	Repair
Bonnet	Chipped	Multiple Chips	Refinish
Bumper Front	Scratched	Over 100mm Thru Paint	Refinish
Screen Front	Chipped	UpTo 10mm	Smart Repair
Wing osf	Scratched	Over 25mm Not Thru Paint	Machine Polish
Wing osf	Chipped	1 To 5	Smart Repair
Door osf	Dented	With Paint Damage	Repair and Refinish
Door osr	Scratched	Over 25mm Not Thru Paint	Machine Polish
Door osr	Chipped	1 To 5	Smart Repair
Qtr Panel osr	Scratched	Over 25mm Thru Paint	Refinish
Roof	Scratched	Over 25mm Not Thru Paint	Machine Polish
Bumper Rear	Scratched	Over 100mm Thru Paint	Refinish
Boot Lid	Chipped	Multiple Chips	Refinish
Bumper Rear Moulding	Broken	Replace	Replace
Qtr Panel nsr	Scratched	Over 25mm Not Thru Paint	Machine Polish
Qtr Panel nsr	Chipped	1 To 5	Smart Repair
Door nsf	Chipped	Multiple Chips	Refinish
Wing nsf	Chipped	1 To 5	Smart Repair
Reflector	Broken	Replace	Replace
Qtr Panel nsr	Dented	With Paint Damage	Repair and Refinish

Door osr	Dented	2 Or Less UpTo 10mm	Smart Repair
Qtr Panel osr	Dented	2 Or Less UpTo 10mm	Smart Repair
