Vehicle Inspection Report

Reg: LC170GA

VIN: 6FPPXXMJ2PHM54202

Appraised By: Eastbourne Car Auctions

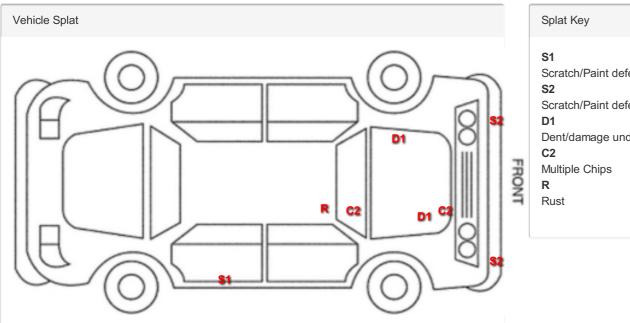
Scratch/Paint defect to 30mm
52
Scratch/Paint defect 30-100mm
01
Dent/damage under 30mm
C2
Multiple Chips
2
