Vehicle Inspection Report

Reg: LM18GGJ

VIN: AHTHB3CD902126961

Make	TOYOTA	Body Type	Pickup	Doors	5
Model	HILUX ICON D-4D	Fuel Type	Diesel	Colour	Black
	4WD DCB A - 2393cc	Transmission	Auto	Year of MFR	2018
Mileage	108,076 miles			Date First Reg	02/07/2018

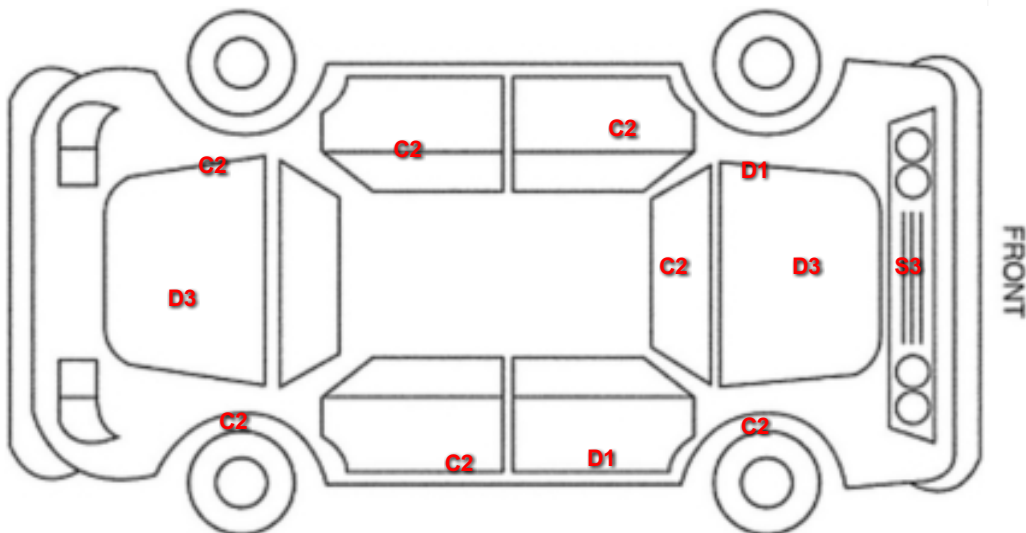
Vehicle Splat

Component	Condition	Severity	Repair
Boot Lid	Dented	With Paint Damage	Repair and Refinish
Bumper Rear	Scratched	Over 25mm Not Thru Paint	Machine Polish
Qtr Panel nsr	Scratched	Over 25mm Not Thru Paint	Machine Polish
Qtr Panel nsr	Chipped	1 To 5	Smart Repair
Qtr Panel osr	Scratched	Over 25mm Not Thru Paint	Machine Polish
Qtr Panel osr	Chipped	1 To 5	Smart Repair
Door nsr	Scratched	Over 25mm Not Thru Paint	Machine Polish
Door nsr	Chipped	1 To 5	Smart Repair
Door nsf	Scratched	Over 25mm Not Thru Paint	Machine Polish
Door nsf	Chipped	1 To 5	Smart Repair
Wing nsf	Scratched	Over 25mm Not Thru Paint	Machine Polish
Wing nsf	Dented	2 Or Less UpTo 10mm	Smart Repair
Screen Front	Chipped	UpTo 10mm	Smart Repair
Bumper Front	Scratched	Over 100mm Thru Paint	Refinish
Bonnet	Dented	With Paint Damage	Repair and Refinish
Wing osf	Scratched	Over 25mm Not Thru Paint	Machine Polish
Wing osf	Chipped	1 To 5	Smart Repair
Door osf	Scratched	Over 25mm Not Thru Paint	Machine Polish

Door osf	Dented	2 Or Less UpTo 10mm	Smart Repair
Door osr	Scratched	Over 25mm Not Thru Paint	Machine Polish
Door osr	Chipped	1 To 5	Smart Repair
Roof	Scratched	Over 25mm Not Thru Paint	Machine Polish
Door nsr	Dented	2 Or Less UpTo 10mm	Smart Repair
Door nsf	Dented	Between 10mm + 30mm	Smart Repair
