### Vehicle Inspection Report

Date Inspected: 14/04/2025 15:39

**Reg:** GF60RZC

**VIN:** SALFA2AE6BH229020

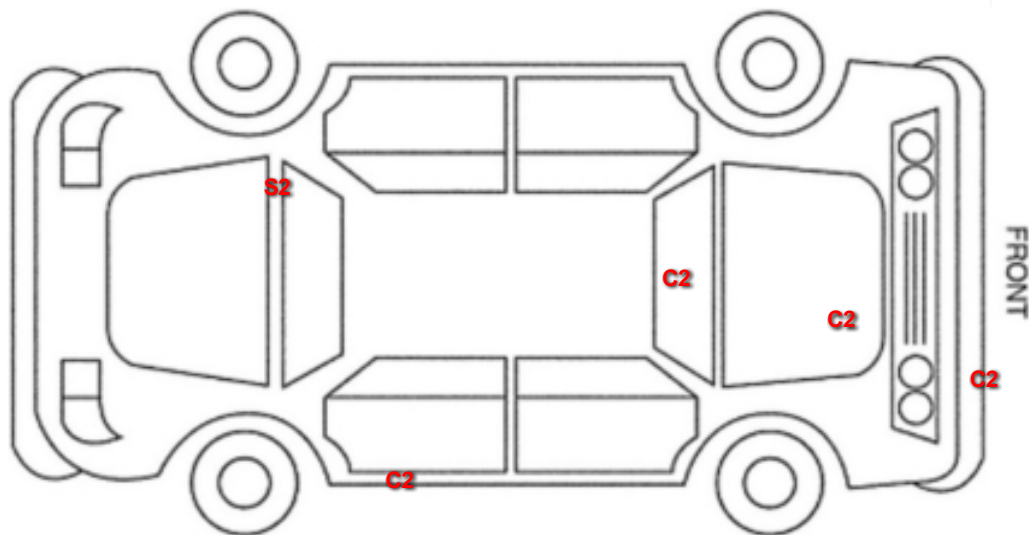
## Vehicle Splat

Damage Lines			
Component	Condition	Severity	Repair
Door osr	Chipped	1 To 5	Smart Repair
Bumper Rear	Scratched	Over 25mm Not Thru Paint	Machine Polish
Qtr Panel nsr	Scratched	Over 25mm Thru Paint	Refinish
Door Mirror Assy nsf	Scratched (Painted)	Over 25mm Not Thru Paint	Machine Polish
Bumper Front	Chipped	Multiple Chips	Smart Repair
Bonnet	Chipped	1 To 5	Smart Repair
Screen Front	Chipped	UpTo 10mm	Smart Repair
