### Vehicle Inspection Report

**Reg:** GU71UFN

**VIN:** JTDKBABB40A006515

<b>Make</b>	TOYOTA	<b>Body Type</b>	Hatchback	<b>Doors</b>	5
<b>Model</b>	YARIS CROSS ICON HEV AUTO - 1490cc	<b>Fuel Type</b>	Hybrid	<b>Colour</b>	Blue
<b>Mileage</b>	19430 miles	<b>Transmission</b>	Auto	<b>Year of MFR</b>	2021
				<b>Date First Reg</b>	08/10/2021

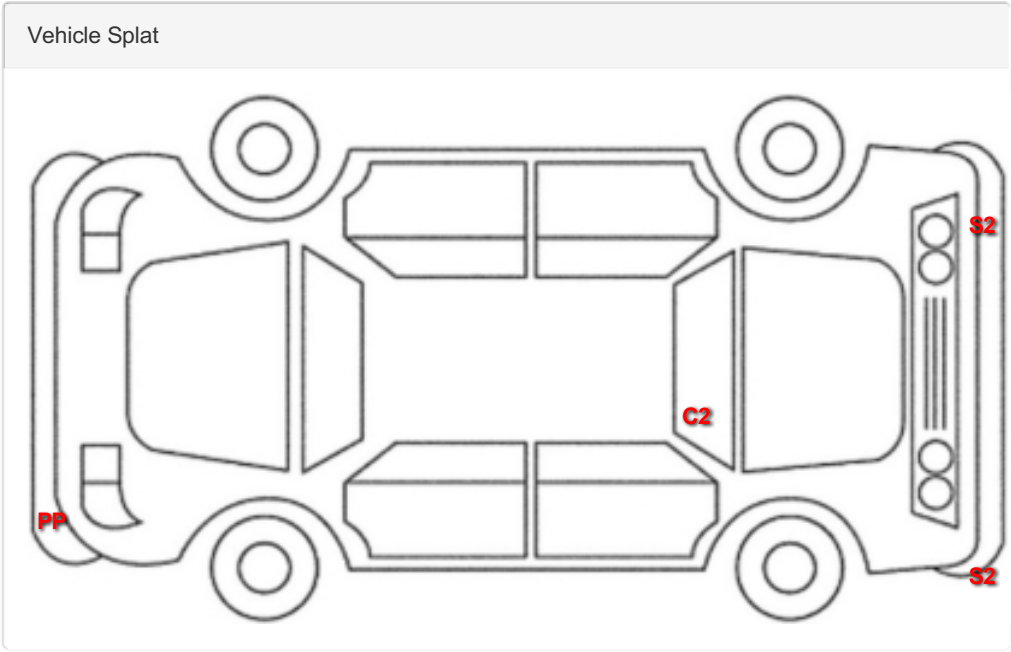
<b>Bumper Rear</b> Poor Previous Repair Poor Paint Refinish		<b>Qtr Panel nsr</b> Scratched Over 25mm Not Thru Paint Machine Polish
	<b>Door nsr</b> Scratched Over 25mm Not Thru Paint Machine Polish		<b>Wing nsf</b> Scratched Over 25mm Not Thru Paint Machine Polish		<b>Bumper Front</b> Scratched Over 100mm Thru Paint Refinish
	<b>Screen Front</b> Chipped UpTo 10mm Smart Repair
