# VEHICLE INSPECTION REPORT

**LG16ZRF**

## Ford Ranger Limited 4x4 Dcb Td - 2198cc

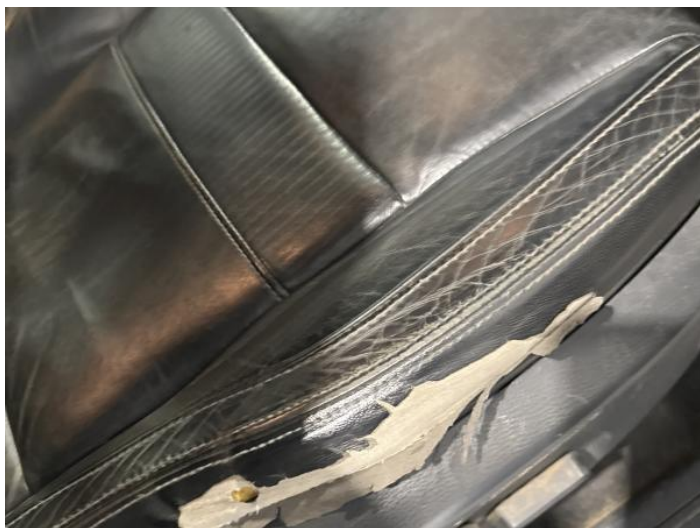
1: Seat Base Cover osf  
Torn  
Over 3mm

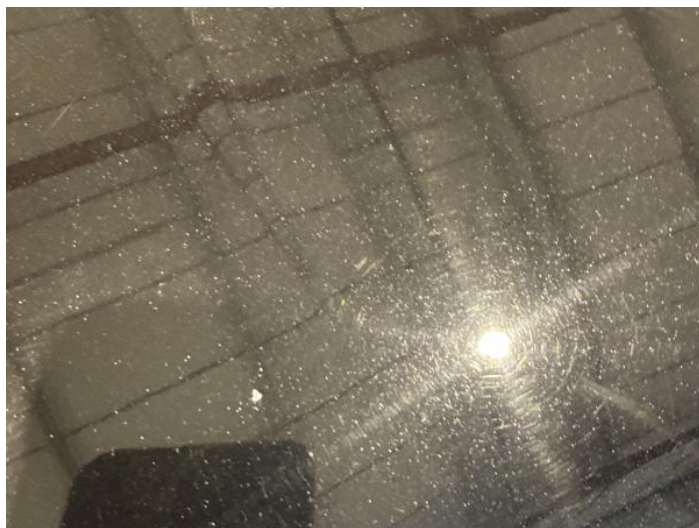
2: Bonnet  
Chipped  
1 To 5

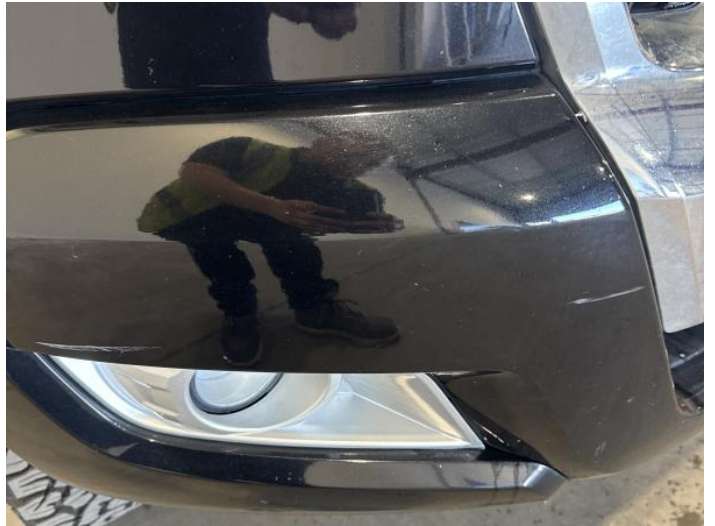
4: Bumper Front  
Scratched  
Over 100mm Thru Paint

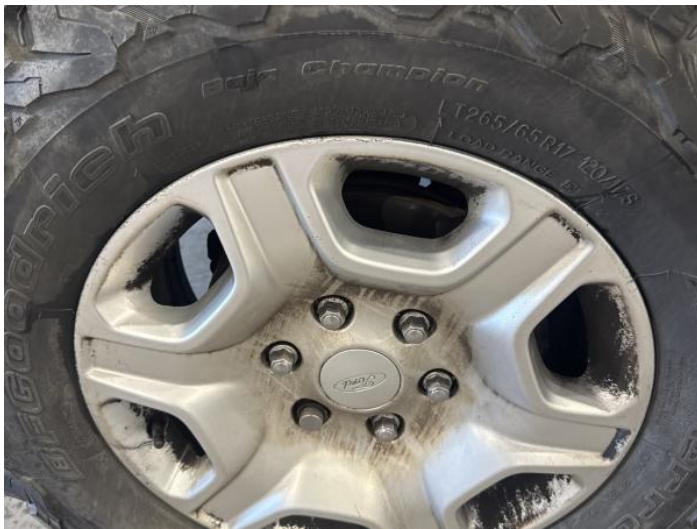
5: Wheel nsf  
Corroded  
Light

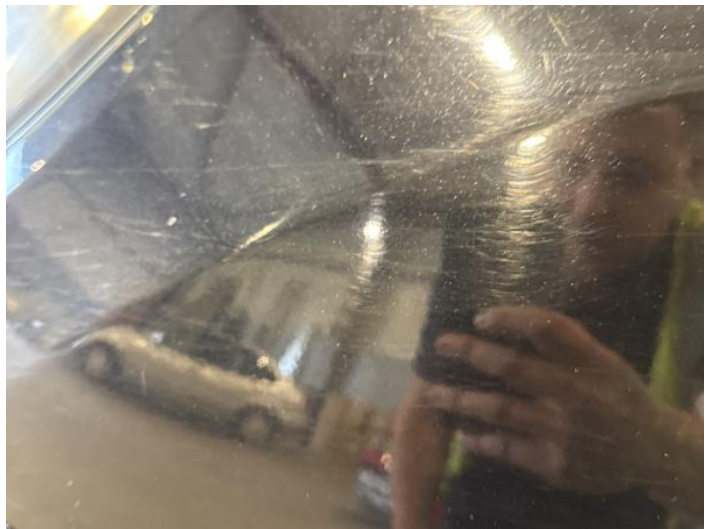
6: Wing nsf  
Chipped  
Multiple Chips

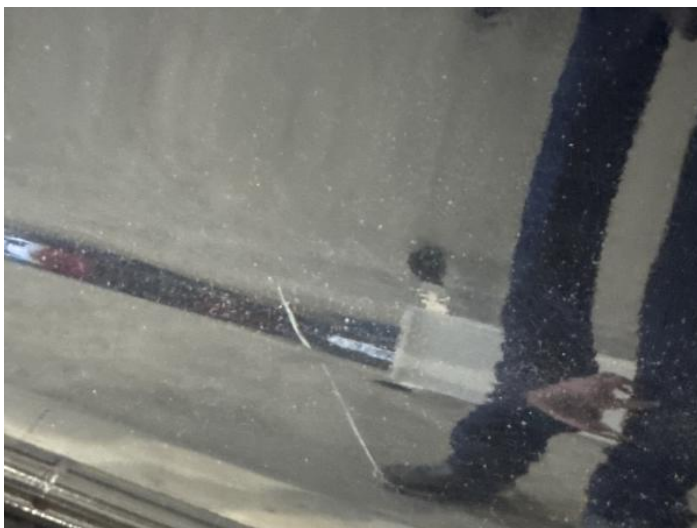
7: Door nsf  
Scratched  
Over 25mm Thru Paint

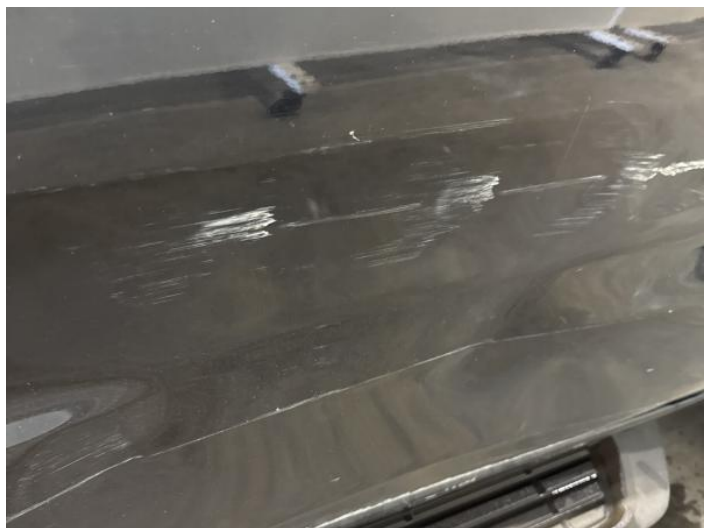
8: Door nsr  
Dented  
With Paint Damage

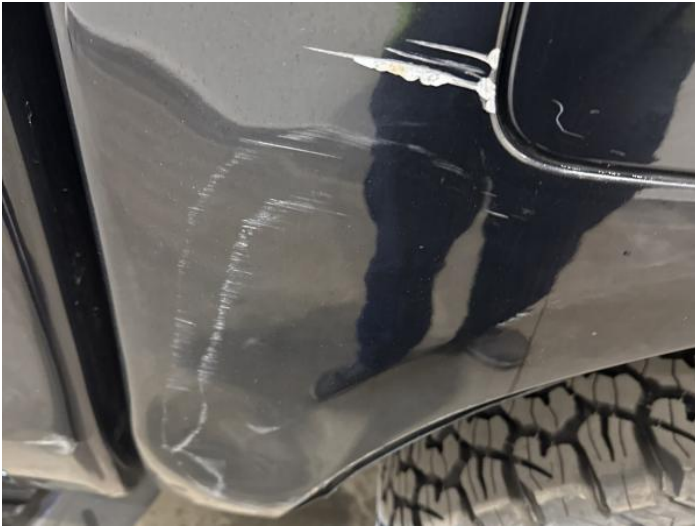
9: Qtr Panel nsr  
Dented  
With Paint Damage

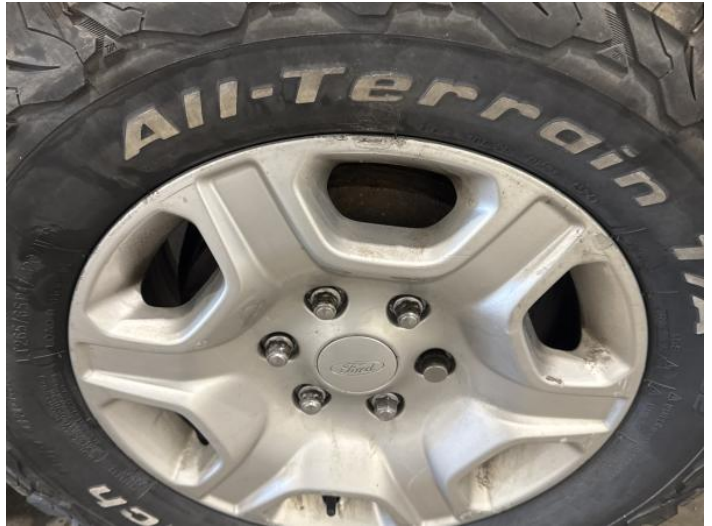
10: Wheel nsf  
Scratched  
Over 50mm

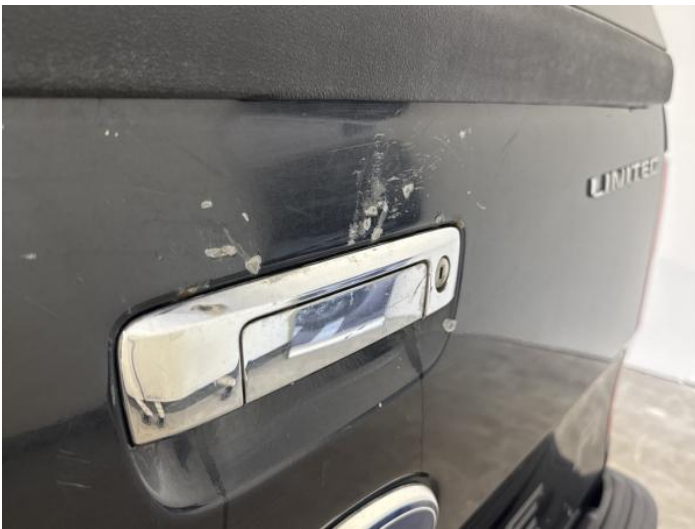
11: Boot Lid  
Dented  
With Paint Damage

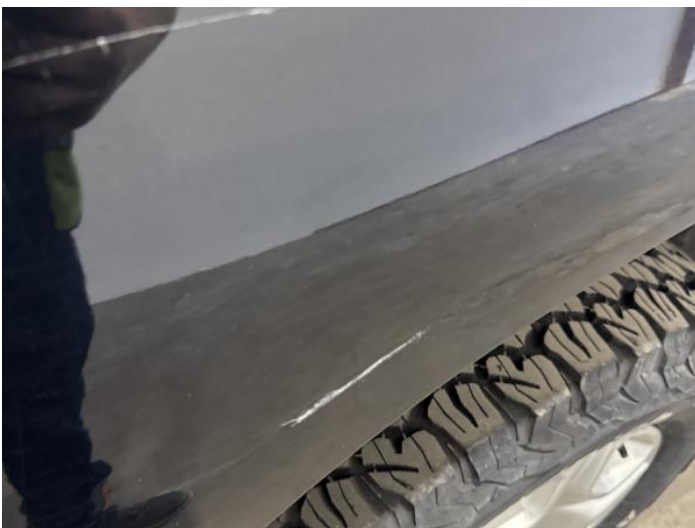
13: Qtr Panel osr  
Dented  
With Paint Damage

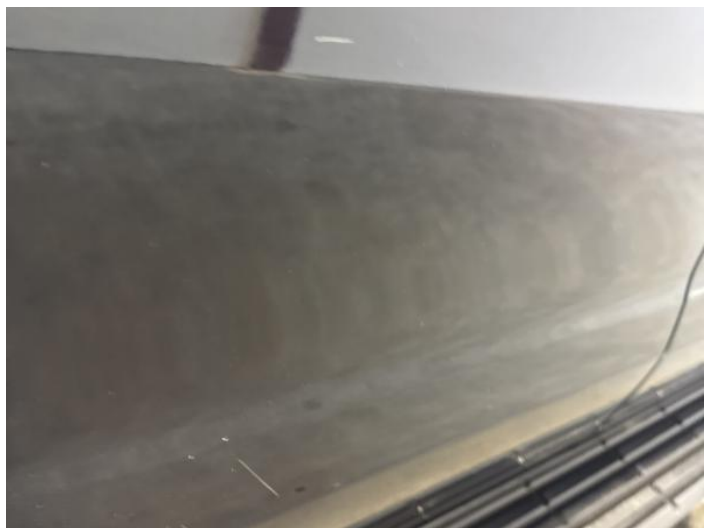
14: Door osr  
Dented  
With Paint Damage

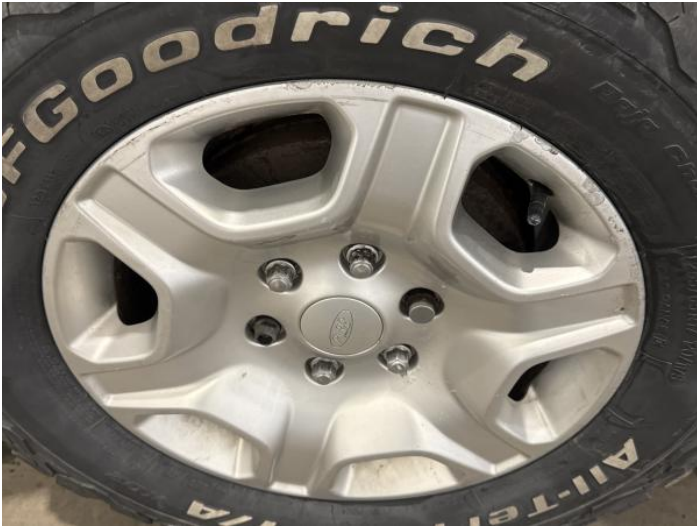
15: Wheel osr  
Scratched  
Over 50mm

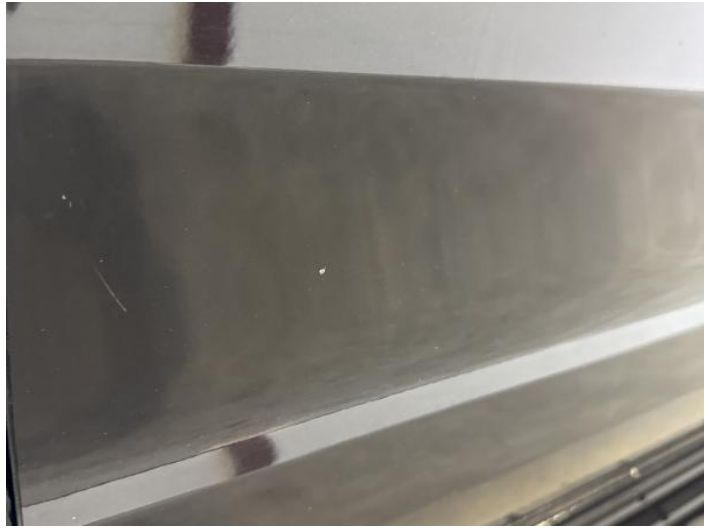
16: Door osr  
Chipped  
1 To 5

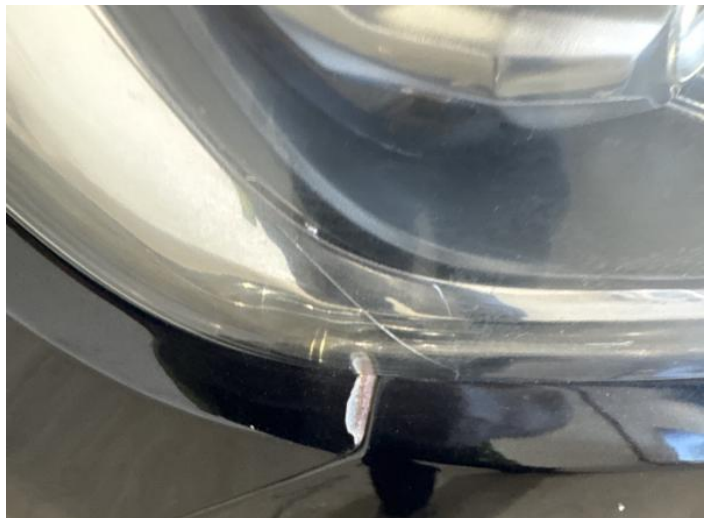
18: Wing osf  
Rusted  
Over 5mm

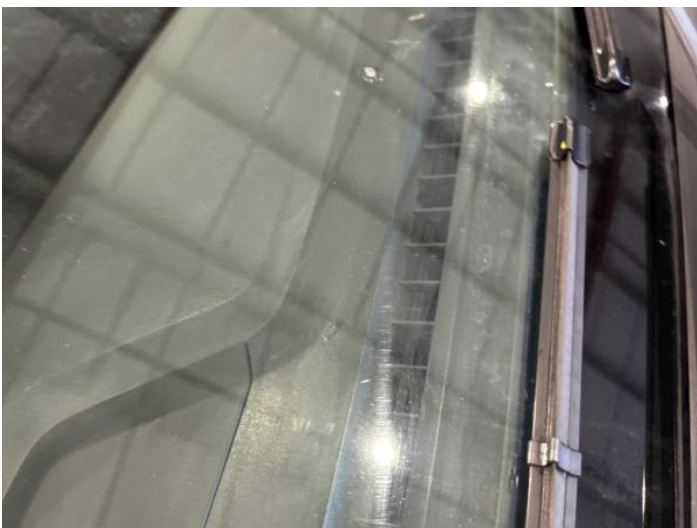
19: Screen Front  
Chipped  
UpTo 10mm

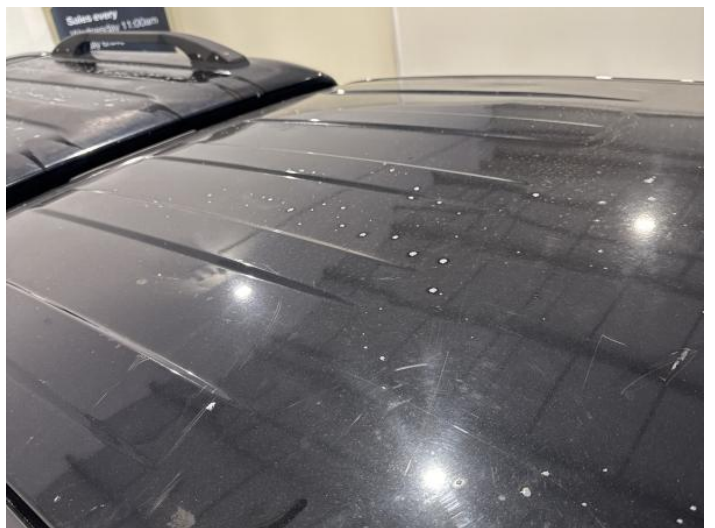
20: Roof  
Chipped  
Multiple Chips
