Vehicle Inspection Report

Reg: LL17EEY

Make	TOYOTA	Body Type	Pickup	Doors	5
Model	HILUX ICON D-4D 4WD DCB - 2393cc	Fuel Type	Diesel	Colour	Blue
Mileage	155,629 miles	Transmission	Manual	Year of MFR	2017
		Gears	6	Date First Reg	21/06/2017

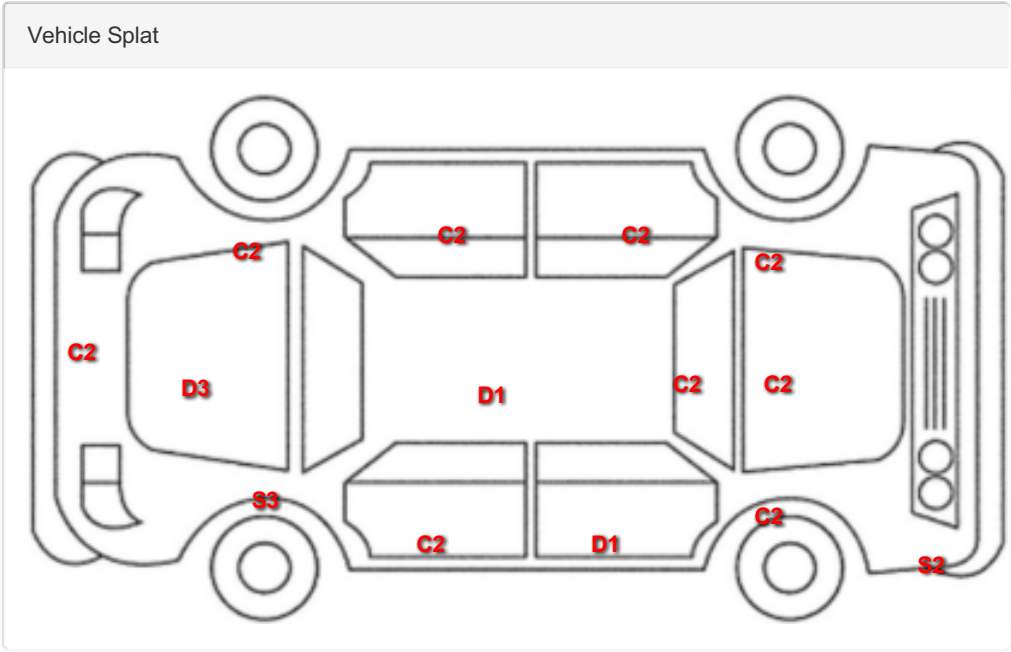
Component	Condition	Severity	Repair
Boot Lid	Dented	With Paint Damage	Repair and Refinish
Bumper Rear	Scratched	Over 25mm Not Thru Paint	Machine Polish
Bumper Rear	Chipped	Multiple Chips	Smart Repair
Qtr Panel nsr	Scratched	Over 25mm Not Thru Paint	Machine Polish
Qtr Panel nsr	Chipped	1 To 5	Smart Repair
Door nsr	Scratched	Over 25mm Not Thru Paint	Machine Polish
Door nsr	Chipped	1 To 5	Smart Repair
Door nsf	Scratched	Over 25mm Not Thru Paint	Machine Polish
Door nsf	Chipped	1 To 5	Smart Repair
Wing nsf	Scratched	Over 25mm Not Thru Paint	Machine Polish
Wing nsf	Chipped	1 To 5	Smart Repair
Bumper Front	Scratched	Over 25mm Not Thru Paint	Machine Polish
Bumper Front	Scratched	25 to 100mm Thru Paint	Smart Repair
Bonnet	Chipped	1 To 5	Smart Repair
Wing osf	Chipped	1 To 5	Smart Repair
Screen Front	Chipped	UpTo 10mm	Smart Repair
Door osf	Dented	Between 10mm + 30mm	Smart Repair
Door osr	Scratched	Over 25mm Not Thru Paint	Machine Polish

Door osr	Chipped	1 To 5	Smart Repair
Qtr Panel osr	Scratched	Over 25mm Thru Paint	Refinish
Roof	Dented	Between 10mm + 30mm	Smart Repair
Door nsr	Dented	Between 10mm + 30mm	Smart Repair
Door nsf	Dented	Between 10mm + 30mm	Smart Repair
Door osr	Dented	Between 10mm + 30mm	Smart Repair
Door Mirror Assy nsf	Broken	Replace	Replace
