Vehicle Inspection Report

Reg: YA61EWR

Appraised By: Eastbourne Car Auctions

Make	CITROEN	Body Type	Hatchback	Doors	5
Model	C1 VTR - 998cc	Fuel Type	Petrol	Colour	Black
Mileage	76,219 miles	Transmission	Manual	Year of MFR	2012
		Gears	5	Date First Reg	20/02/2012

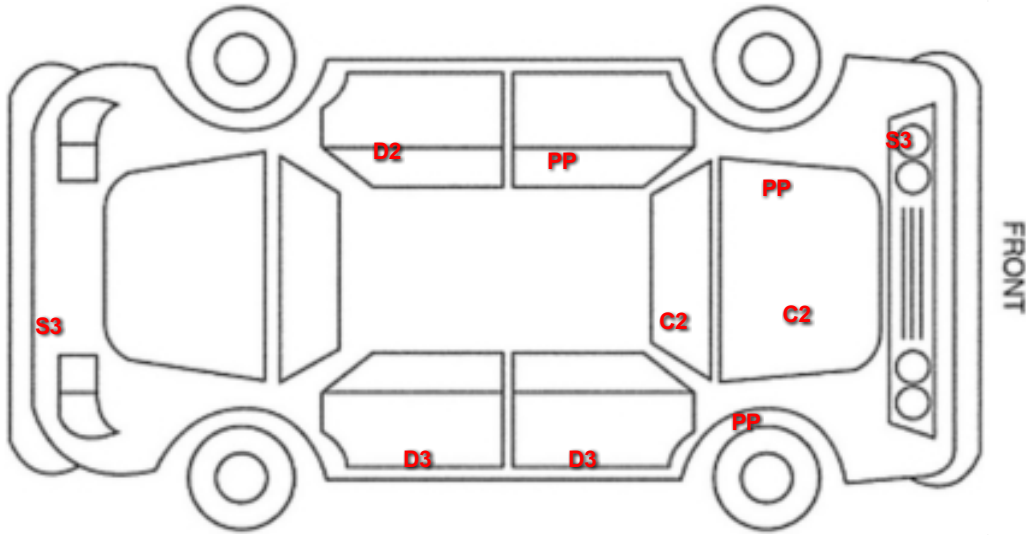
## Vehicle Splat

Component	Condition	Severity	Repair
Bumper Front	Scratched	25 to 100mm Thru Paint	Smart Repair
Bumper Front	Scratched	Over 25mm Not Thru Paint	Machine Polish
Bonnet	Chipped	1 To 5	Smart Repair
Wing osf	Poor Previous Repair	Poor Paint	Refinish
Screen Front	Chipped	UpTo 10mm	Smart Repair
Door osf	Dented	With Paint Damage	Repair and Refinish
Door osr	Dented	With Paint Damage	Repair and Refinish
Bumper Rear	Scratched	Over 100mm Thru Paint	Refinish
Door nsr	Dented	With Paint Damage	Repair and Refinish
Door nsf	Poor Previous Repair	Poor Paint	Refinish
Wing nsf	Poor Previous Repair	Poor Paint	Refinish
