## VEHICLE INSPECTION REPORT

**AU63NFH**

### Citroen Berlingo Multispace 1.6 e-HDi 90 Airdream VTR 5dr EGS6

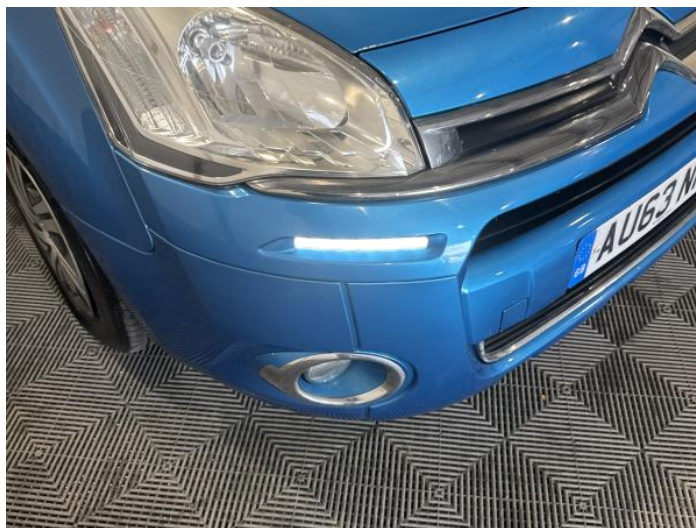
2: Bumper Front  
Chipped  
Multiple Chips

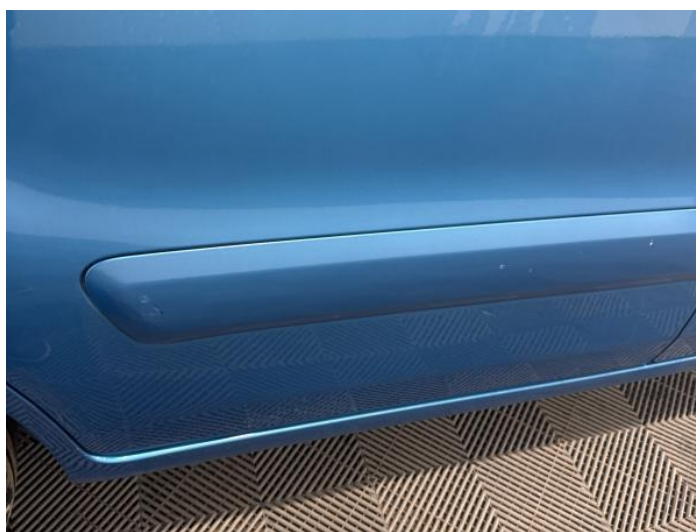
12: Door Moulding osr  
Scratched (Painted)  
Over 25mm Thru Paint
