Vehicle Inspection Report

Reg: WF68VWN

VIN: W0VZRHNS4KS020898

Appraised By: Eastbourne Car Auctions

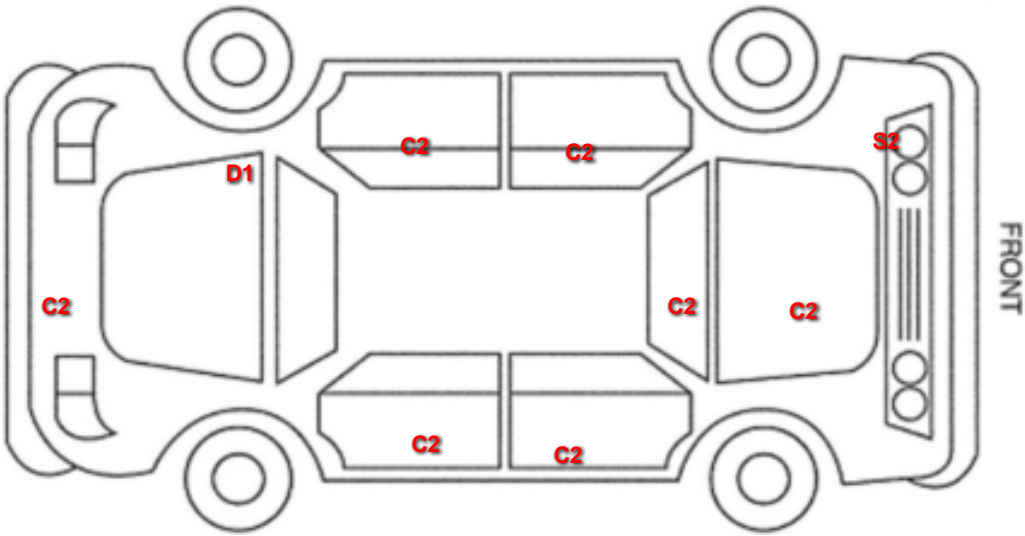
Vehicle Splat

S2
Scratch/Paint defect 30-100mm

D1
Dent/damage under 30mm

C2
Multiple Chips
