Vehicle Inspection Report

Date Inspected: 23/04/2025 15:39

Reg: VE63NHO

VIN: WMWZD52030WL72786

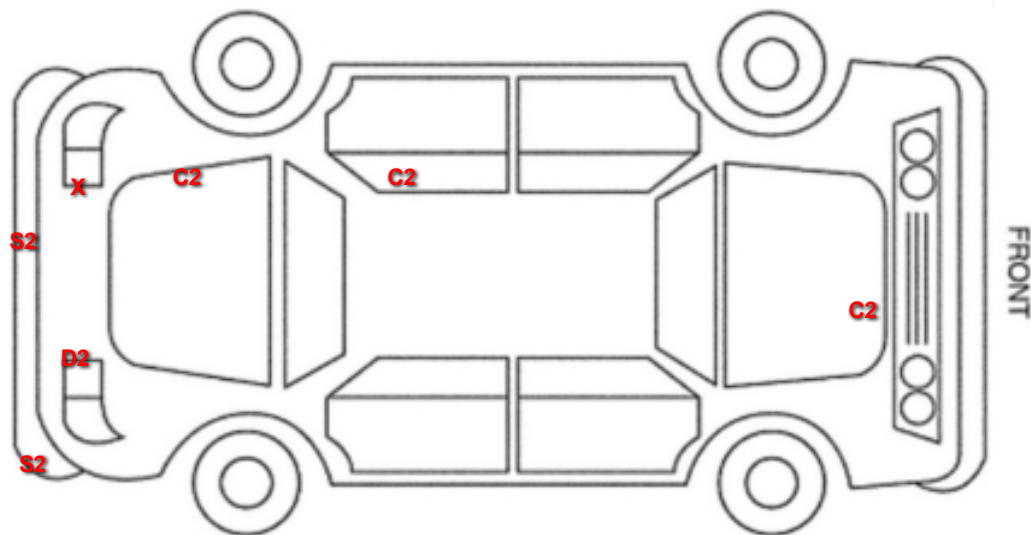
Vehicle Splat

Door Mirror Assy osf

Missing
Needs Replaced
Replace

Door osf

Scratched
Over 25mm Not Thru Paint
Machine Polish

Chipped
Edge Chip
Smart Repair

Door osr

Bumper Rear

Scratched
Over 100mm Thru Paint
Refinish

Tailgate

Dented
Over 30mm
Repair and Refinish

Qtr Panel nsr

Chipped
1 To 5
Smart Repair

Door nsr

Door nsf

Door Mirror Assy nsf

Scratched (Painted)
UpTo 25mm Thru Paint
Smart Repair

Bonnet

Chipped
Multiple Chips
Refinish

Lamp nsr

Broken
Needs Replaced
Replace
