# VEHICLE INSPECTION REPORT

**YB12CYF**

## Mini Clubman 1.6 Cooper 5dr

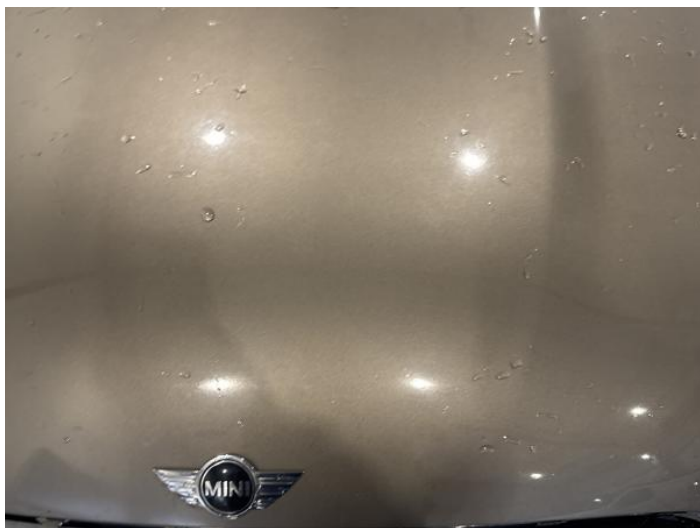
1: Bonnet  
Scratched  
Over 25mm Not Thru Paint

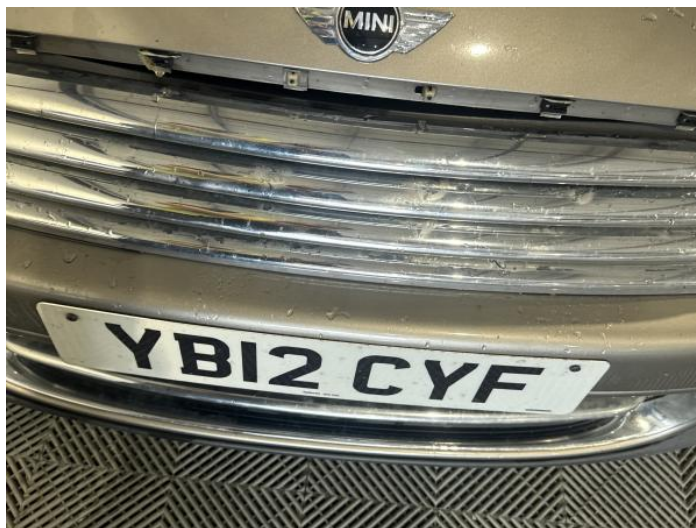
2: Bumper Front Grill  
Broken  
Replace

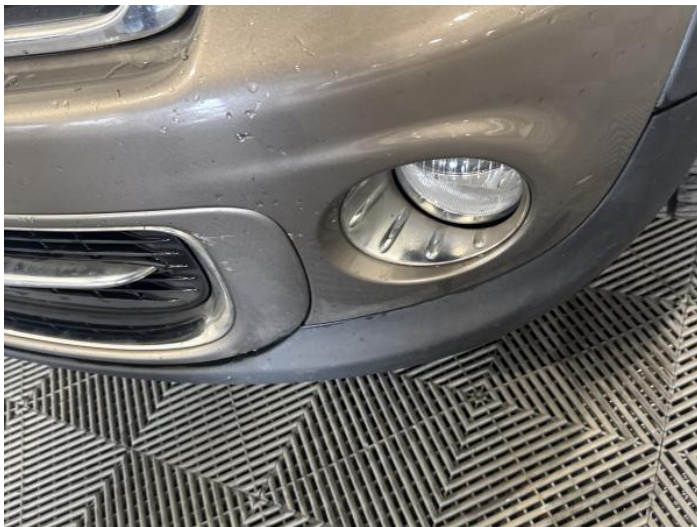
3: Bumper Front  
Scratched  
Over 100mm Thru Paint

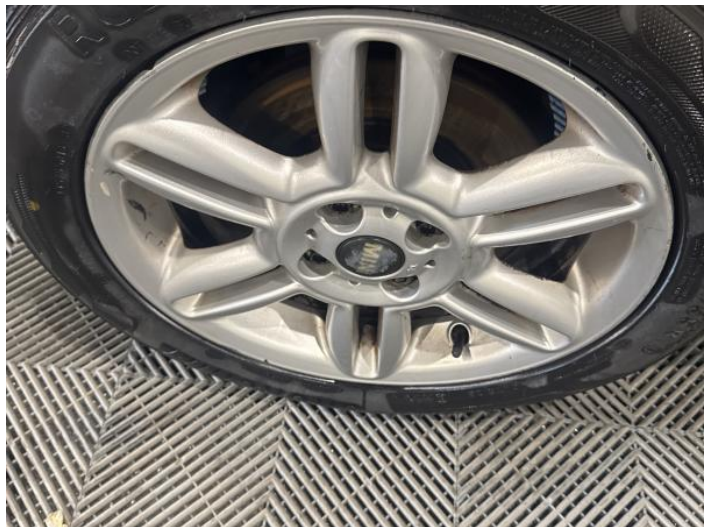
4: Wheel nsf  
Scratched  
Over 50mm

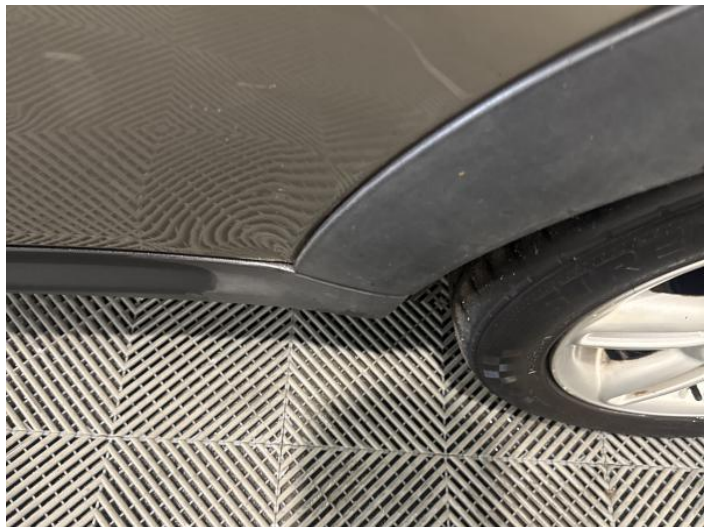
6: Qtr Panel nsr  
Dented  
With Paint Damage

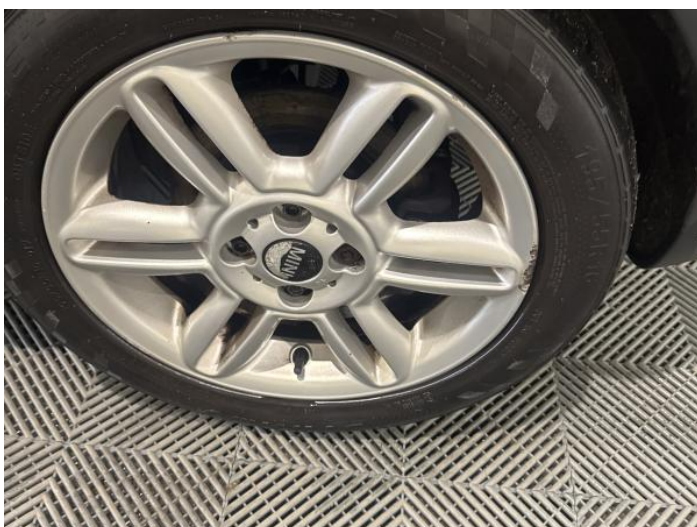
7: Wheel nsr  
Scratched  
Over 50mm

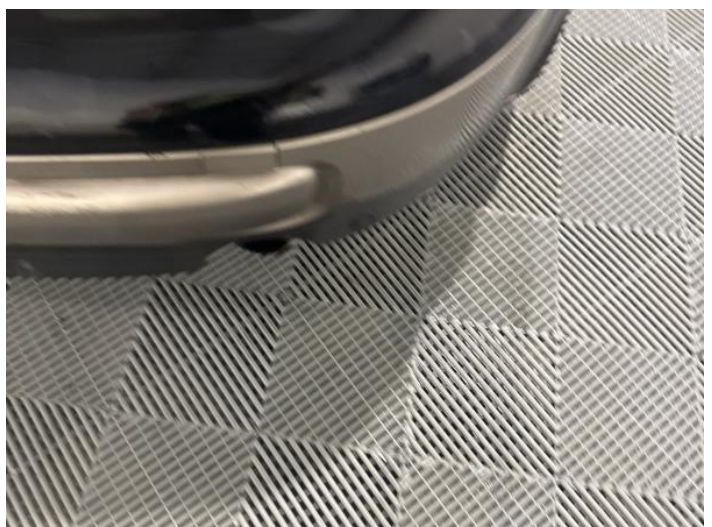
8: Bumper Rear  
Poor Previous Repair  
Rippled Over 30%

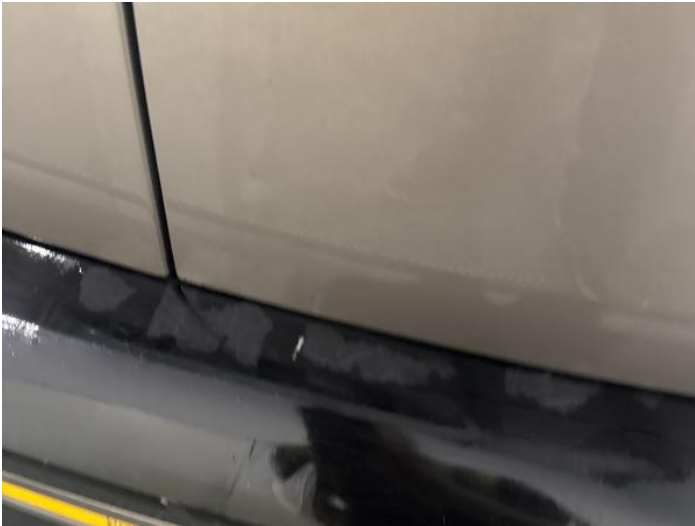
9: Boot Lid  
Dented  
Over 2 UpTo 10mm

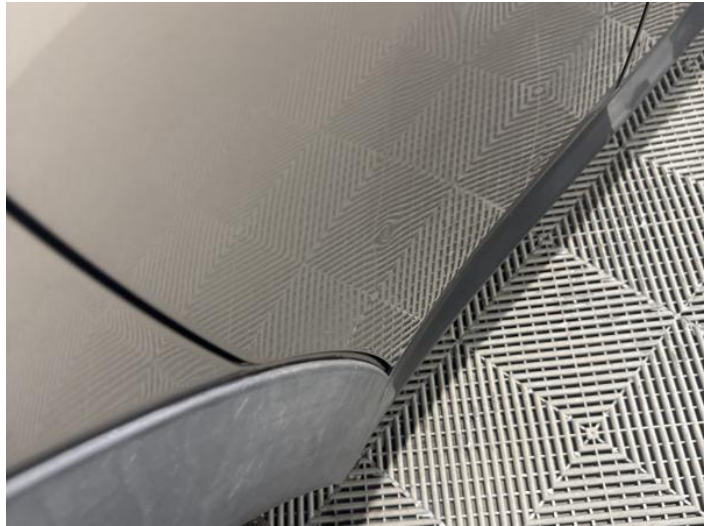
10: Door osr  
Dented  
Over 2 UpTo 10mm

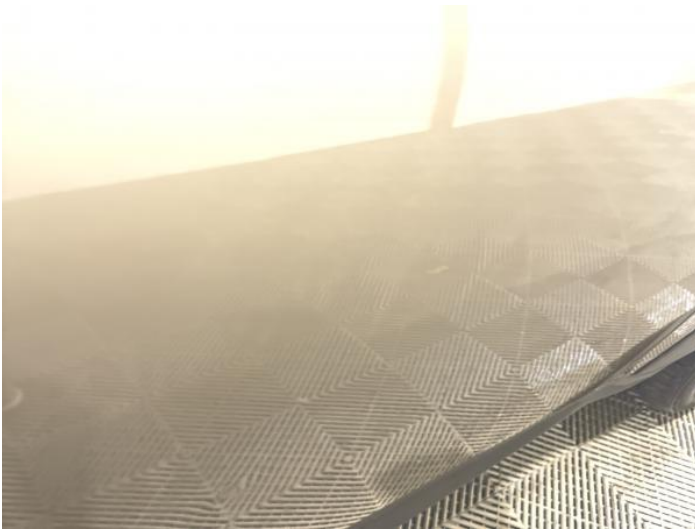
11: Door osf  
Dented  
Over 2 UpTo 10mm

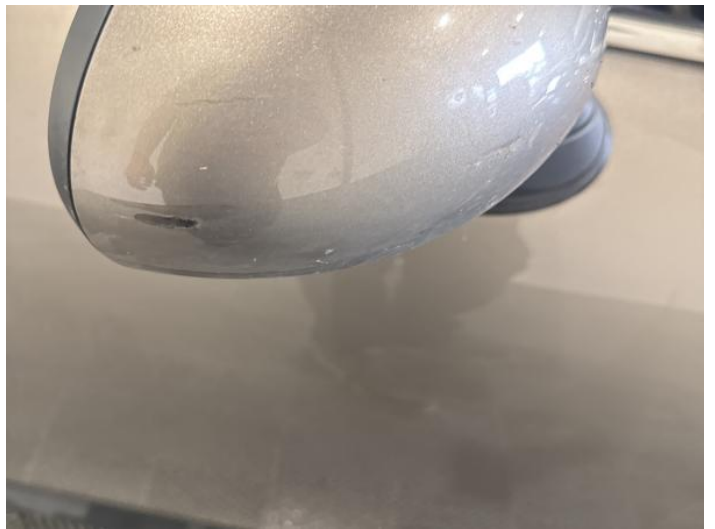
12: Door Mirror Assy osf  
Scratched (Painted)  
Over 25mm Thru Paint

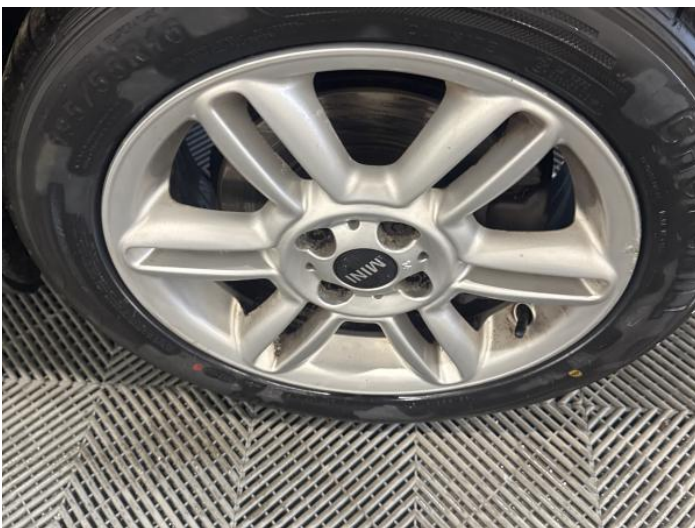
13: Wheel osf  
Scratched  
Over 50mm
