VEHICLE INSPECTION REPORT

HJ12XTW

Skoda Yeti 1.6 TDI CR SE GreenLine II 5dr

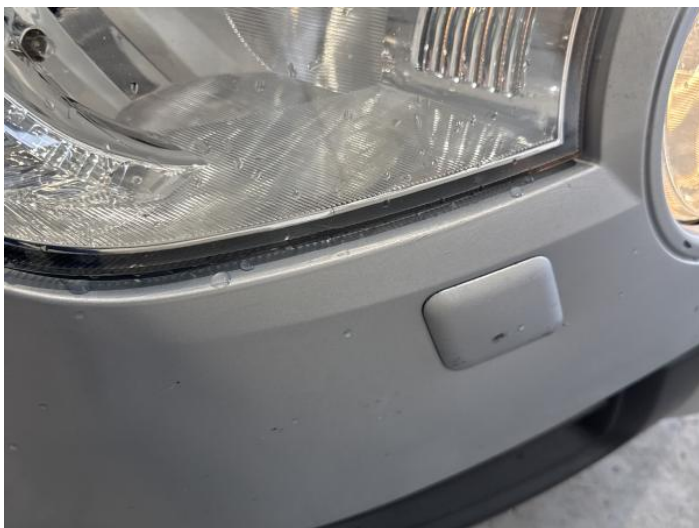
1: Bumper Front
Poor Previous Repair
Poor Paint

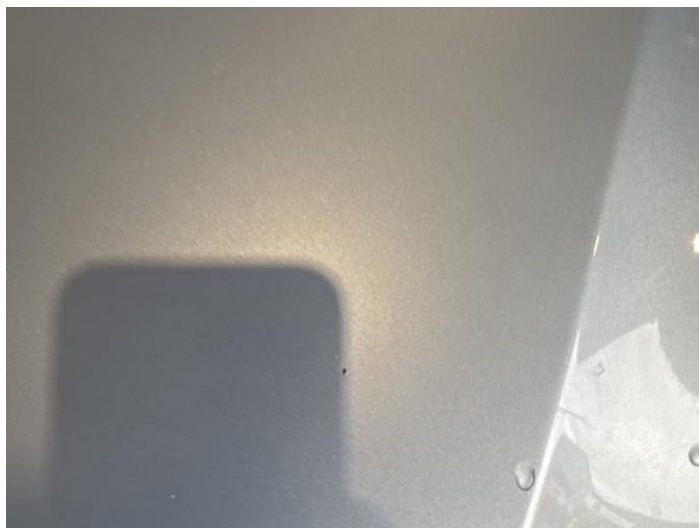
2: Bonnet
Chipped
1 To 5

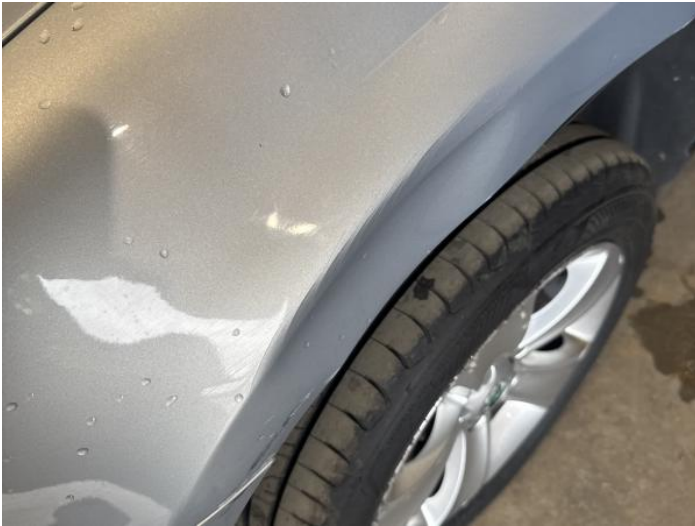
3: Wing nsf
Dented
Over 30mm

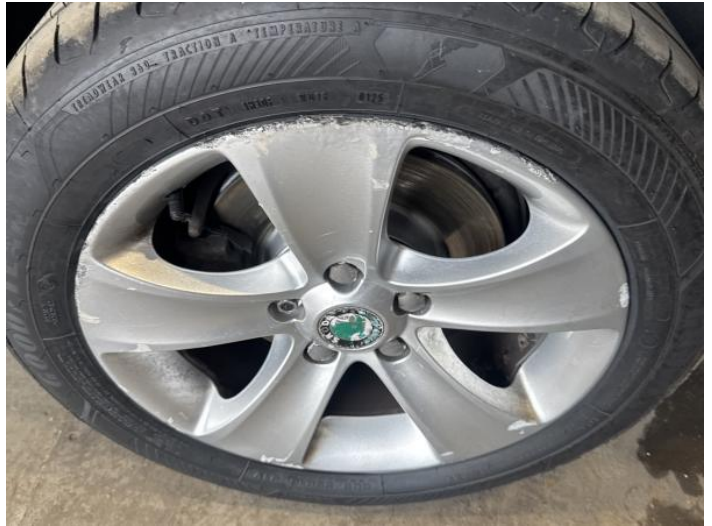
4: Wheel nsf
Scratched
Over 50mm

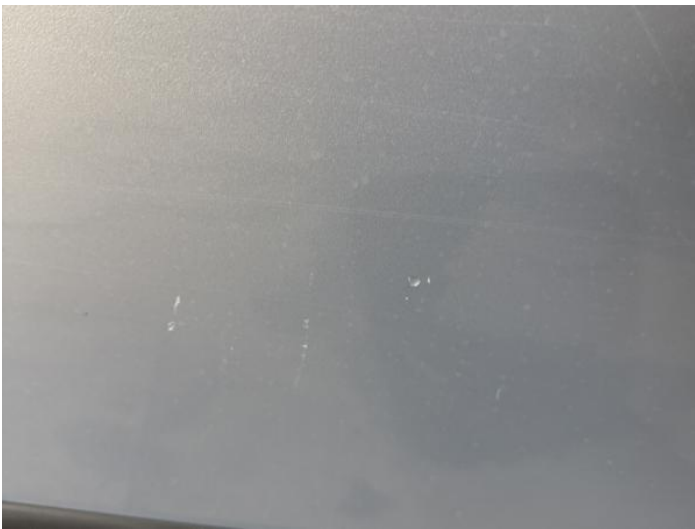
5: Door nsf
Chipped
1 To 5

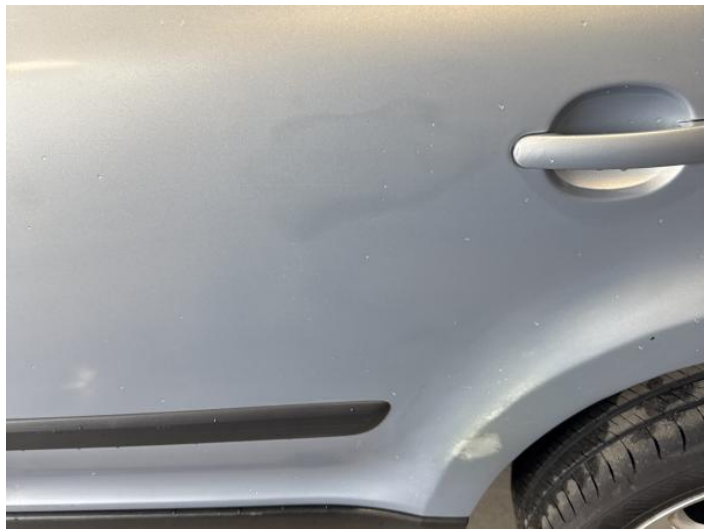
6: Door nsr
Poor Previous Repair
Poor Colour

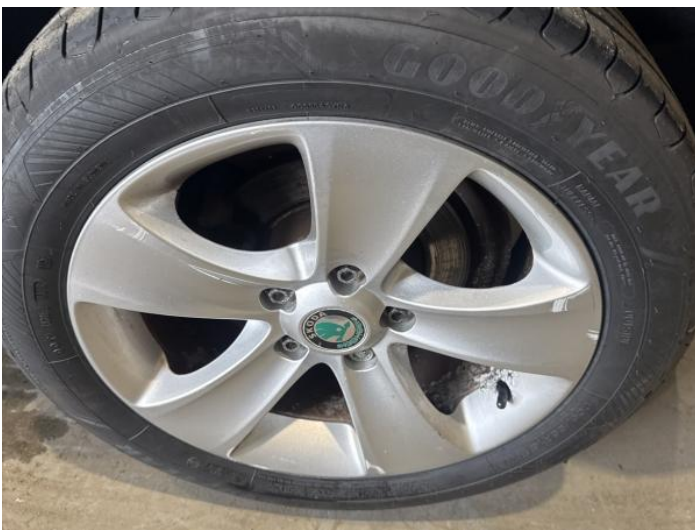
7: Wheel nsr
Scratched
Over 50mm

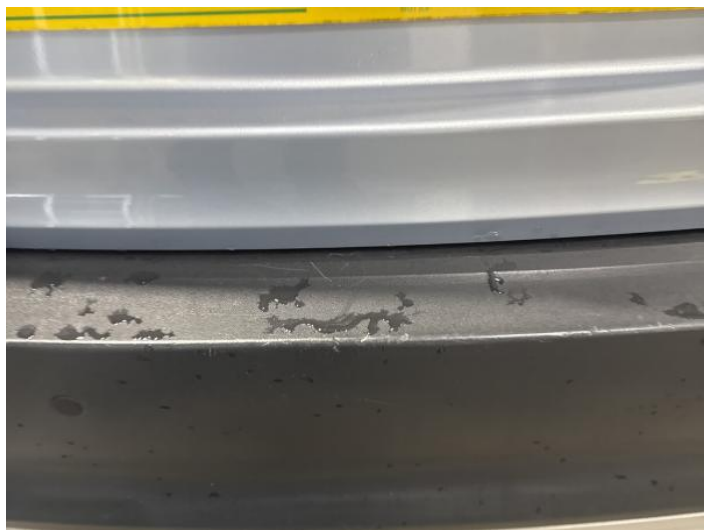
8: Bumper Rear Moulding
Scuffed (Unpainted)
UpTo 100mm

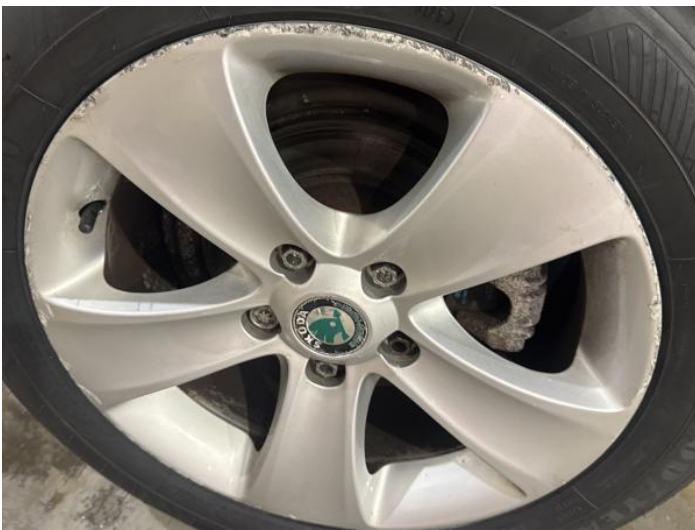
11: Wheel osr
Scratched
Over 50mm

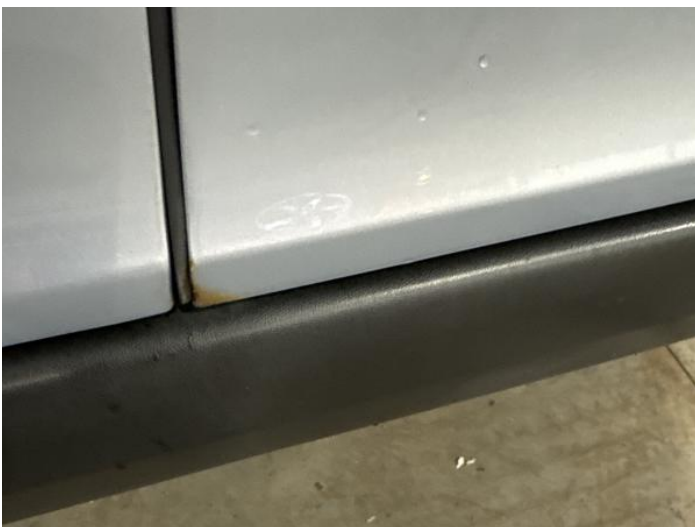
13: Door osf
Rusted
UpTo 5mm

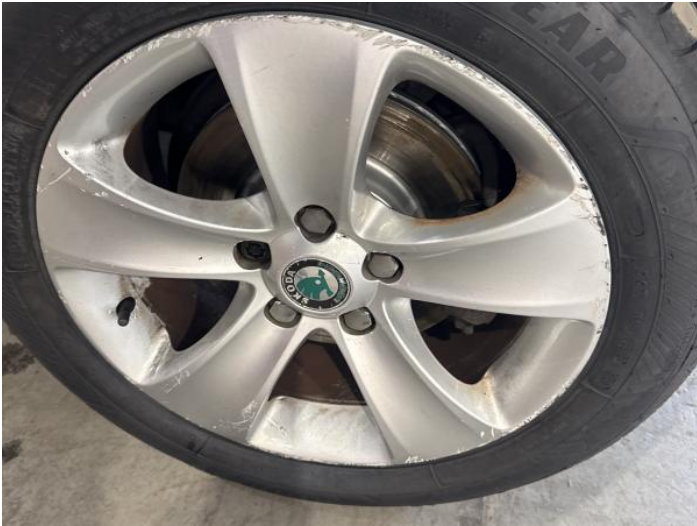
15: Wheel osf
Scratched
Over 50mm

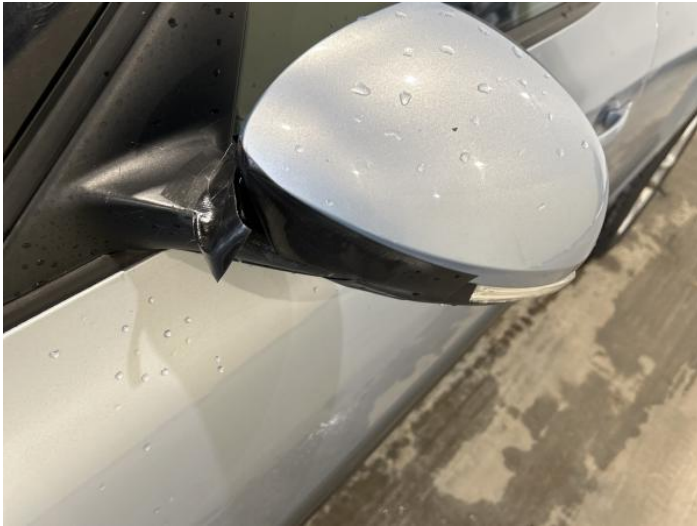
16: Door Mirror Assy nsf
Broken
Replace

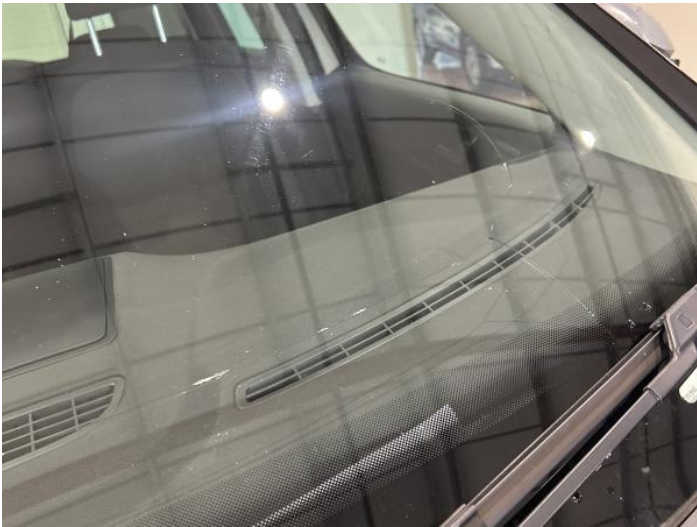
17: Screen Front
Cracked
Replace
