VEHICLE INSPECTION REPORT

DY66GXA

Vauxhall Astra 1.0T 12V ecoFLEX SRi 5dr

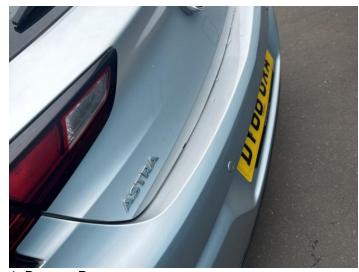
1: Bumper Rear Scratched 25 to 100mm Thru Paint No Image

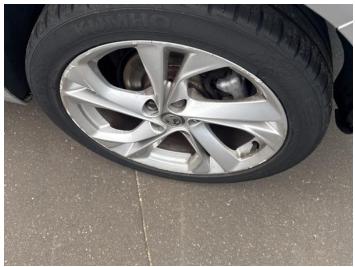
3: Wheel nsr Scratched Over 50mm

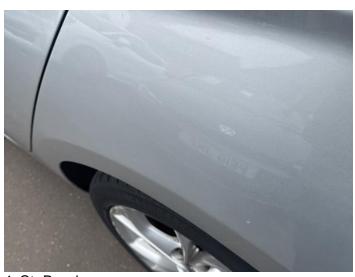
4: Qtr Panel nsr Dented Over 2 UpTo 10mm

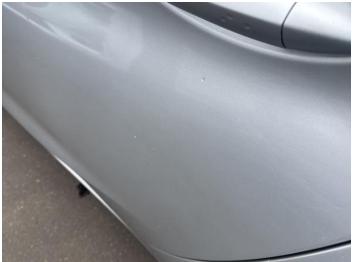
5: Door nsr Chipped Multiple Chips

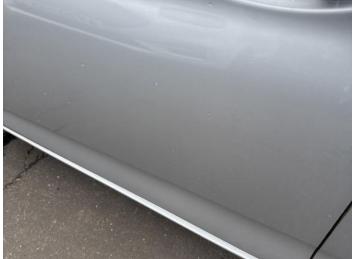
6: Door nsf Chipped 1 To 5

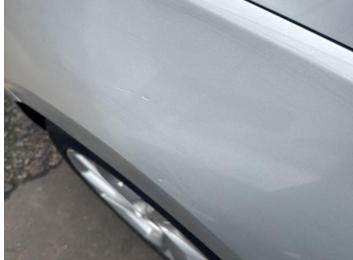
7: Wing nsf Poor Previous Repair Poor Paint

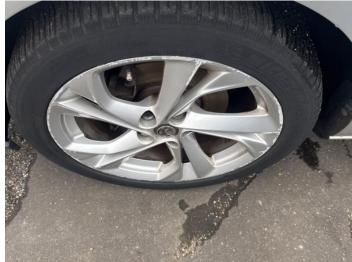
8: Wheel nsf Scratched Over 50mm

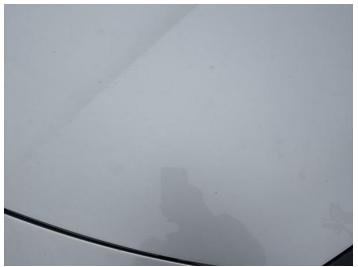
9: Bonnet Chipped Multiple Chips

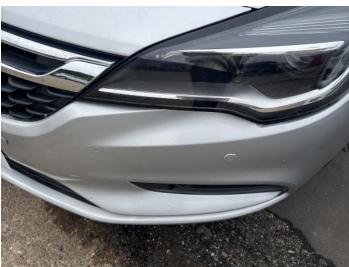
10: Bumper Front Cracked UpTo 25mm

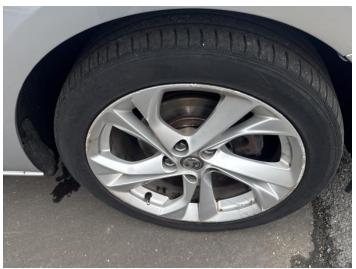
11: Wheel osf Scratched Over 50mm

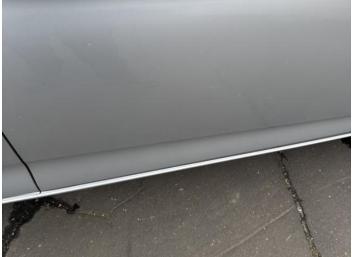
12: Door osf Chipped 1 To 5

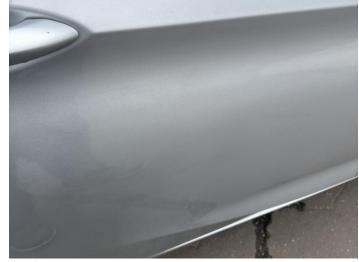
13: Door osr Poor Previous Repair Poor Paint

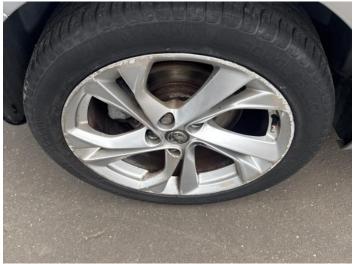
14: Wheel osr Scratched Over 50mm
