# **VEHICLE INSPECTION REPORT**

KY110BF

## Mazda 6 2.0 Takuya 5dr

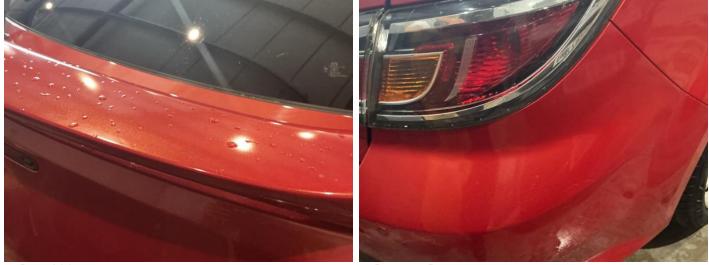
1: Boot Lid Scratched Over 25mm Not Thru Paint

2: Bumper Rear Scratched Over 100mm Thru Paint

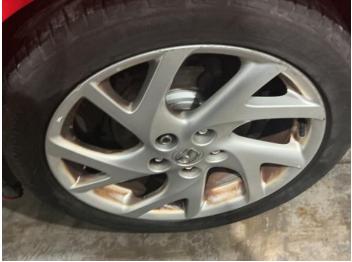
4: Qtr Panel osr

3: Wheel osr Scratched Over 50mm

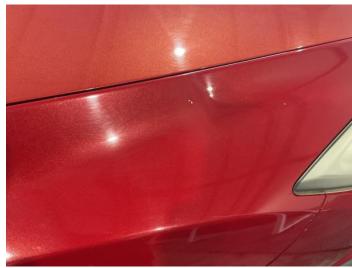
7: Wing osf Chipped Multiple Chips

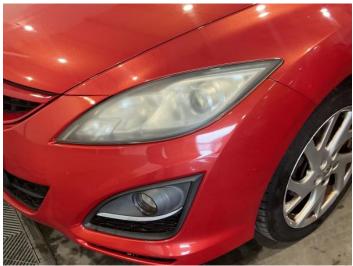
8: Bumper Front Scratched 25 to 100mm Thru Paint

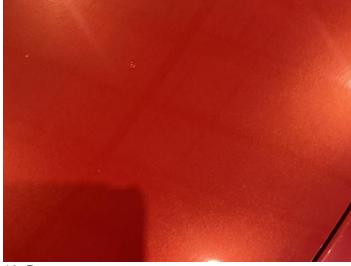
10: Bonnet Chipped 1 To 5

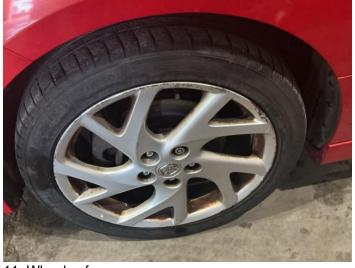
11: Wheel nsf Scratched Over 50mm

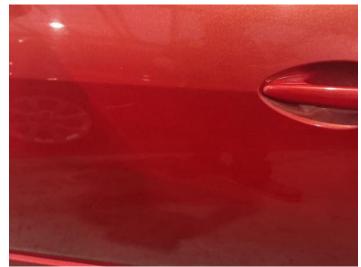
13: Door nsf Dented Over 2 UpTo 10mm

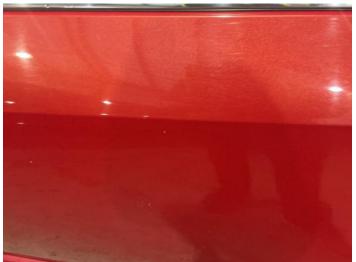
14: Door nsr Chipped 1 To 5

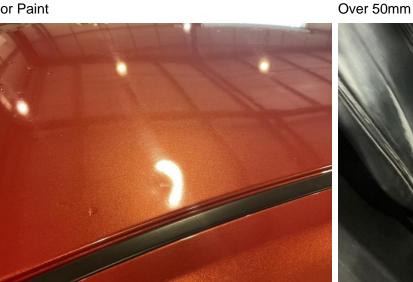
17: Roof Dented Between 10mm + 30mm
