# VEHICLE INSPECTION REPORT

**WF59KWG**

## Citroen C4 Picasso 1.6HDi 16V VTR Plus 5dr [5 Seat]

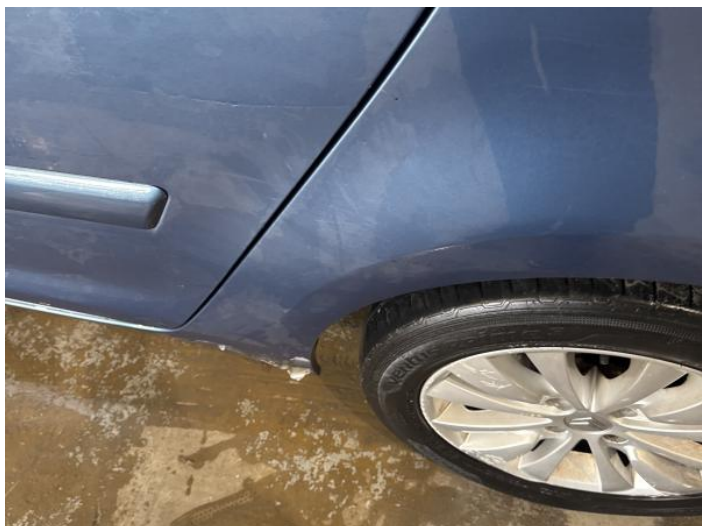
3: Qtr Panel nsr  
Dented  
With Paint Damage

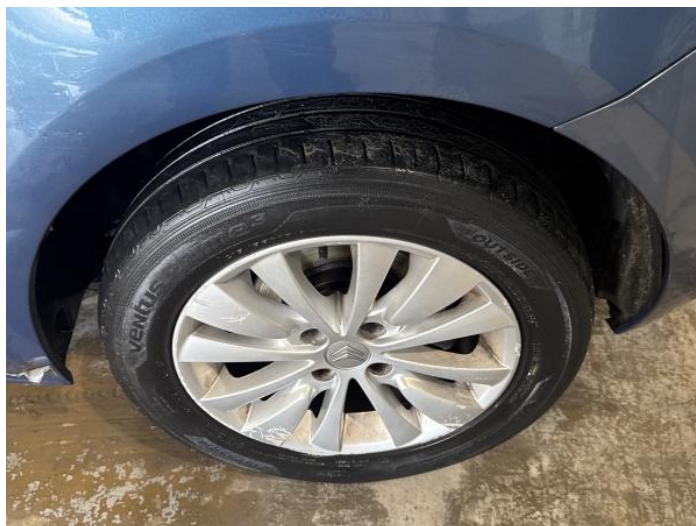
4: Wheel nsr  
Scratched  
Over 50mm

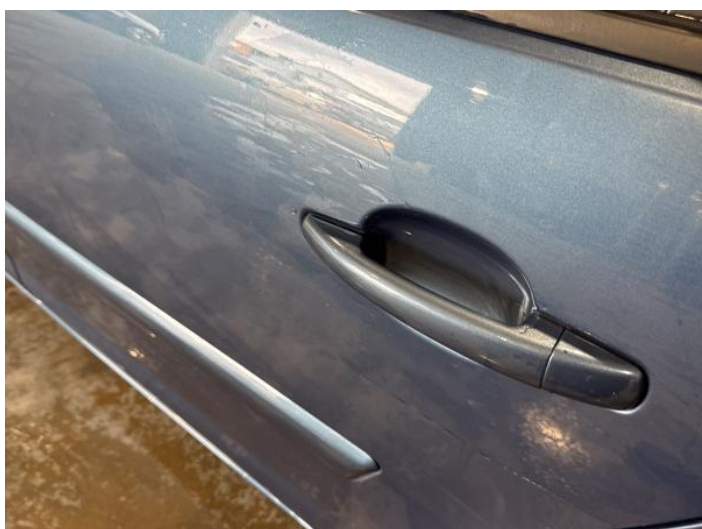
5: Door nsr  
Chipped  
1 To 5

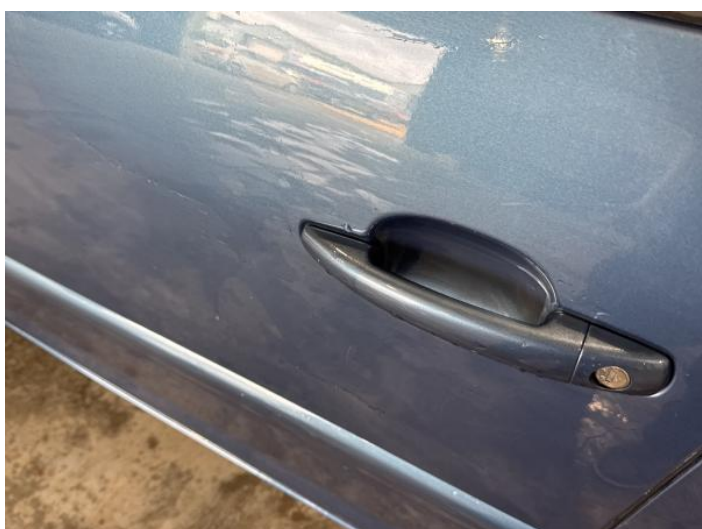
7: Door nsf  
Chipped  
1 To 5

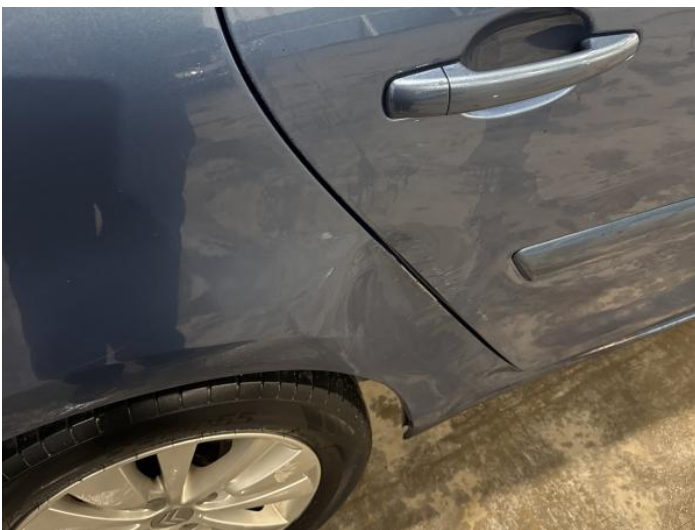
19: Qtr Panel osr  
Dented  
With Paint Damage

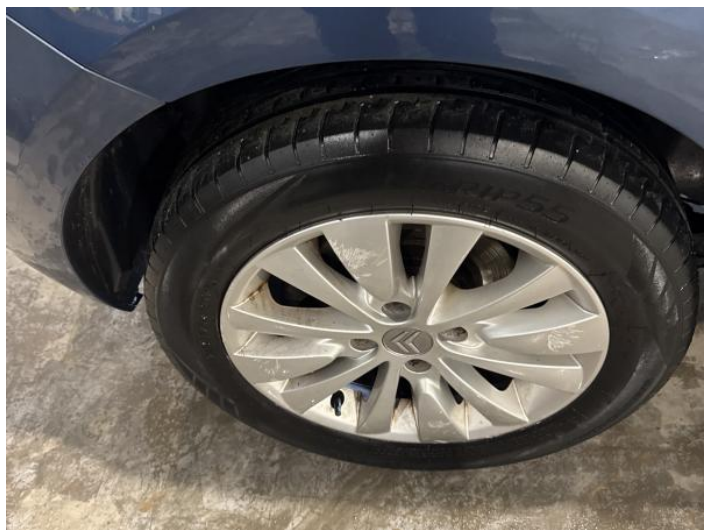
20: Wheel osr  
Scratched  
Over 50mm
