Vehicle Inspection Report

Date Inspected: 28/04/2025 09:41

Reg: AU69YBO

VIN: NMTKZ3BXX0R329021

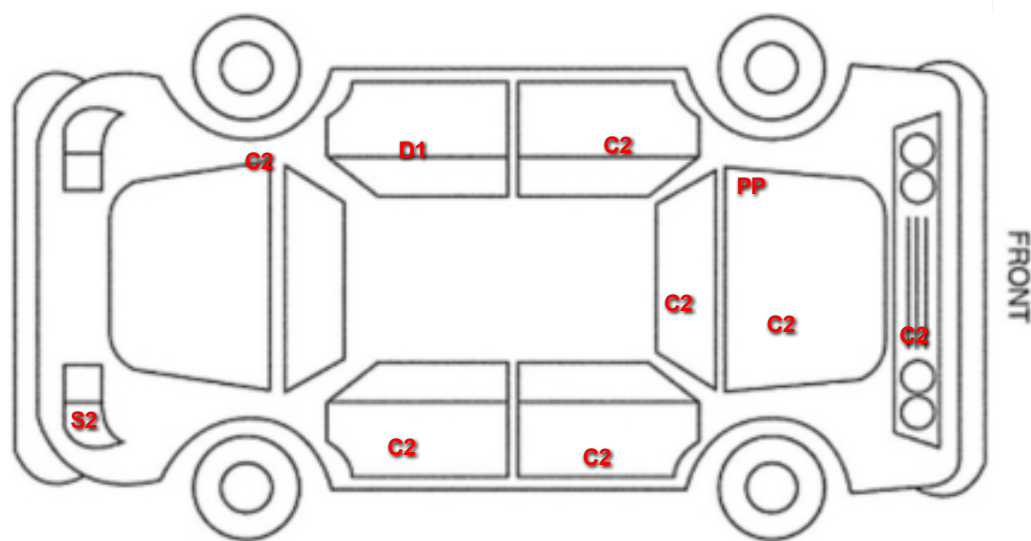
Vehicle Splat

Component	Condition	Severity	Repair
Bumper Rear	Scratched	Over 25mm Not Thru Paint	Machine Polish
Bumper Rear	Scratched	25 to 100mm Thru Paint	Smart Repair
Qtr Panel nsr	Scratched	Over 25mm Not Thru Paint	Machine Polish
Screen Front	Chipped	UpTo 10mm	Smart Repair
Bonnet	Scratched	Over 25mm Not Thru Paint	Machine Polish
Bonnet	Chipped	1 To 5	Smart Repair
Bumper Front	Chipped	Multiple Chips	Smart Repair
Bumper Front	Scratched	Over 25mm Not Thru Paint	Machine Polish
Wing osf	Scratched	Over 25mm Not Thru Paint	Machine Polish
Wing osf	Chipped	1 To 5	Smart Repair
Door osf	Scratched	Over 25mm Not Thru Paint	Machine Polish
Door osf	Chipped	1 To 5	Smart Repair
Door osr	Scratched	Over 25mm Not Thru Paint	Machine Polish
Qtr Panel osr	Scratched	Over 25mm Not Thru Paint	Machine Polish
Door nsr	Scratched	Over 25mm Not Thru Paint	Machine Polish
Door nsf	Scratched	Over 25mm Not Thru Paint	Machine Polish
Wing nsf	Scratched	Over 25mm Not Thru Paint	Machine Polish

Door nsf	Chipped	1 To 5	Smart Repair
Door nsr	Dented	2 Or Less UpTo 10mm	Smart Repair
Qtr Panel nsr	Chipped	1 To 5	Smart Repair
