VEHICLE INSPECTION REPORT

LG12WLB

Hyundai Santa Fe 2.2 CRDi Premium 5dr [7 Seats]

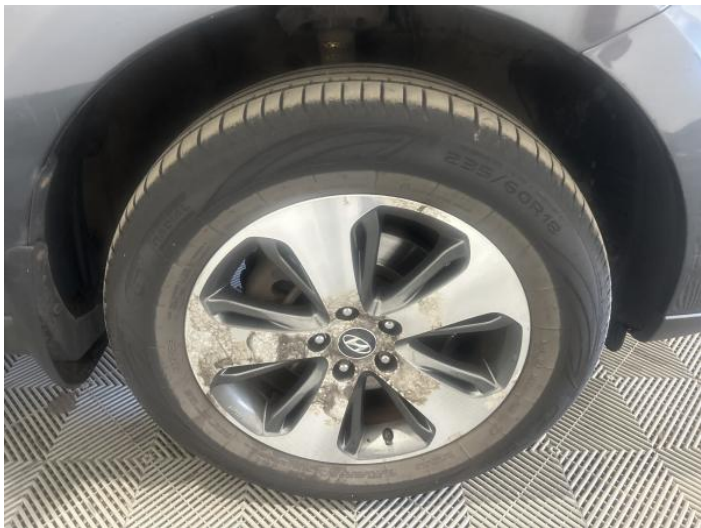
1: Wheel osf
Corroded
Light

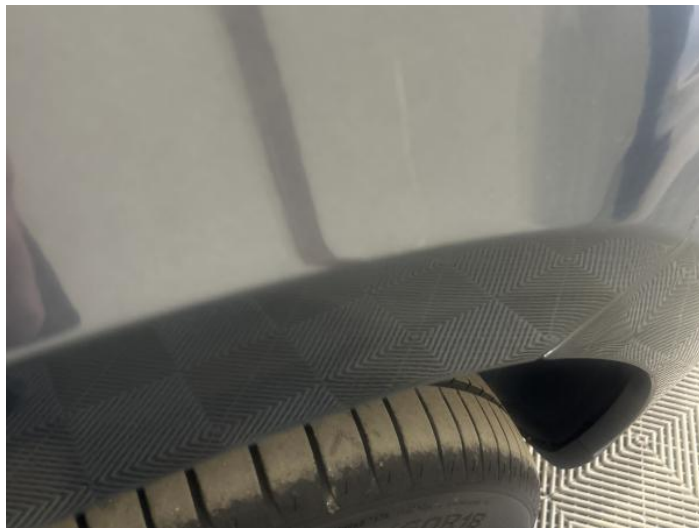
2: Wing osf
Scratched
UpTo 25mm Thru Paint

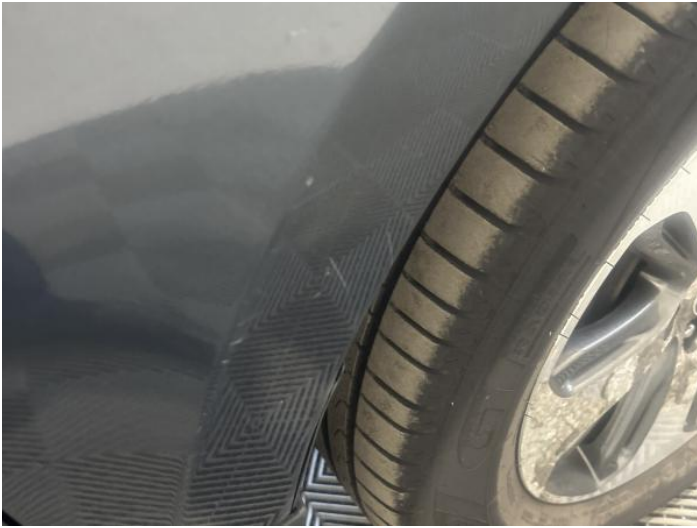
3: Wing osf
Chipped
1 To 5

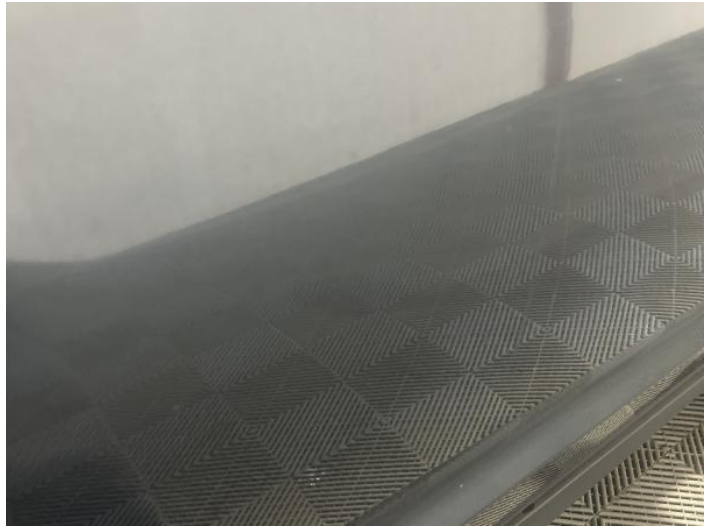
4: Door osf
Scratched
Over 25mm Not Thru Paint

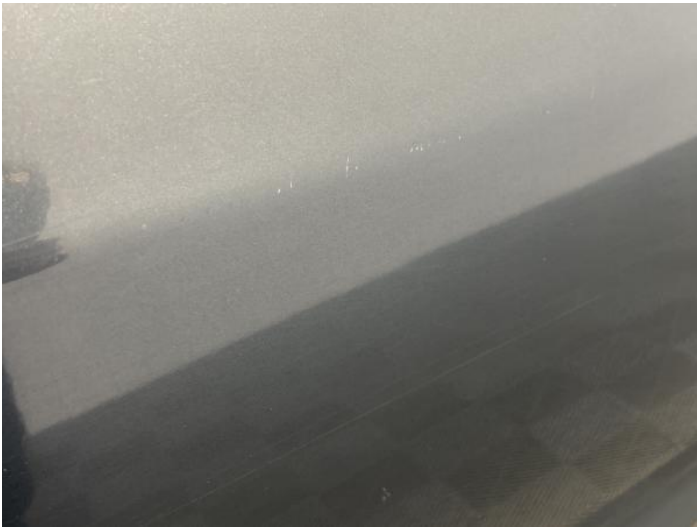
5: Door osr
Chipped
Multiple Chips

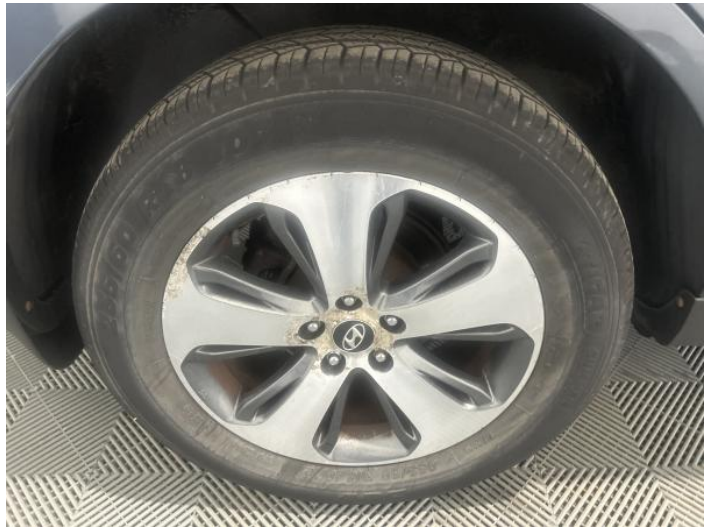
6: Wheel osr
Corroded
Light

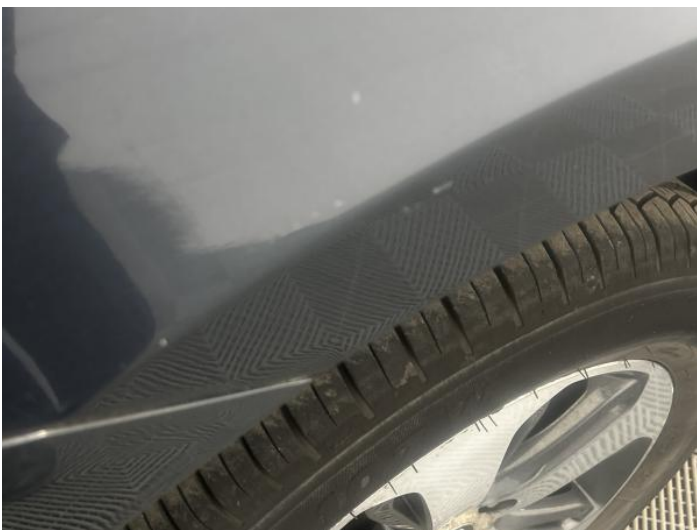
7: Qtr Panel osr
Chipped
1 To 5

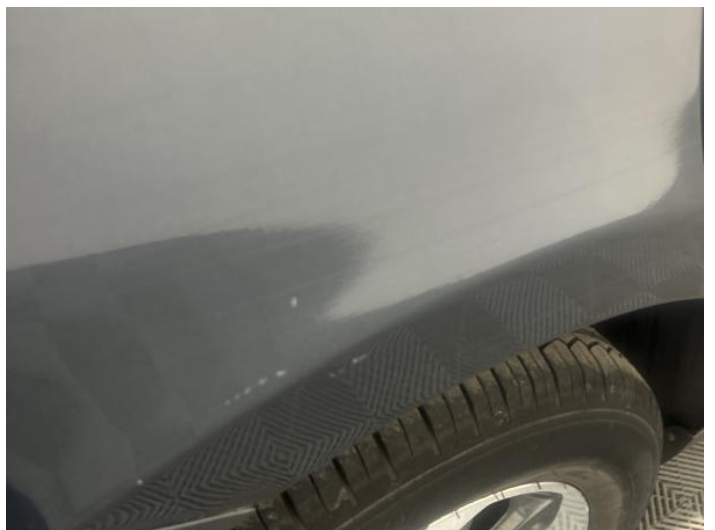
8: Qtr Panel osr
Scratched
Over 25mm Not Thru Paint

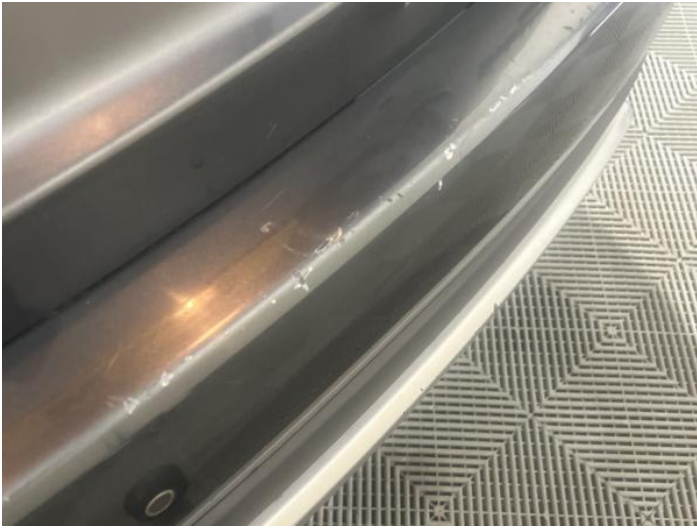
9: Bumper Rear
Scratched
Over 100mm Thru Paint

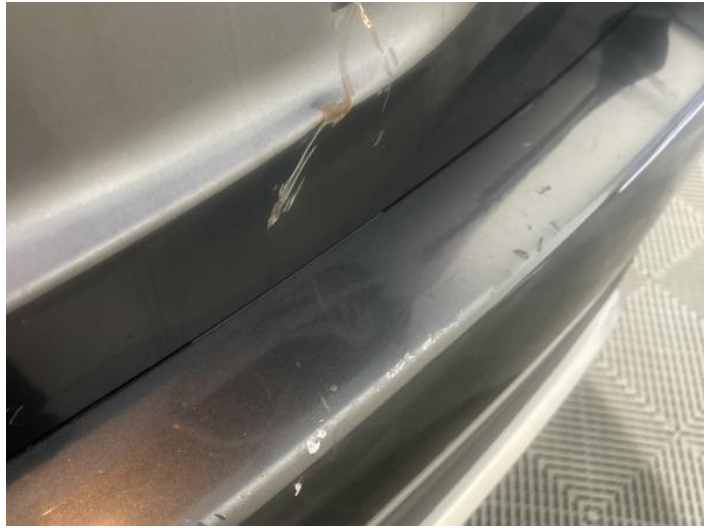
10: Tailgate
Dented
With Paint Damage

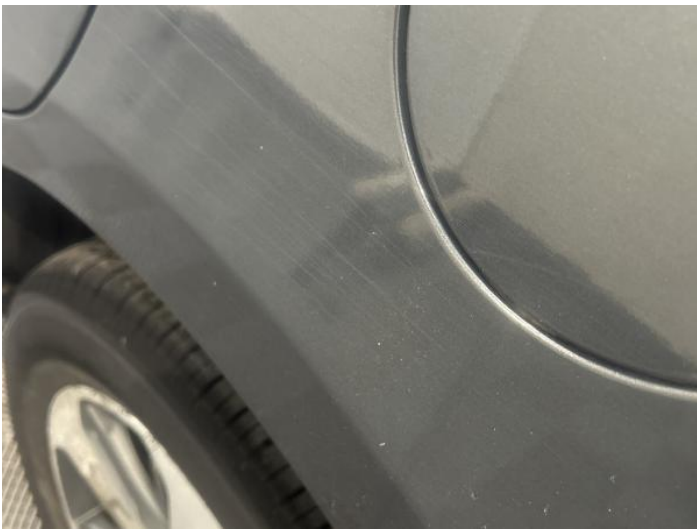
11: Qtr Panel nsr
Scratched
Over 25mm Not Thru Paint

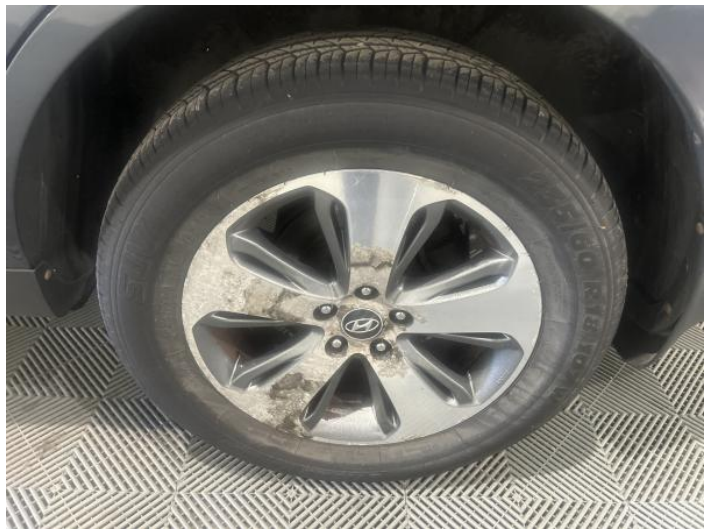
12: Wheel nsr
Corroded
Light

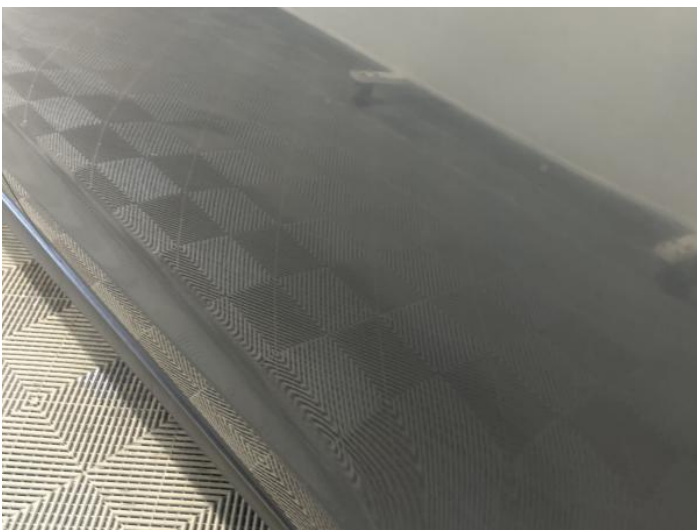
13: Door nsr
Scratched
Over 25mm Not Thru Paint

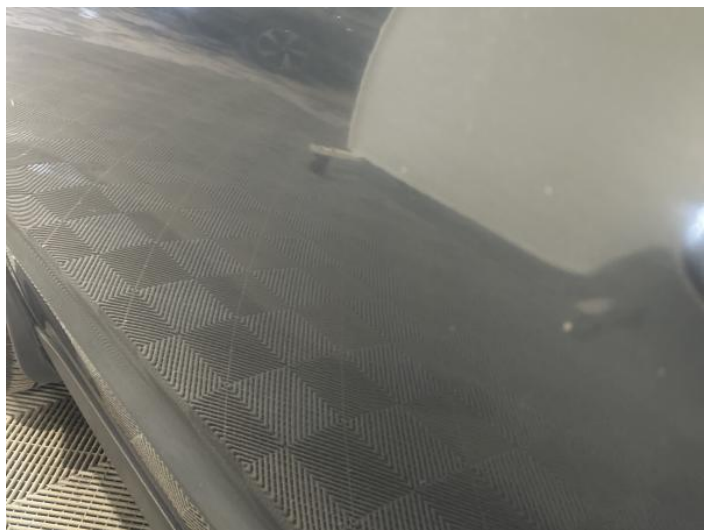
14: Door nsf
Scratched
Over 25mm Not Thru Paint

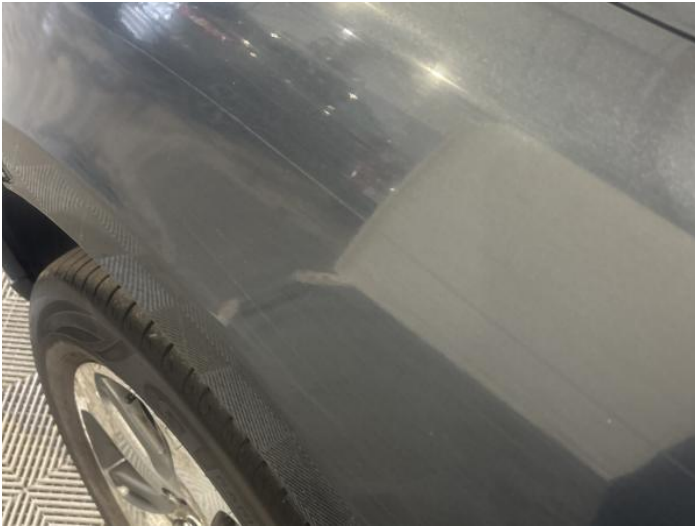
15: Wing nsf
Scratched
Over 25mm Not Thru Paint

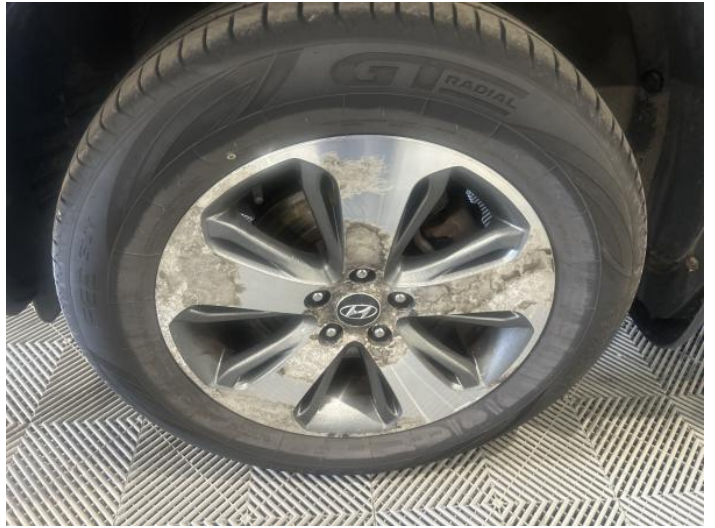
16: Wheel nsf
Corroded
Light

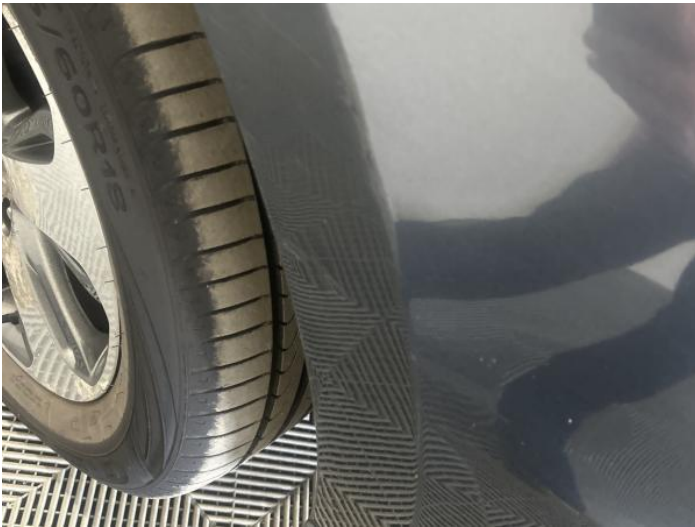
17: Bumper Front
Scratched
25 to 100mm Thru Paint

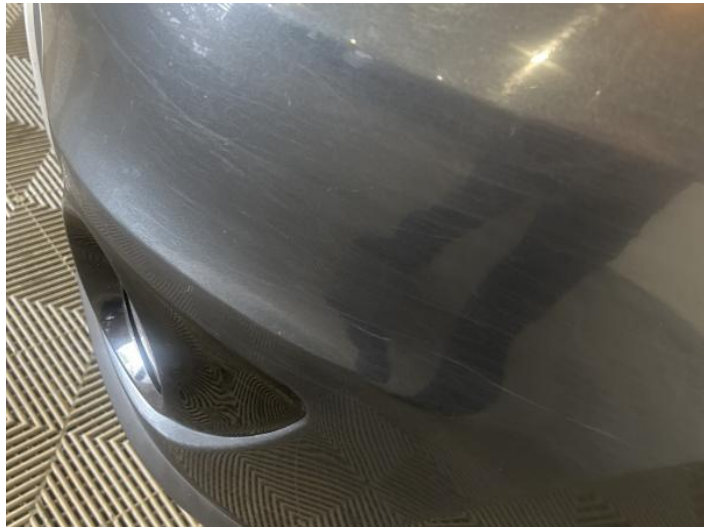
18: Bumper Front
Scratched
Over 25mm Not Thru Paint

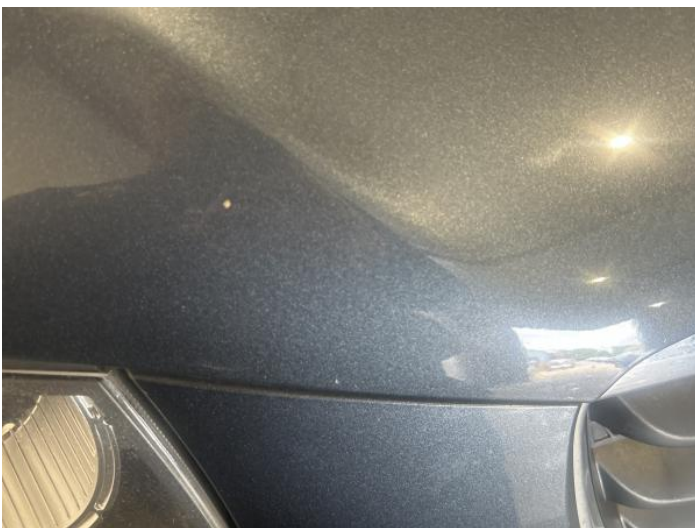
19: Bonnet
Chipped
1 To 5

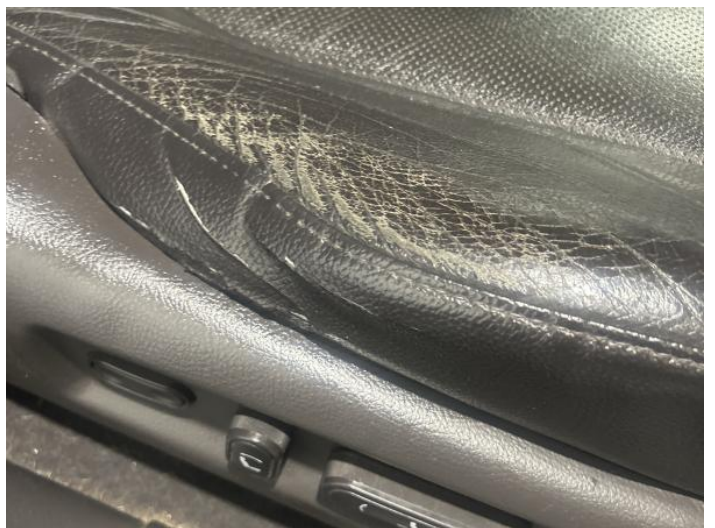
20: Seat Base Cover osf
Torn
Over 3mm

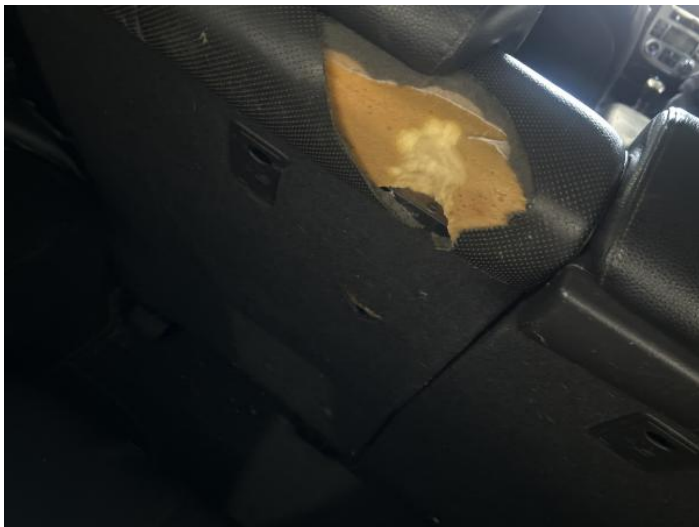
21: Seat Back Cover nsr
 Holed
 Over 3mm
