VEHICLE INSPECTION REPORT

KN15GZO

Citroen C4 Picasso 1.6 HDi VTR+ 5dr

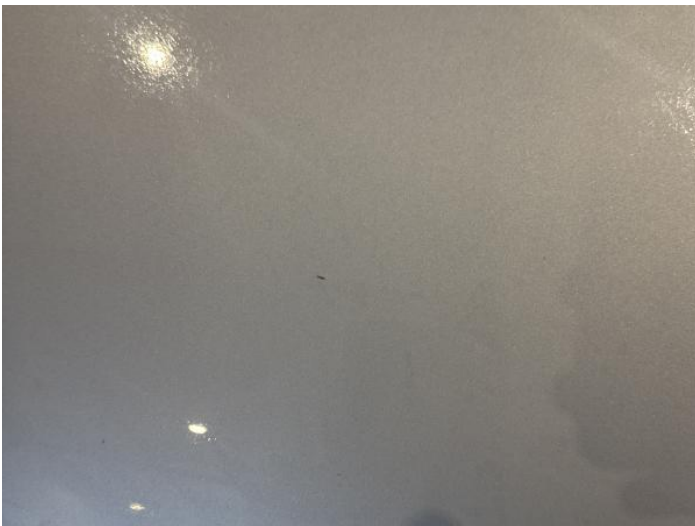
1: Bonnet
Chipped
1 To 5

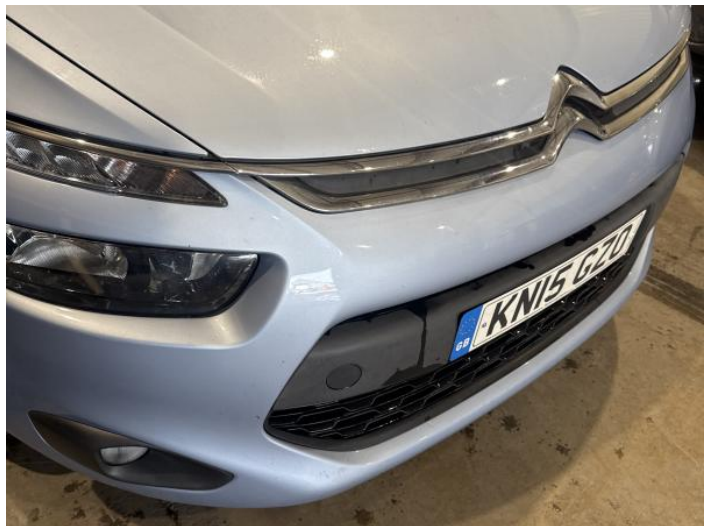
2: Bumper Front
Chipped
Multiple Chips

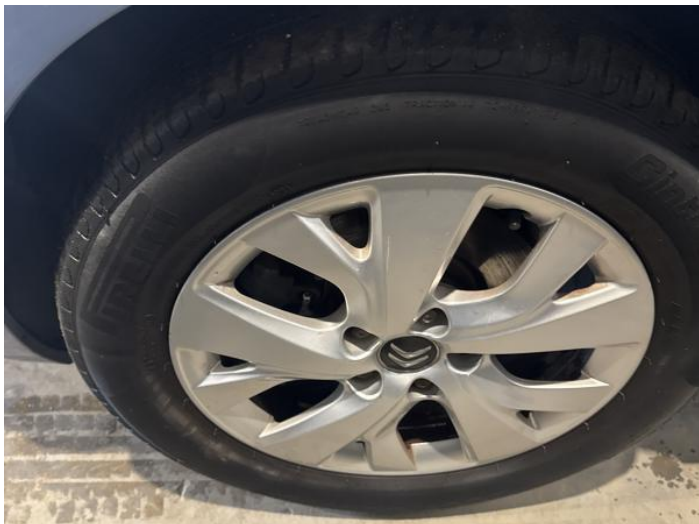
3: Wheel nsf
Scratched
Up To 50mm

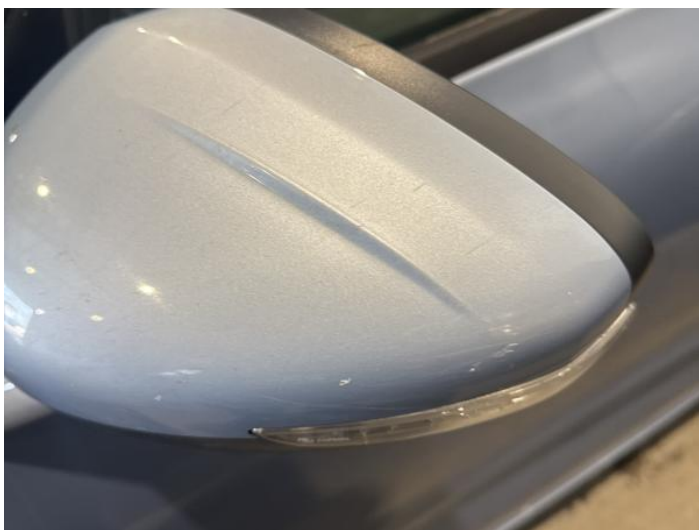
5: Door Mirror Assy nsf
Scratched (Painted)
Over 25mm Thru Paint

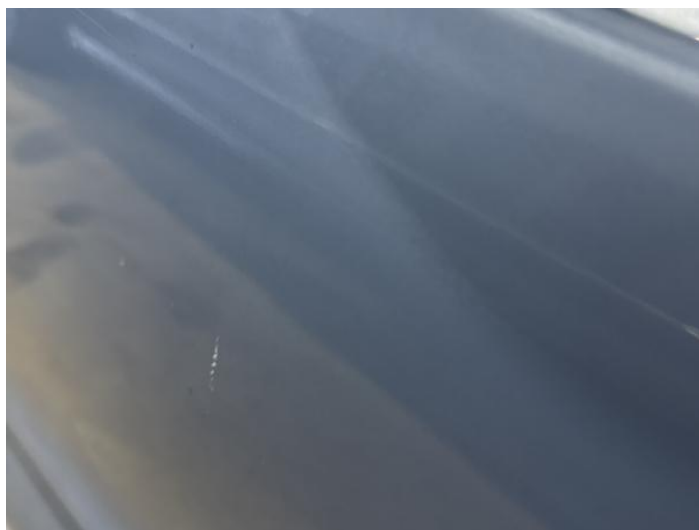
6: Door nsf
Chipped
1 To 5

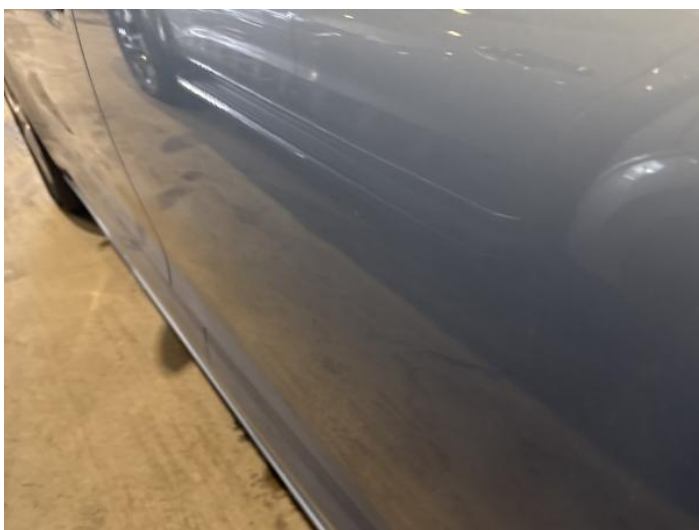
7: Door nsr
Dented
With Paint Damage

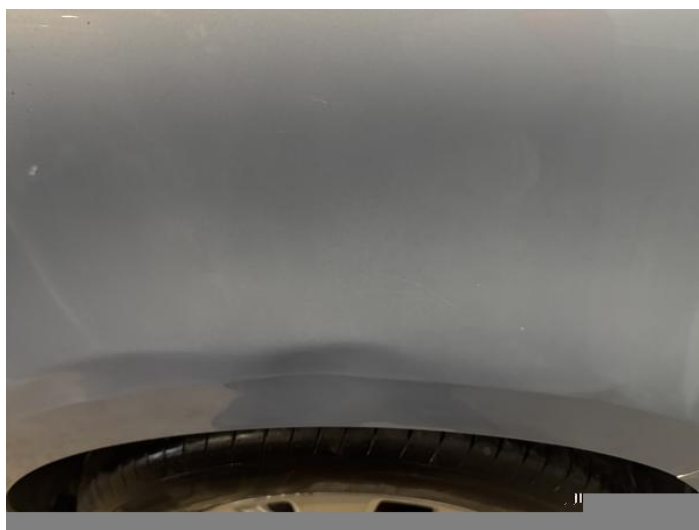
8: Qtr Panel nsr
Dented
Over 30mm

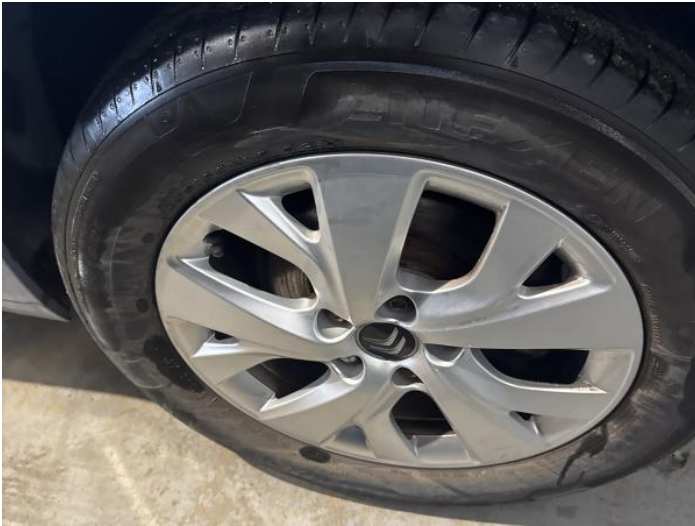
9: Wheel nsr
Corroded
Light

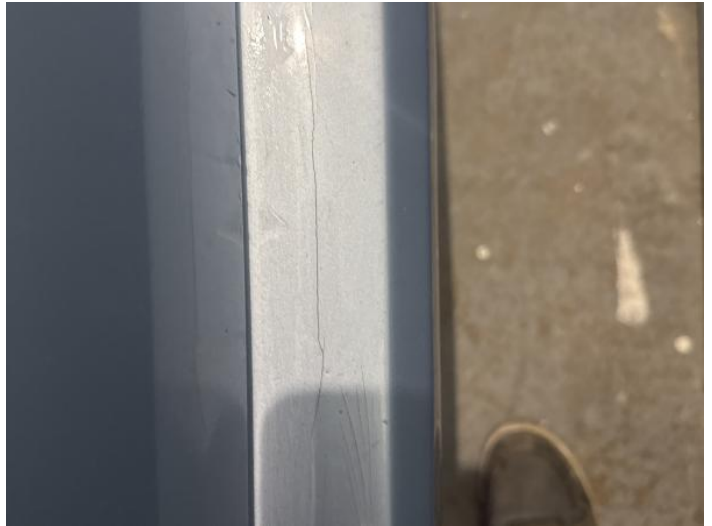
10: Bumper Rear
Poor Previous Repair
Rippled UpTo 30%

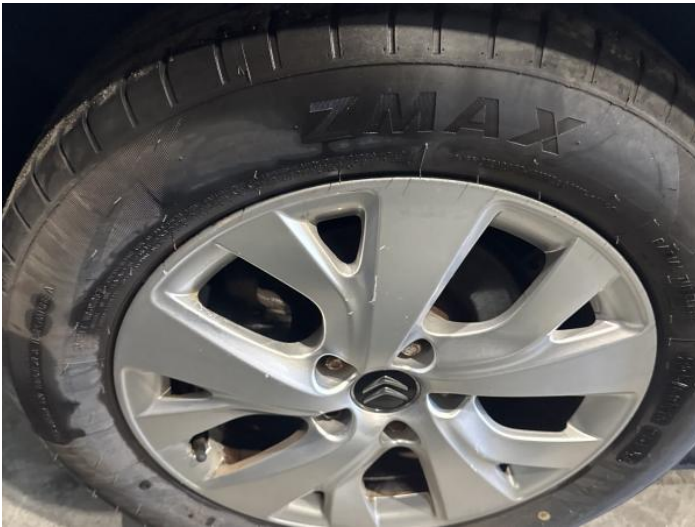
11: Wheel osr
Scratched
Over 50mm

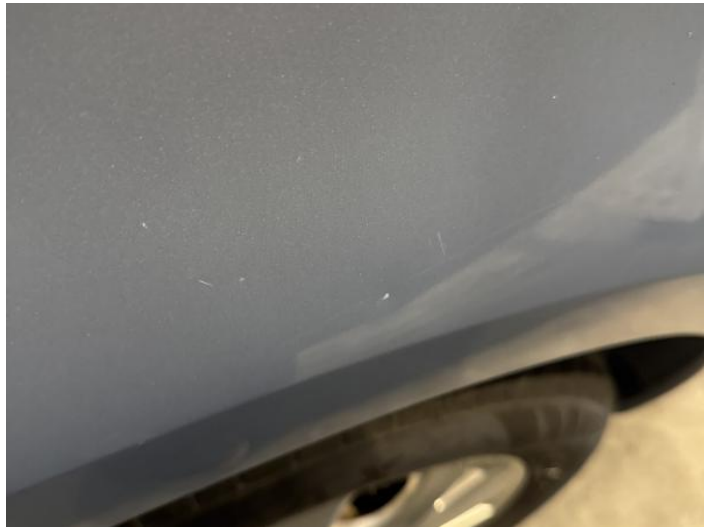
12: Qtr Panel osr
Chipped
1 To 5

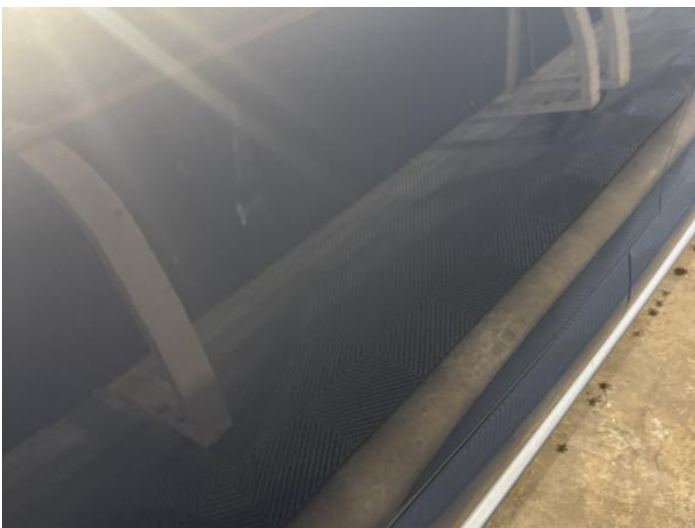
13: Door osr
Chipped
1 To 5

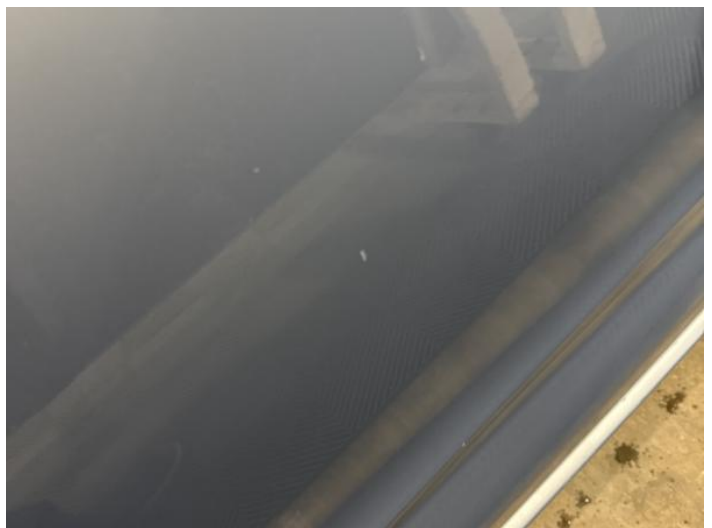
14: Door osf
Chipped
1 To 5

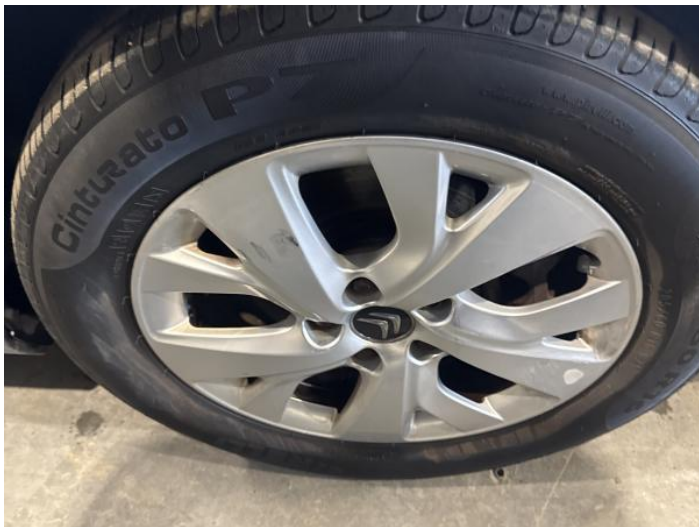
15: Wheel osf
Scratched
Over 50mm
