### **VEHICLE INSPECTION REPORT**

**HG13CNY**

### BMW 5 Series 520d M Sport 4dr

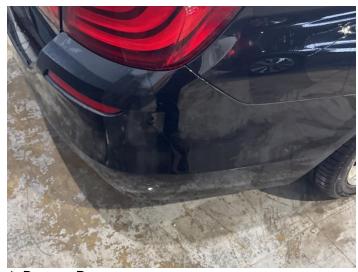
2: Boot Lid Scratched Over 25mm Not Thru Paint

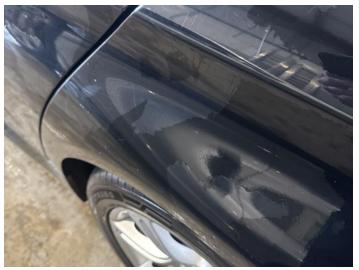
3: Qtr Panel nsr Dented Over 2 UpTo 10mm

4: Qtr Panel nsr Scratched Over 25mm Not Thru Paint

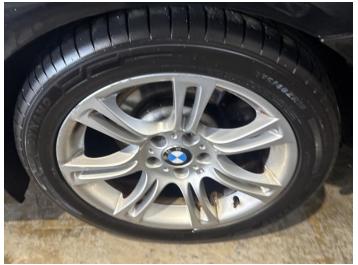
5: Wheel nsr Scratched Over 50mm

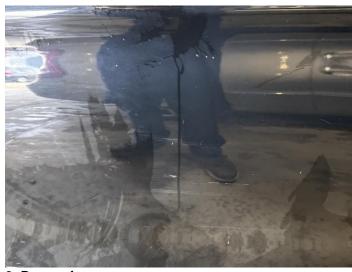
8: Door nsf Scratched Over 25mm Thru Paint

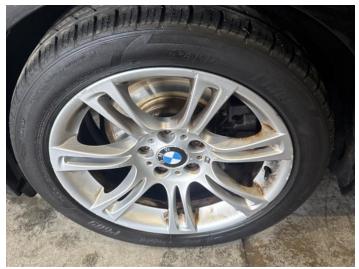
9: Wheel nsf Scratched Over 50mm

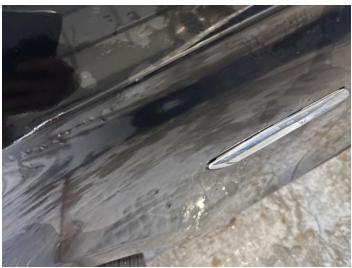
10: Wing nsf Chipped 1 To 5

11: Wing nsf Scratched Over 25mm Not Thru Paint

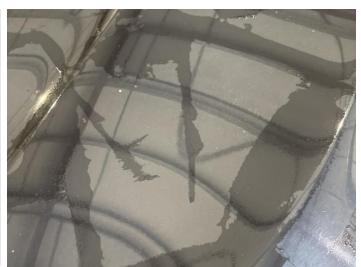
12: Bonnet Chipped Multiple Chips

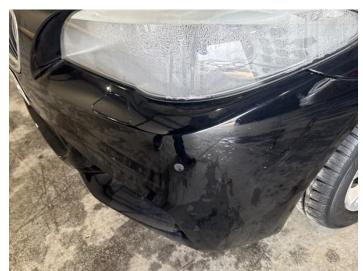
13: Bumper Front Scratched Over 100mm Thru Paint

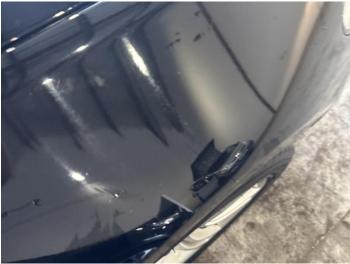
14: Wing osf Chipped 1 To 5

15: Wing osf Scratched Over 25mm Not Thru Paint

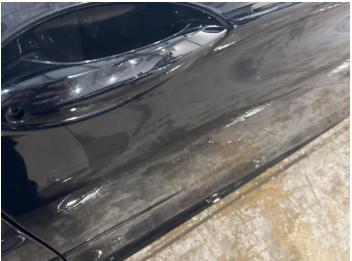
17: Door osf Chipped 1 To 5

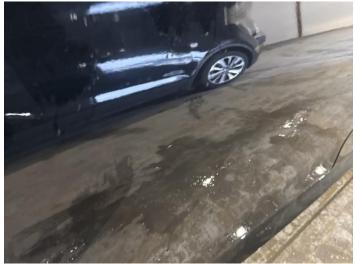
19: Door osr Chipped 1 To 5

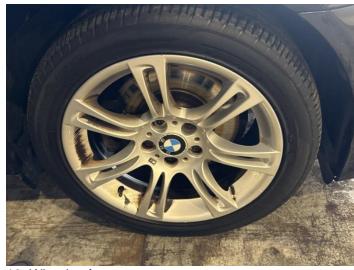
16: Wheel osf Scratched Over 50mm

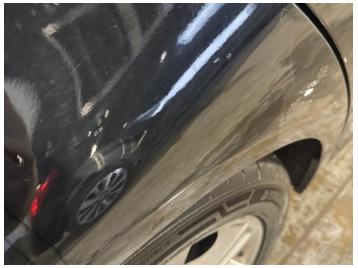
21: Qtr Panel osr Scratched UpTo 25mm Thru Paint

22: Qtr Panel osr Scratched Over 25mm Not Thru Paint

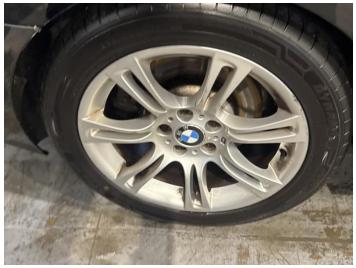
23: Wheel osr Scratched Over 50mm
