Vehicle Inspection Report

Reg: GV18OWR
VIN: JSAAZC13S00200881

Make	SUZUKI	Body Type	Hatchback	Doors	5
Model	SWIFT SZ5 BOOSTERJET AUTO - 998cc	Fuel Type	Petrol	Colour	Black
		Transmission	Auto	Year of MFR	2018
				Date First Reg	07/07/2018
Mileage	82,705 miles

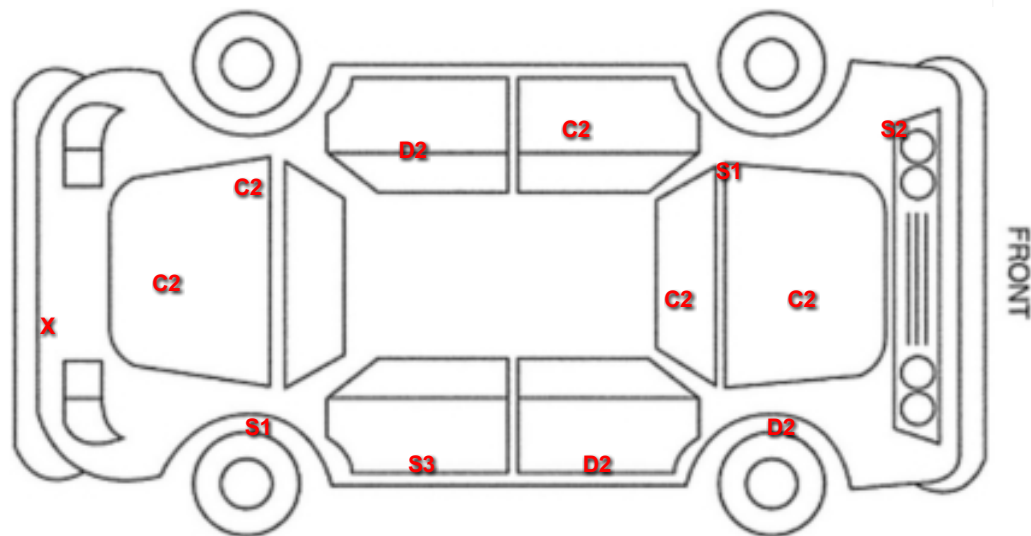
Vehicle Splat

Component	Condition	Severity	Repair
Bumper Rear	Cracked	Over 25mm	Replace
Bumper Rear	Scratched	Over 25mm Not Thru Paint	Machine Polish
Boot Lid	Chipped	1 To 5	Smart Repair
Qtr Panel nsr	Chipped	Multiple Chips	Refinish
Door nsr	Dented	With Paint Damage	Repair and Refinish
Door nsf	Chipped	Multiple Chips	Refinish
Door Mirror Assy nsf	Broken	Replace	Replace
Wing nsf	Scratched	Over 25mm Not Thru Paint	Machine Polish
Wing nsf	Scratched	UpTo 25mm Thru Paint	Smart Repair
Screen Front	Chipped	UpTo 10mm	Smart Repair
Bonnet	Chipped	Multiple Chips	Refinish
Bumper Front	Scratched	25 to 100mm Thru Paint	Smart Repair
Bumper Front	Scratched	Over 25mm Not Thru Paint	Machine Polish
Wing osf	Dented	Over 30mm	Repair and Refinish
Door osf	Dented	Over 30mm	Repair and Refinish
Door osr	Scratched	Over 25mm Thru Paint	Refinish
Qtr Panel osr	Scratched	Over 25mm Not Thru Paint	Machine Polish
Qtr Panel osr	Scratched	UpTo 25mm Thru Paint	Smart Repair

Roof	Scratched	Over 25mm Not Thru Paint	Machine Polish

osr light broken and rear wiper broken. noisy engine and interior trims missing
