Vehicle Inspection Report

Date Inspected: 29/04/2025 16:53

Reg: GY22BGK

Appraised By: Eastbourne Car Auctions

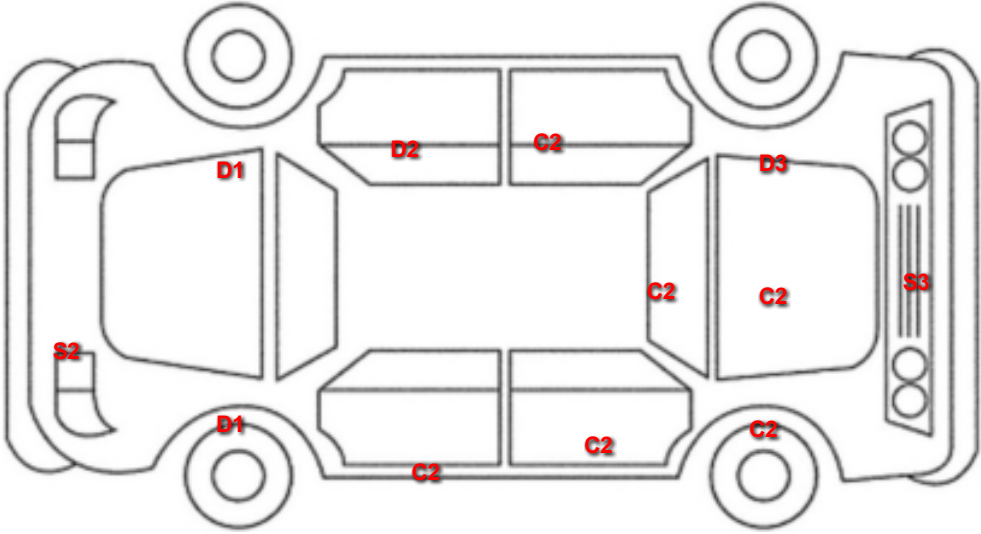
Vehicle Splat

Damage Lines			
Component	Condition	Severity	Repair
Bumper Rear	Scratched	Over 25mm Not Thru Paint	Machine Polish
Bumper Rear	Scratched	25 to 100mm Thru Paint	Smart Repair
Boot Lid	Scratched	Over 25mm Not Thru Paint	Machine Polish
Qtr Panel nsr	Scratched	Over 25mm Not Thru Paint	Machine Polish
Qtr Panel nsr	Dented	Between 10mm + 30mm	Smart Repair
Door nsr	Dented	Over 30mm	Repair and Refinish
Door nsf	Scratched	Over 25mm Not Thru Paint	Machine Polish
Door nsf	Chipped	1 To 5	Smart Repair
Wing nsf	Dented	Over 30mm	Repair and Refinish
Bonnet	Chipped	1 To 5	Smart Repair
Bumper Front	Scratched	Over 100mm Thru Paint	Refinish
Wing osf	Scratched	Over 25mm Not Thru Paint	Machine Polish
Wing osf	Chipped	1 To 5	Smart Repair
Screen Front	Chipped	UpTo 10mm	Smart Repair
Door osf	Scratched	Over 25mm Not Thru Paint	Machine Polish
Door osf	Chipped	1 To 5	Smart Repair
Door osr	Scratched	Over 25mm Not Thru Paint	Machine Polish

Door osr	Chipped	1 To 5	Smart Repair
Qtr Panel osr	Scratched	Over 25mm Not Thru Paint	Machine Polish
Qtr Panel osr	Dented	2 Or Less UpTo 10mm	Smart Repair
