Vehicle Inspection Report

Reg: OV14OXB

VIN: SALGA2JE7EA170237

Appraised By: Eastbourne Car Auctions

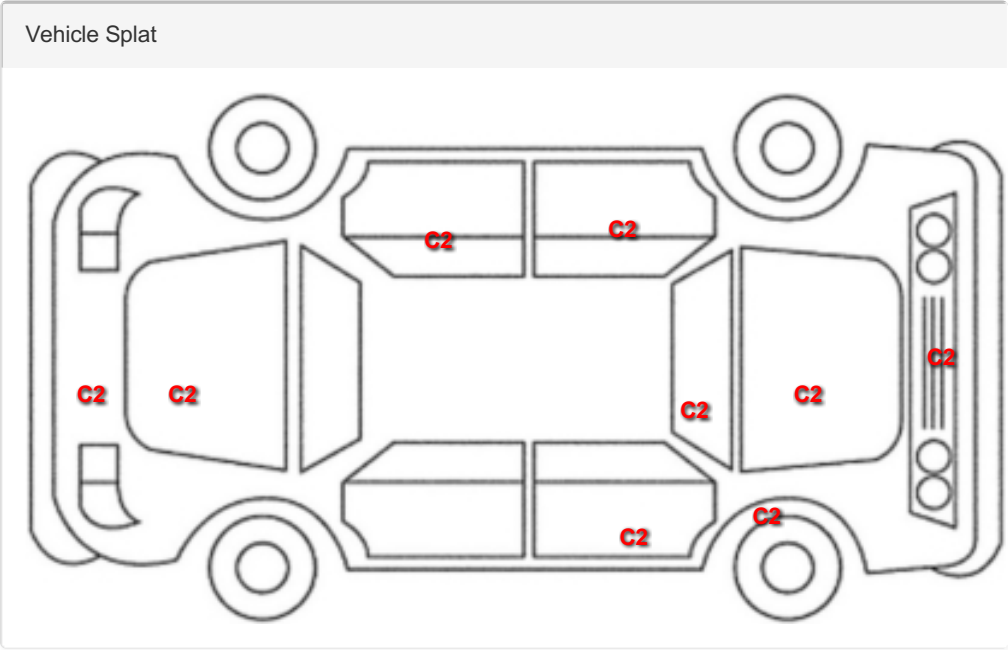
Damage Lines			
Component	Condition	Severity	Repair
Bonnet	Chipped	Multiple Chips	Refinish
Bumper Front	Scratched	Over 25mm Not Thru Paint	Machine Polish
Bumper Front	Chipped	Multiple Chips	Smart Repair
Wing osf	Scratched	Over 25mm Not Thru Paint	Machine Polish
Wing osf	Chipped	1 To 5	Smart Repair
Screen Front	Chipped	UpTo 10mm	Smart Repair
Door osf	Scratched	Over 25mm Not Thru Paint	Machine Polish
Door osf	Chipped	1 To 5	Smart Repair
Door osr	Scratched	Over 25mm Not Thru Paint	Machine Polish
Qtr Panel osr	Scratched	Over 25mm Not Thru Paint	Machine Polish
Bumper Rear	Scratched	Over 25mm Not Thru Paint	Machine Polish
Bumper Rear	Chipped	Multiple Chips	Smart Repair
Boot Lid	Chipped	1 To 5	Smart Repair
Qtr Panel nsr	Scratched	Over 25mm Not Thru Paint	Machine Polish
Door nsr	Scratched	Over 25mm Not Thru Paint	Machine Polish
Door nsf	Chipped	1 To 5	Smart Repair
Door nsf	Scratched	Over 25mm Not Thru Paint	Machine Polish

Door nsf	Chipped	1 To 5	Smart Repair
Wing nsf	Scratched	Over 25mm Not Thru Paint	Machine Polish
