Vehicle Inspection Report

Reg: GV16DWN

Make	MERCEDES-BENZ	Body Type	Hatchback	Doors	5
Model	A 180 D SE EXECUTIVE - 1461cc	Fuel Type	Diesel	Colour	White
Mileage	116,590 miles	Transmission	Manual	Year of MFR	2016
		Gears	6	Date First Reg	31/05/2016

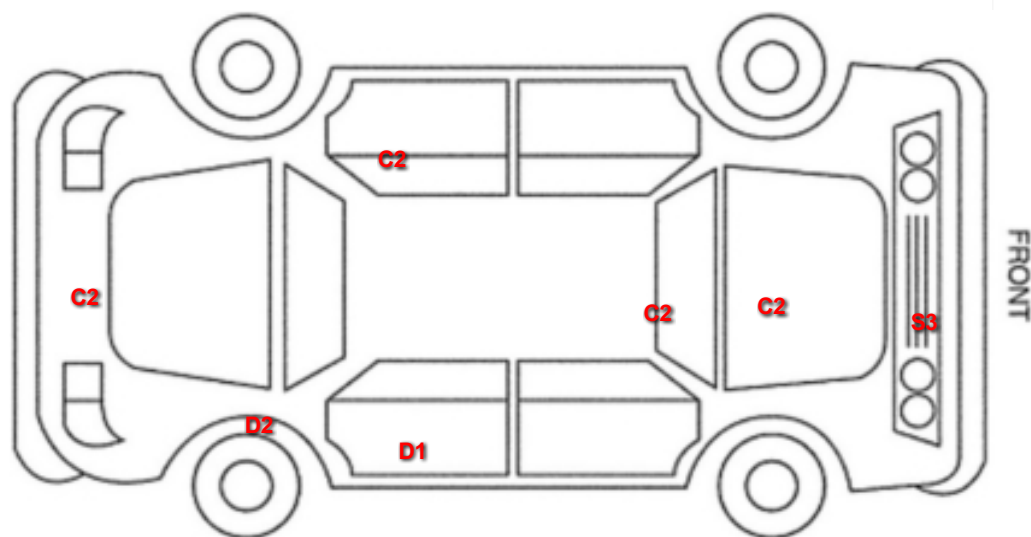
Vehicle Splat

- S3**
Scratch/Paint defect 100m +
- D1**
Dent/damage under 30mm
- D2**
Dent/damage 30-100mm
- C2**
Multiple Chips
