Vehicle Inspection Report

Date Inspected: 29/04/2025 17:16

Reg: LA23HKN

VIN: VR3USHNKKPJ625068

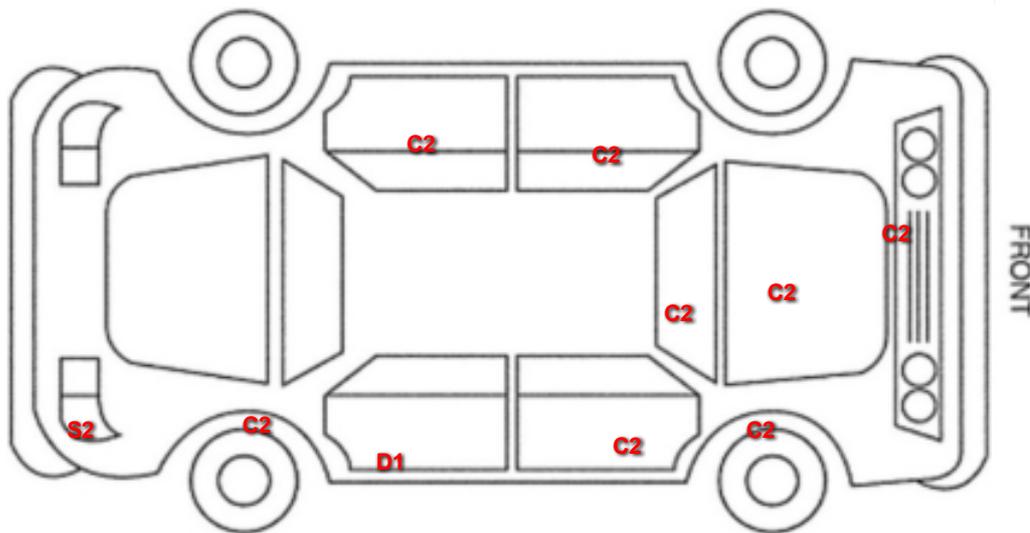
Vehicle Splat

Component	Condition	Severity	Repair
Bumper Rear	Scratched	25 to 100mm Thru Paint	Smart Repair
Bumper Rear	Scratched	Over 25mm Not Thru Paint	Machine Polish
Boot Lid	Scratched	Over 25mm Not Thru Paint	Machine Polish
Qtr Panel nsr	Scratched	Over 25mm Not Thru Paint	Machine Polish
Door nsr	Scratched	Over 25mm Not Thru Paint	Machine Polish
Door nsr	Chipped	1 To 5	Smart Repair
Door nsf	Scratched	Over 25mm Not Thru Paint	Machine Polish
Door nsf	Chipped	1 To 5	Smart Repair
Qtr Panel nsr	Dented	2 Or Less UpTo 10mm	Smart Repair
Wing nsf	Scratched	Over 25mm Not Thru Paint	Machine Polish
Screen Front	Chipped	UpTo 10mm	Smart Repair
Bonnet	Chipped	1 To 5	Smart Repair
Bumper Front	Scratched	Over 25mm Not Thru Paint	Machine Polish
Bumper Front	Chipped	Multiple Chips	Smart Repair
Wing osf	Scratched	Over 25mm Not Thru Paint	Machine Polish
Wing osf	Chipped	1 To 5	Smart Repair
Door osf	Scratched	Over 25mm Not Thru Paint	Machine Polish

Door osf	Chipped	1 To 5	Smart Repair
Door osr	Scratched	Over 25mm Not Thru Paint	Machine Polish
Door osr	Dented	2 Or Less UpTo 10mm	Smart Repair
Qtr Panel osr	Chipped	1 To 5	Smart Repair
