Vehicle Inspection Report

Reg: YD610EA

VIN: WMWZM32060T130399

Make	MINI	Body Type	Convertible	Doors	2
Model	ONE - 1598cc	Fuel Type	Petrol	Colour	White
Mileage	108,164 miles	Transmission	Manual	Year of MFR	2011
		Gears	6	Date First Reg	12/10/2011

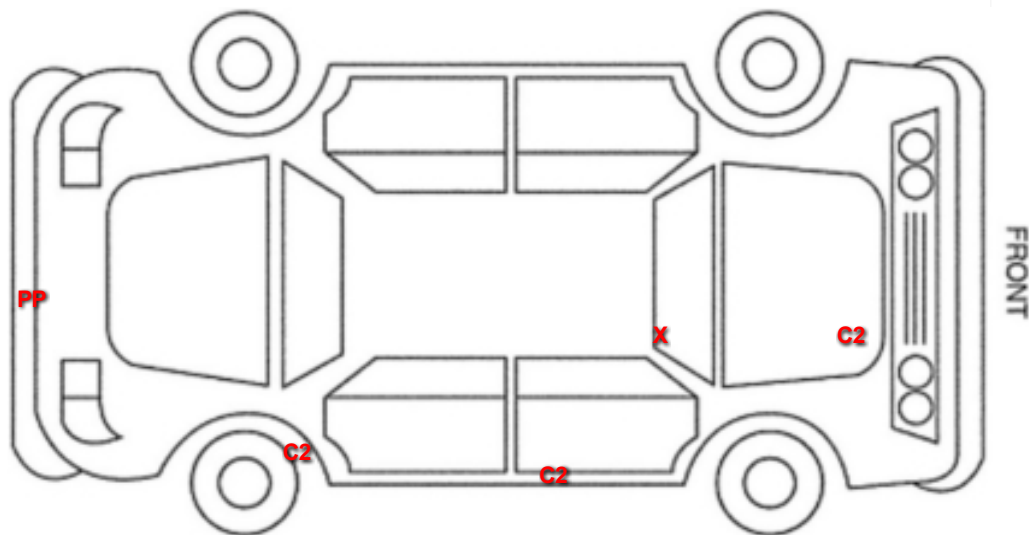
Vehicle Splat

Door osf Chipped 1 To 5 Smart Repair	Door osf Scratched Over 25mm Not Thru Paint Machine Polish	Qtr Panel osr Scratched Over 25mm Not Thru Paint Machine Polish

Qtr Panel osr Chipped 1 To 5 Smart Repair

Bumper Rear Poor Previous Repair Paint Flake Refinish

Bonnet Chipped 1 To 5 Smart Repair

Screen Front Chipped Over 10mm Replace

Door Pad osf Scuffed UpTo 25mm Smart Repair
