Vehicle Inspection Report

Reg: GV19OAP

Make	CITROEN	Body Type	Hatchback	Doors	5
Model	C3 ORIGINS PURETECH S/S - 1199cc	Fuel Type	Petrol	Colour	Grey
		Transmission	Manual	Year of MFR	2019
Mileage	38,977 miles	Gears	5	Date First Reg	30/04/2019

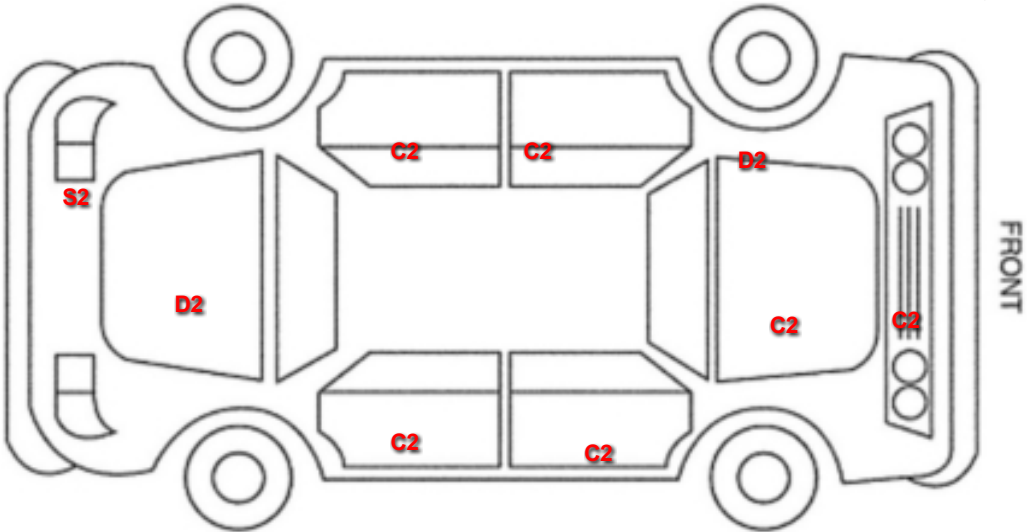
Vehicle Splat

Damage Lines			
Component	Condition	Severity	Repair
Boot Lid	Dented	Over 30mm	Repair and Refinish
Bumper Rear	Scratched	25 to 100mm Thru Paint	Smart Repair
Bumper Rear	Scratched	Over 25mm Not Thru Paint	Machine Polish
Qtr Panel nsr	Scratched	Over 25mm Not Thru Paint	Machine Polish
Door nsr	Scratched	Over 25mm Not Thru Paint	Machine Polish
Door nsr	Chipped	1 To 5	Smart Repair
Door nsf	Scratched	Over 25mm Not Thru Paint	Machine Polish
Door nsf	Chipped	1 To 5	Smart Repair
Door Mirror Assy nsf	Scratched (Painted)	Over 25mm Not Thru Paint	Machine Polish
Wing nsf	Dented	Over 30mm	Repair and Refinish
Bumper Front	Chipped	Multiple Chips	Smart Repair
Bumper Front	Scratched	Over 25mm Not Thru Paint	Machine Polish
Bonnet	Chipped	1 To 5	Smart Repair
Wing osf	Scratched	Over 25mm Not Thru Paint	Machine Polish
Door Mirror Assy osf	Scratched (Painted)	Over 25mm Not Thru Paint	Machine Polish
Door osf	Scratched	Over 25mm Not Thru Paint	Machine Polish

Door osf	Chipped	1 To 5	Smart Repair
Door osr	Scratched	Over 25mm Not Thru Paint	Machine Polish
Door osr	Chipped	1 To 5	Smart Repair
