Vehicle Inspection Report

Date Inspected: 17/03/2025 17:27

Reg: EJ70HTV

VIN: JTDKGNEC00N577862

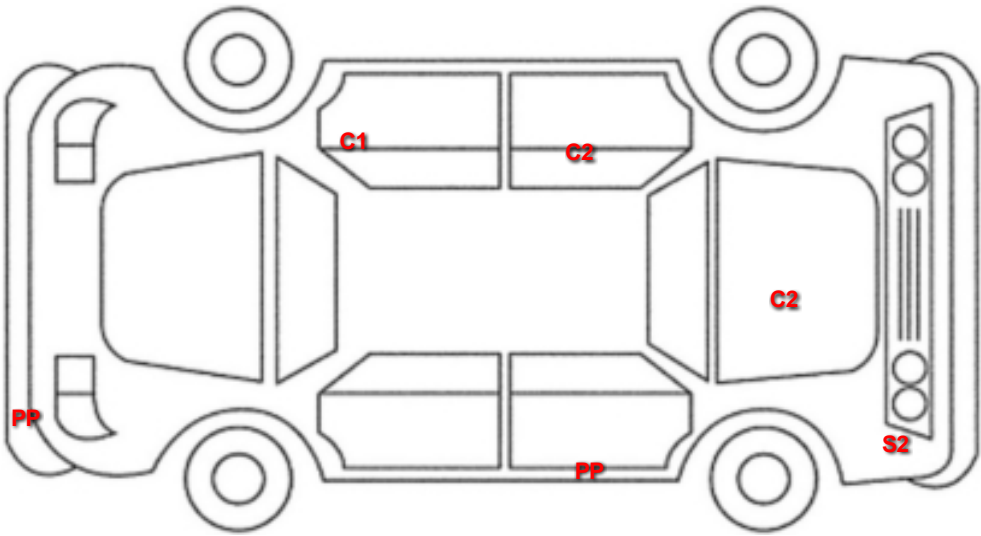
Vehicle Splat

Damage Lines			
Component	Condition	Severity	Repair
Bonnet	Chipped	1 To 5	Smart Repair
Bumper Front	Scratched	25 to 100mm Thru Paint	Smart Repair
Wing osf	Scratched	Over 25mm Not Thru Paint	Machine Polish
Door osr	Scratched	Over 25mm Not Thru Paint	Machine Polish
Qtr Panel osr	Chipped	Edge Chip	Smart Repair
Qtr Panel nsr	Scratched	Over 25mm Not Thru Paint	Machine Polish
Door nsr	Scratched	Over 25mm Not Thru Paint	Machine Polish
Door nsf	Chipped	1 To 5	Smart Repair
Door nsf	Scratched	Over 25mm Not Thru Paint	Machine Polish
Wing nsf	Scratched	Over 25mm Not Thru Paint	Machine Polish
Door Mirror Assy osf	Scratched (Painted)	Over 25mm Not Thru Paint	Machine Polish
Bumper Rear	Poor Previous Repair	Poor Paint	Refinish
Door nsr	Chipped	1 To 5	Smart Repair
Door osf	Poor Previous Repair	Poor Paint	Refinish
Seat Base Cover osr	Scuffed	UpTo 25mm	Smart Repair
Seat Base Cover nsr	Scuffed	UpTo 25mm	Smart Repair

£100 Additional Fee. EXPIRED MOT. Signs of front end accident damage.
