Vehicle Inspection Report

Date Inspected: 29/04/2025 16:54

Reg: VN66VVM

VIN: SJNFEAJ11U1852674

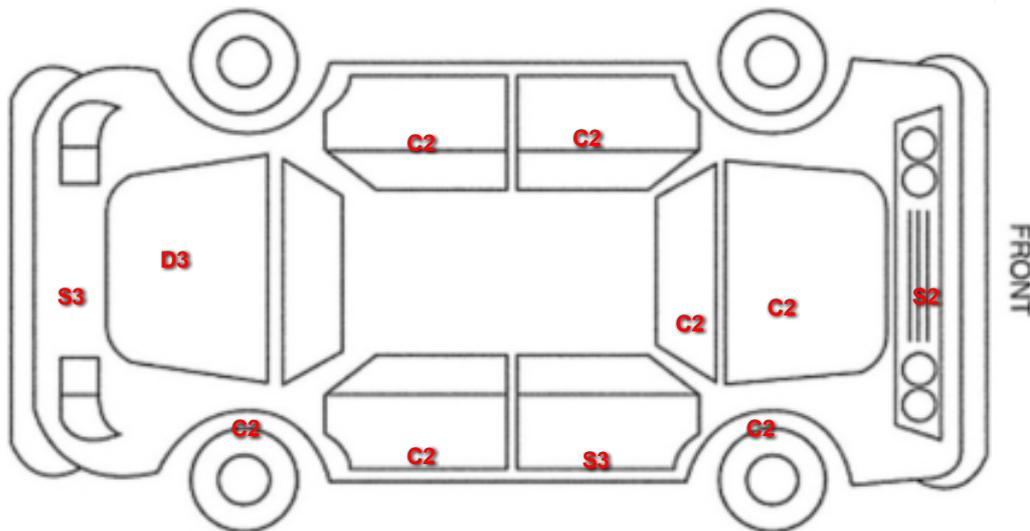
Vehicle Splat

Component	Condition	Severity	Repair
Bumper Front	Scratched	25 to 100mm Thru Paint	Smart Repair
Bumper Front	Scratched	Over 25mm Not Thru Paint	Machine Polish
Bonnet	Chipped	1 To 5	Smart Repair
Wing osf	Scratched	Over 25mm Not Thru Paint	Machine Polish
Wing osf	Chipped	1 To 5	Smart Repair
Screen Front	Chipped	UpTo 10mm	Smart Repair
Door osf	Scratched	Over 25mm Thru Paint	Refinish
Door osr	Chipped	Multiple Chips	Refinish
Qtr Panel osr	Scratched	Over 25mm Not Thru Paint	Machine Polish
Qtr Panel osr	Chipped	1 To 5	Smart Repair
Bumper Rear	Scratched	Over 100mm Thru Paint	Refinish
Boot Lid	Dented	Over 30mm	Repair and Refinish
Qtr Panel nsr	Scratched	Over 25mm Not Thru Paint	Machine Polish
Door nsr	Scratched	Over 25mm Not Thru Paint	Machine Polish
Door nsr	Chipped	1 To 5	Smart Repair
Door nsf	Chipped	Multiple Chips	Refinish
Wing nsf	Scratched	Over 25mm Not Thru Paint	Machine Polish
Wing nsf	Chipped	1 To 5	Smart Repair

rear bumper misaligned and slight noise from engine bay
