Vehicle Inspection Report

Reg: MK67MJE

Make	FORD	Body Type	Van	Doors	5
Model	TRANSIT CONNECT 240 TREND - 1499cc	Fuel Type	Diesel	Colour	White
Mileage	92,666 miles	Transmission	Manual	Year of MFR	2017
		Gears	5	Date First Reg	29/09/2017

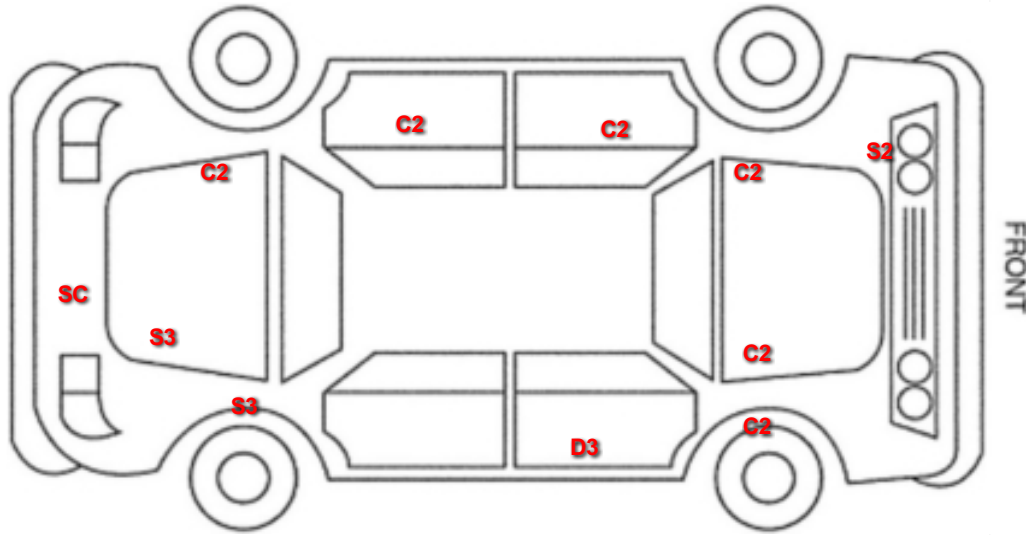
Vehicle Splat

Component	Condition	Severity	Repair
Bonnet	Chipped	1 To 5	Smart Repair
Bumper Front	Scratched	25 to 100mm Thru Paint	Smart Repair
Bumper Front	Scratched	Over 25mm Not Thru Paint	Machine Polish
Wing nsf	Chipped	1 To 5	Smart Repair
Door nsf	Chipped	1 To 5	Smart Repair
Door nsr	Chipped	Multiple Chips	Refinish
Qtr Panel nsr	Chipped	Multiple Chips	Refinish
Boot Lid	Scratched	Over 25mm Thru Paint	Refinish
Bumper Rear Moulding	Scuffed (Unpainted)	Over 100mm	Smart Repair
Qtr Panel osr	Scratched	Over 25mm Thru Paint	Refinish
Door osf	Dented	Over 30mm	Repair and Refinish
Wing osf	Chipped	1 To 5	Smart Repair
