# VEHICLE INSPECTION REPORT

SL14OXU

## Kia Sportage 1.6 GDi ISG 2 5dr

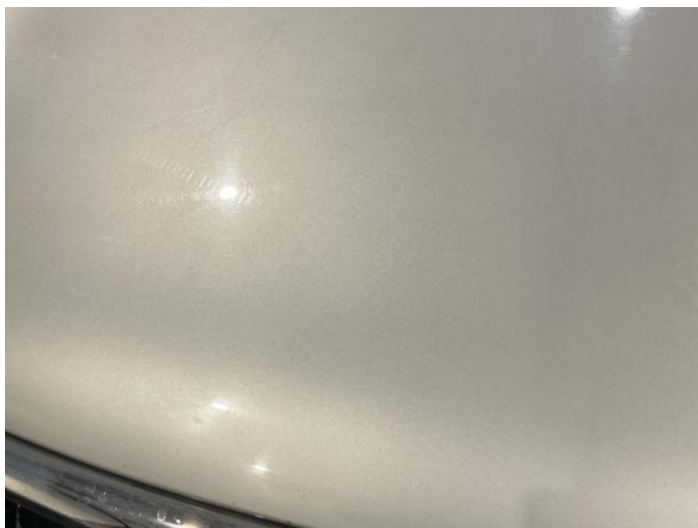
1: Bonnet  
Chipped  
1 To 5

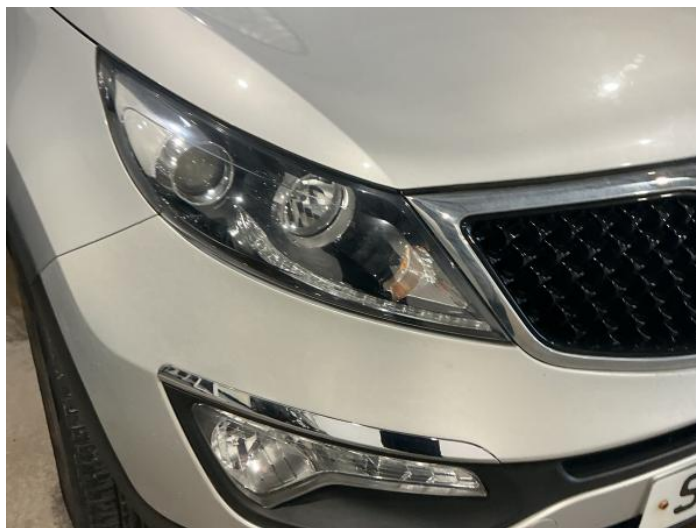
2: Bumper Front  
Poor Previous Repair  
Poor Paint

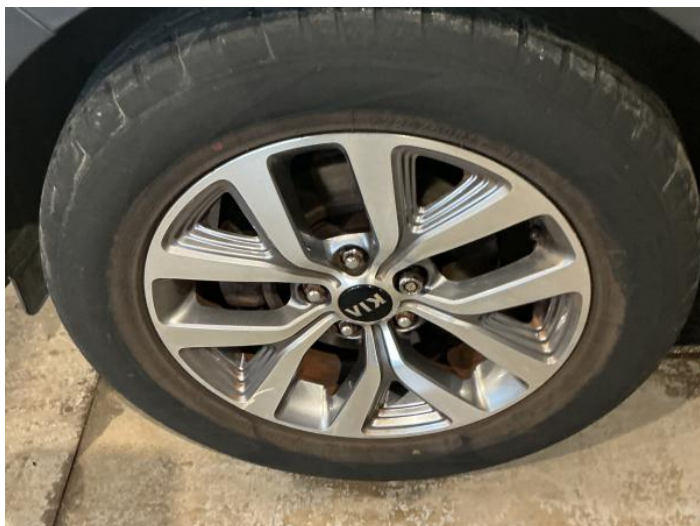
3: Wheel nsf  
Scratched  
Up To 50mm

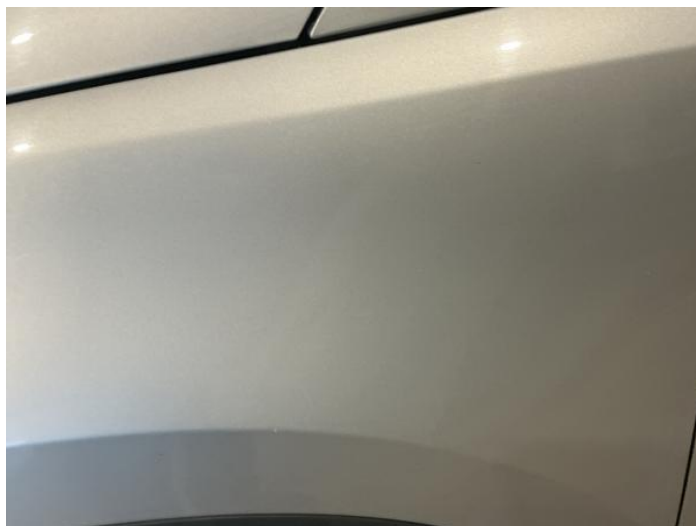
4: Wing nsf  
Chipped  
1 To 5

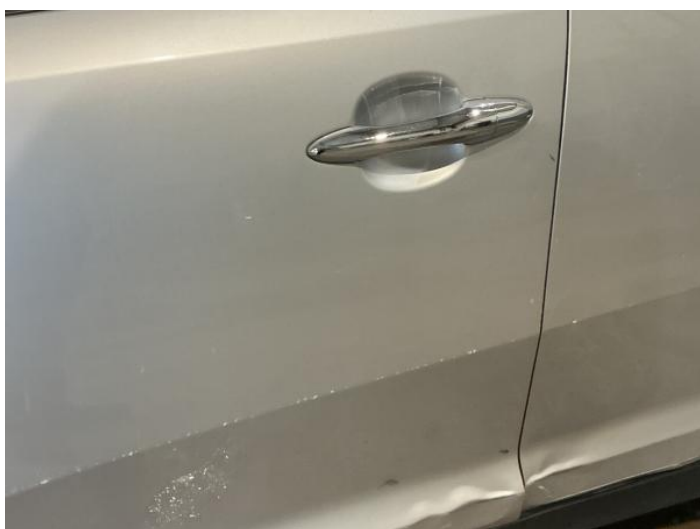
5: Door nsf  
Dented  
With Paint Damage

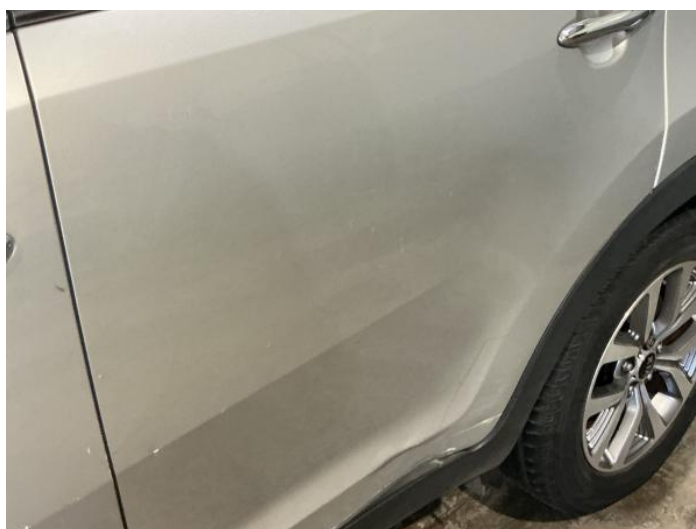
6: Door nsr  
Dented  
With Paint Damage

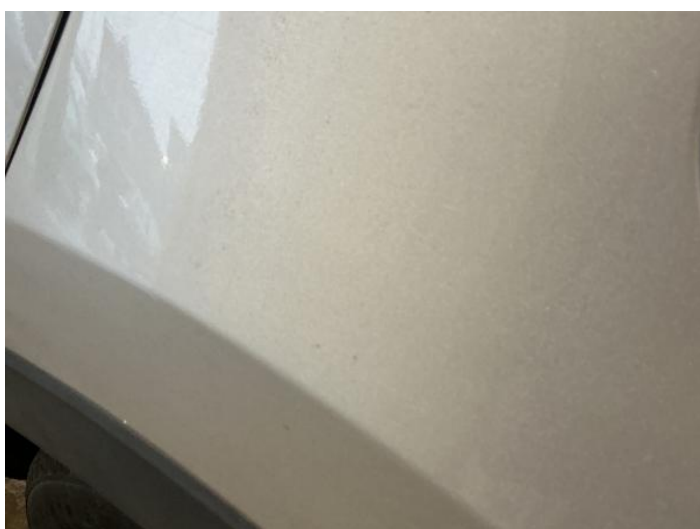
7: Qtr Panel nsr  
Chipped  
1 To 5

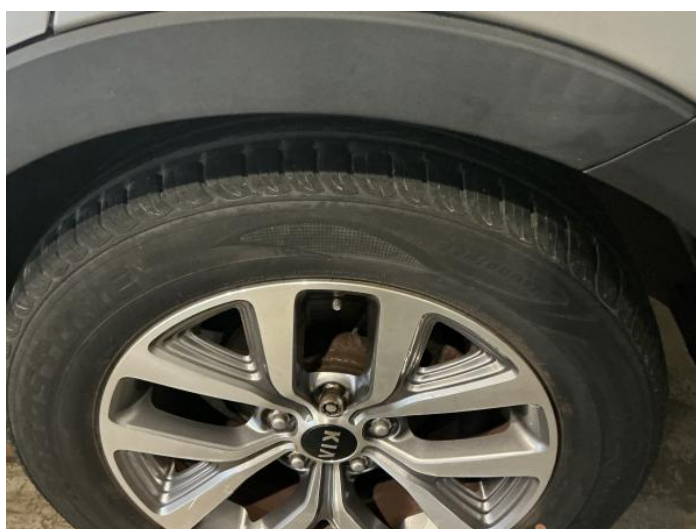
8: Wheel nsr  
Scratched  
Up To 50mm

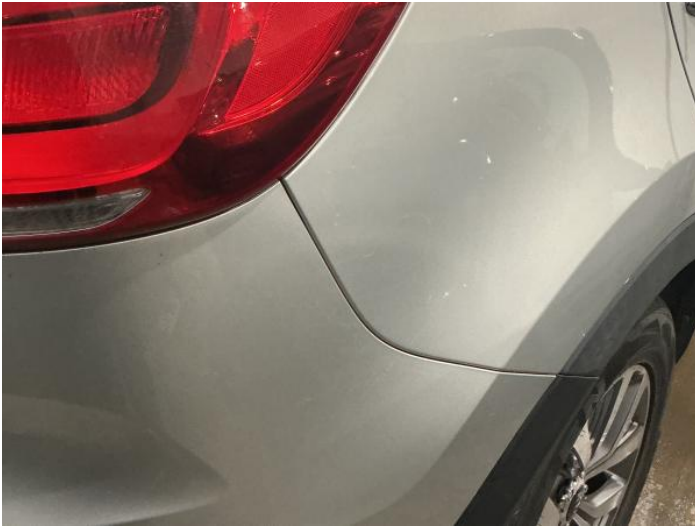
9: Bumper Rear  
Scratched  
25 to 100mm Thru Paint

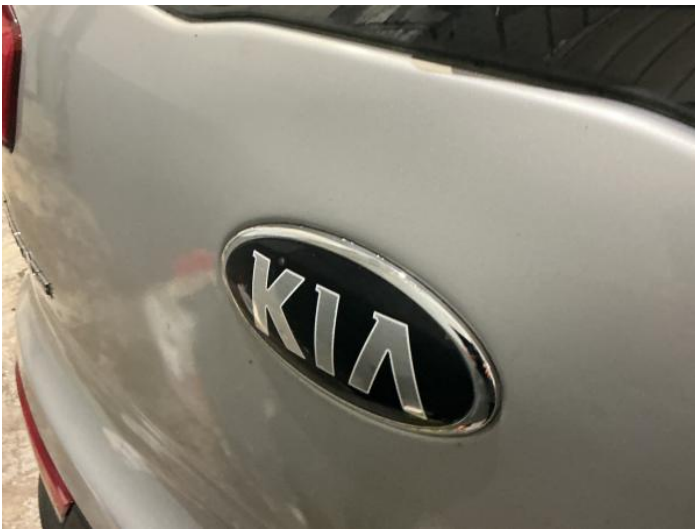
11: Boot Lid  
Poor Previous Repair  
Poor Paint

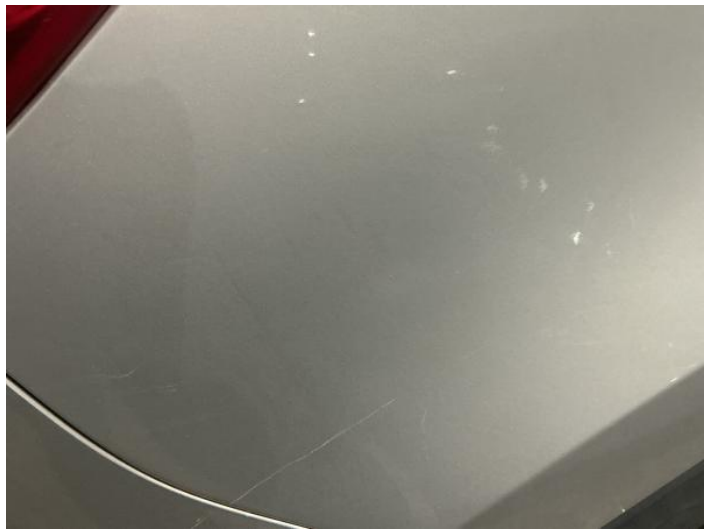
12: Qtr Panel osr  
Scratched  
Over 25mm Thru Paint

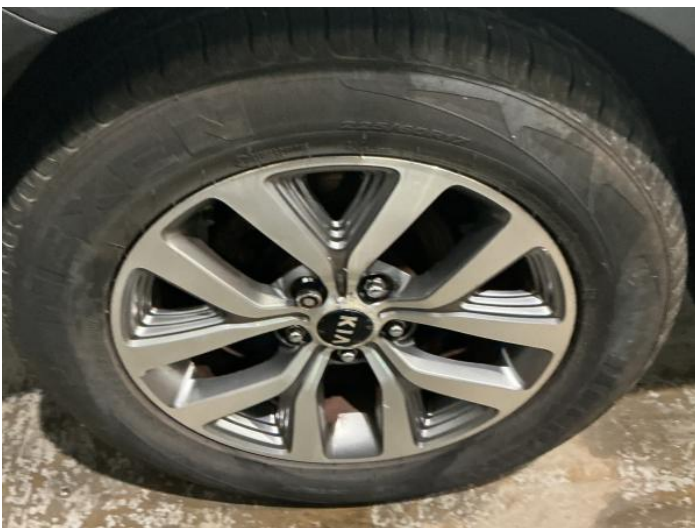
13: Wheel osr  
Scratched  
Up To 50mm

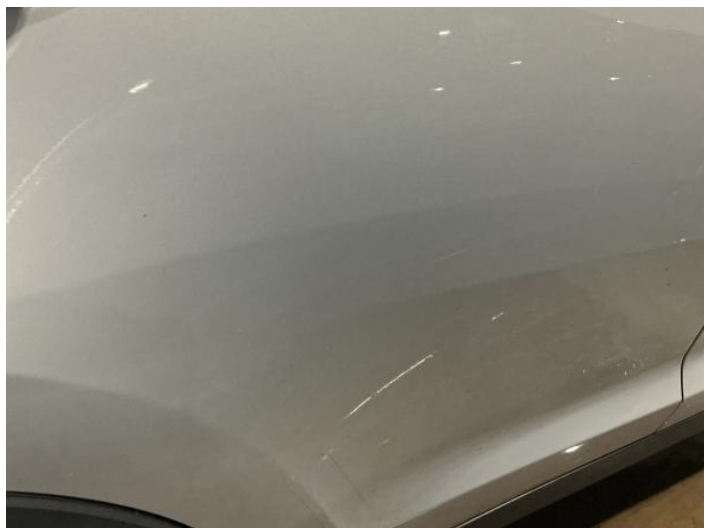
14: Door osr  
Dented  
With Paint Damage

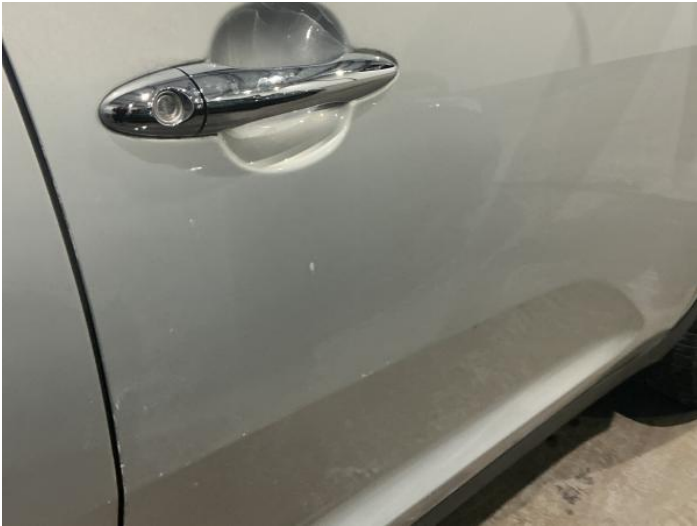
15: Door osf  
Chipped  
Multiple Chips

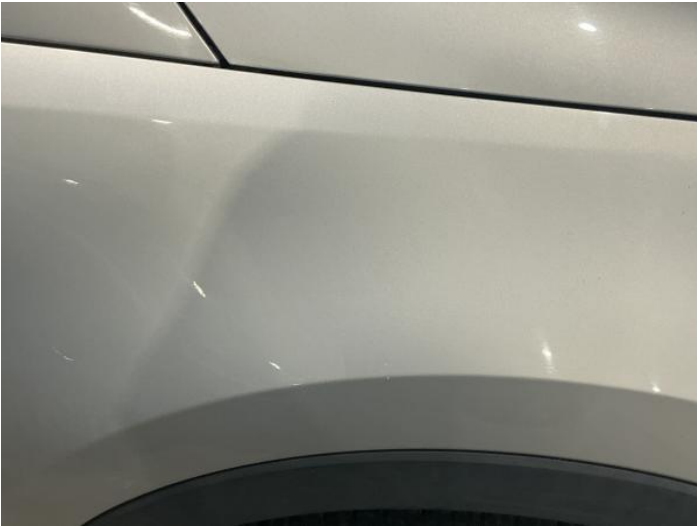
16: Wing osf  
Chipped  
1 To 5

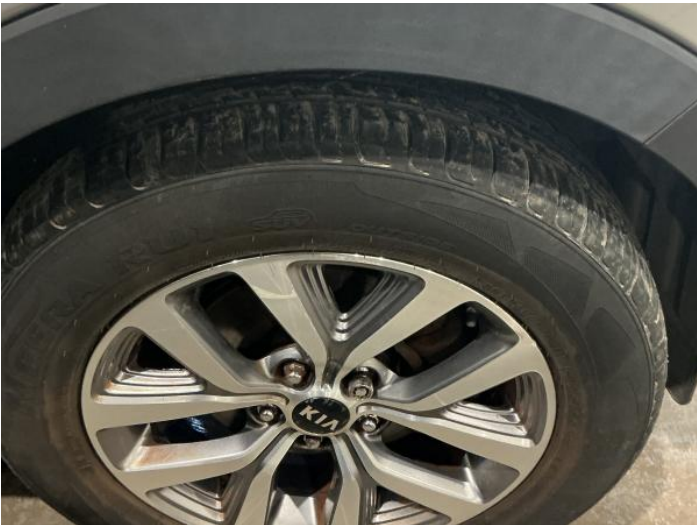
18: Wheel osf  
Scratched  
Over 50mm
