# VEHICLE INSPECTION REPORT

**MK59ABF**

## Mini Convertible 1.6 Cooper S 2dr

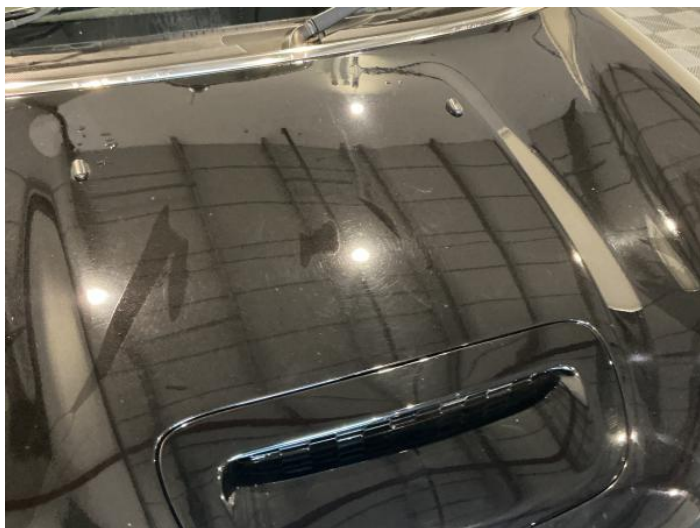
1: Bonnet  
Chipped  
Multiple Chips

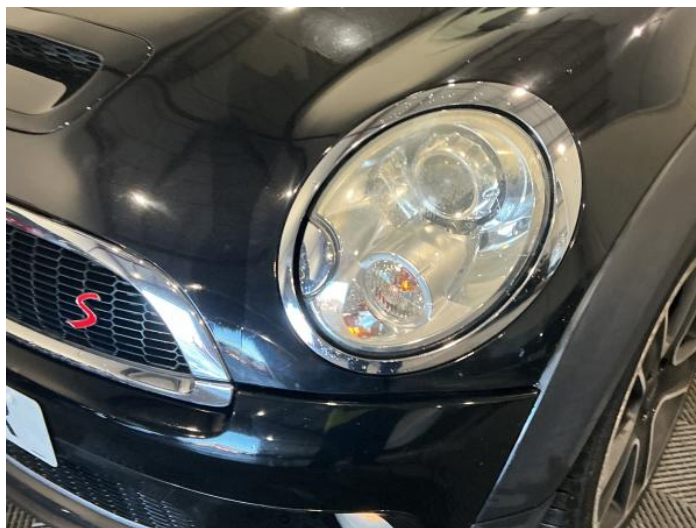
2: Bumper Front  
Chipped  
Multiple Chips

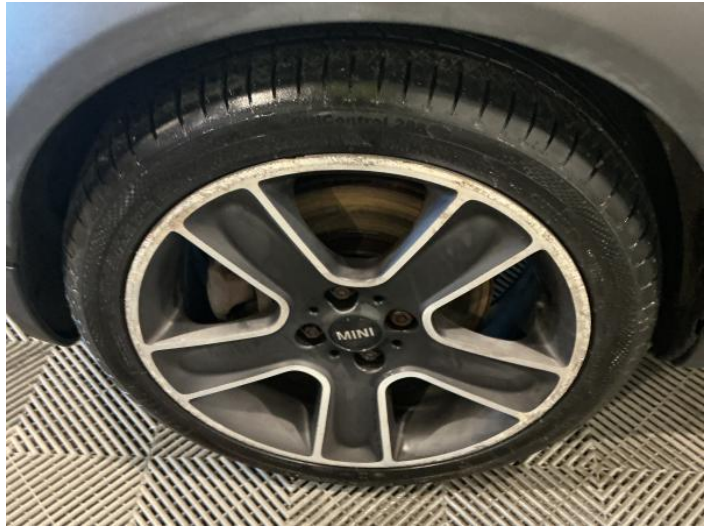
4: Wheel nsf  
Scratched  
Over 50mm

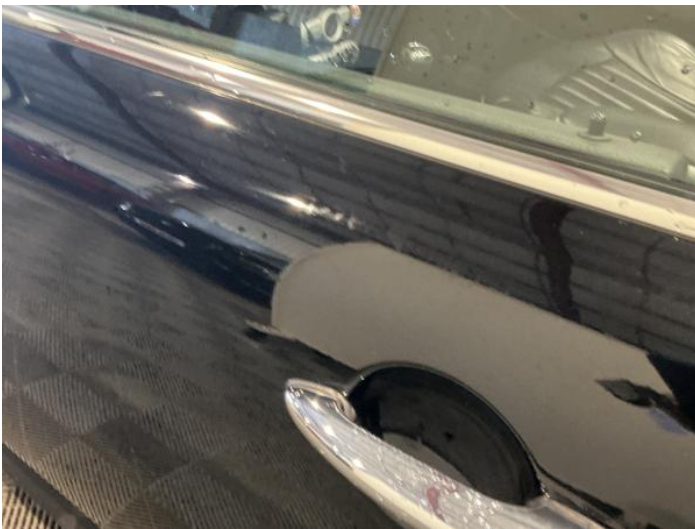
5: Door nsf  
Poor Previous Repair  
Poor Paint

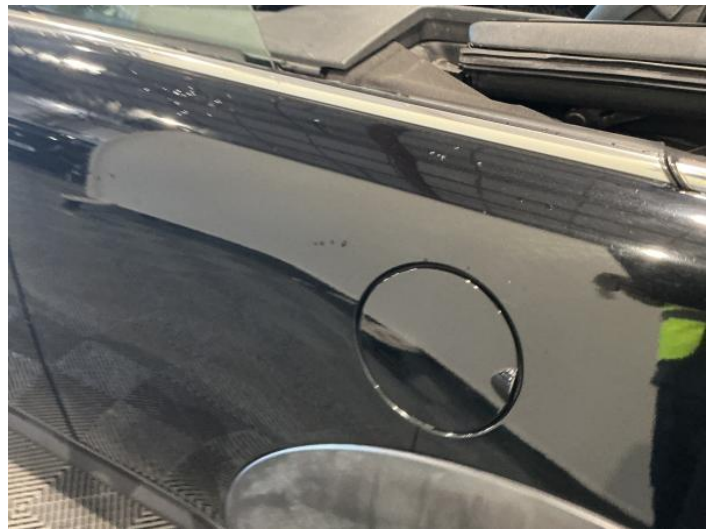
6: Qtr Panel nsr  
Chipped  
1 To 5

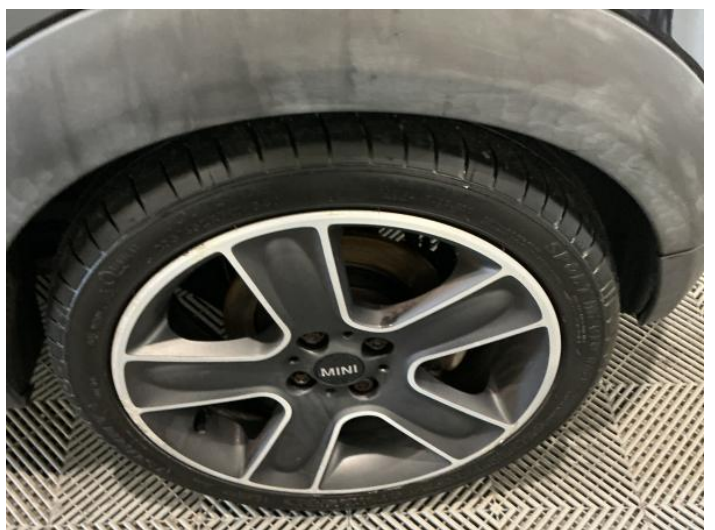
8: Wheel nsr  
Scratched  
Up To 50mm

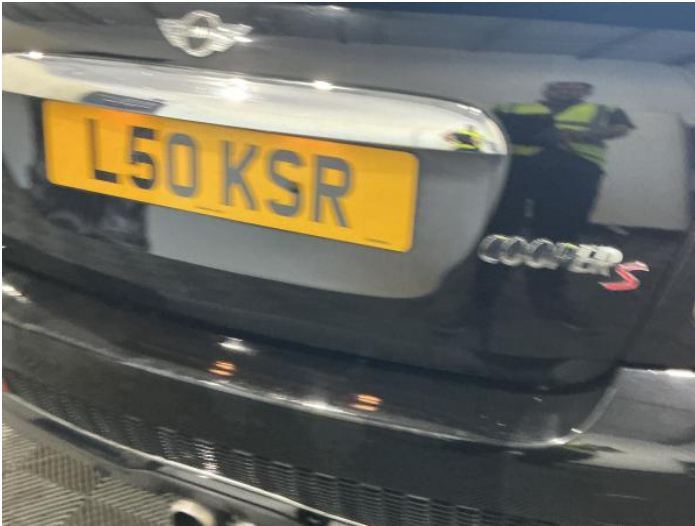
9: Bumper Rear  
Chipped  
Multiple Chips

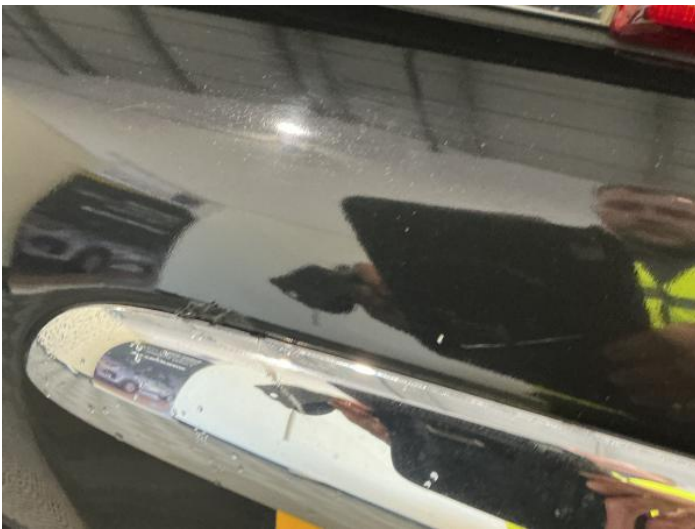
11: Boot Lid  
Poor Previous Repair  
Poor Paint

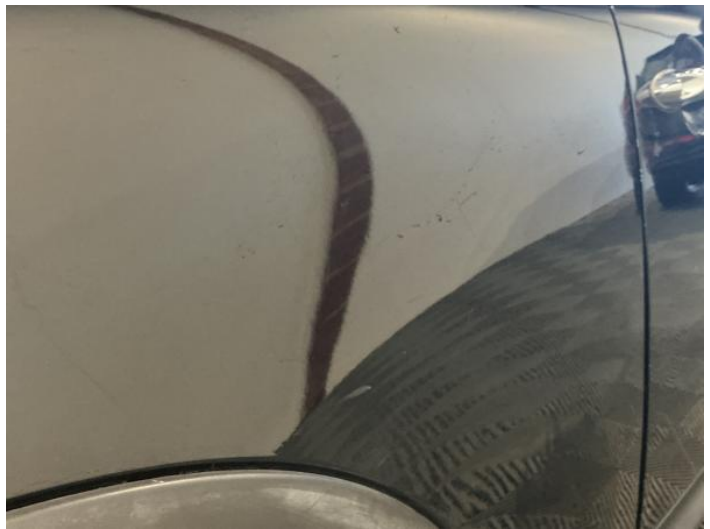
12: Qtr Panel osr  
Chipped  
1 To 5

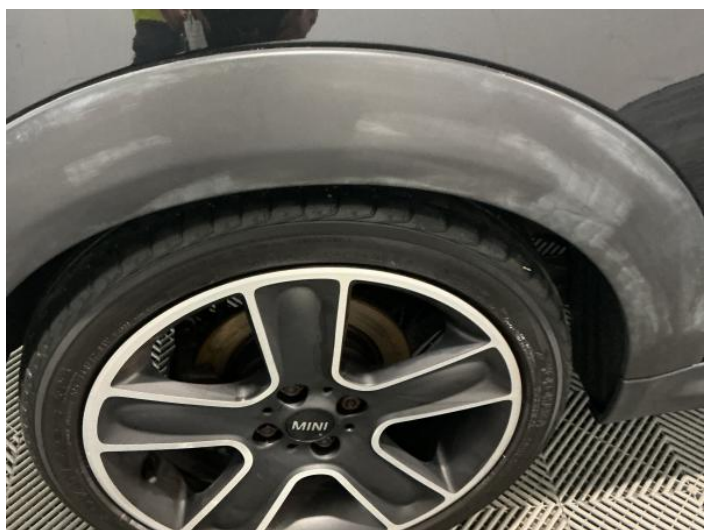
14: Wheel osr  
Scratched  
Up To 50mm

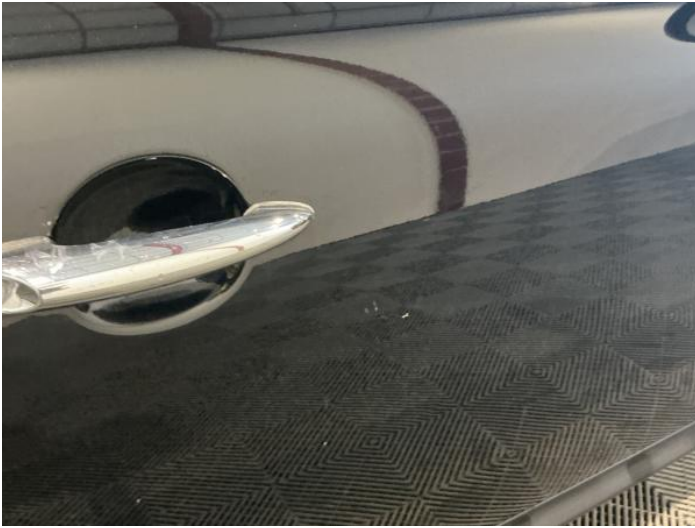
15: Door osf  
Dented  
With Paint Damage

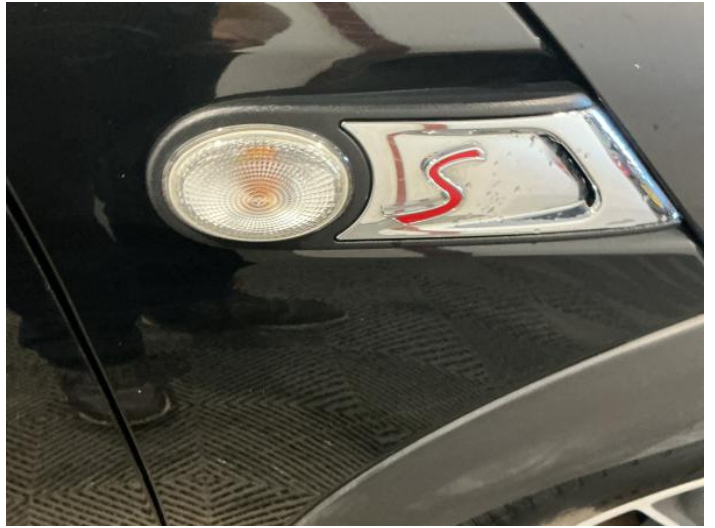
16: Wing osf  
Chipped  
1 To 5

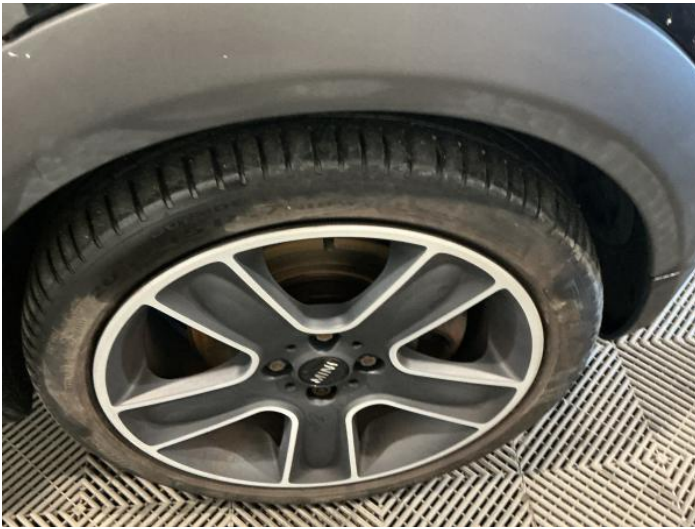
17: Wheel osf  
Scratched  
Up To 50mm

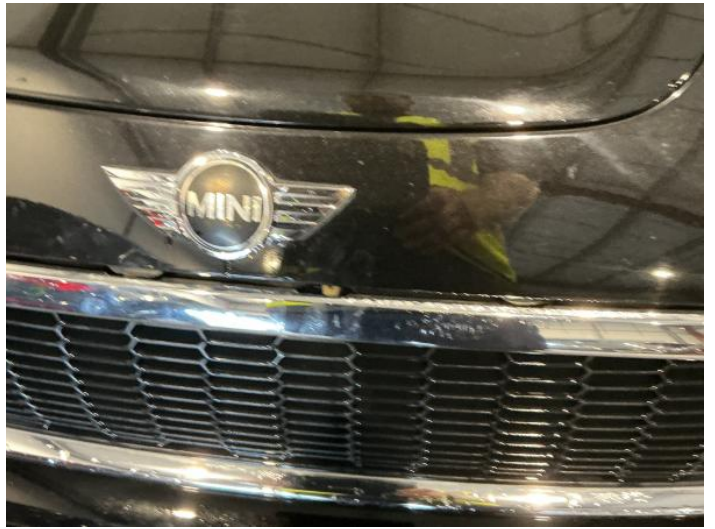
18: Bumper Front Grill  
Broken  
Replace

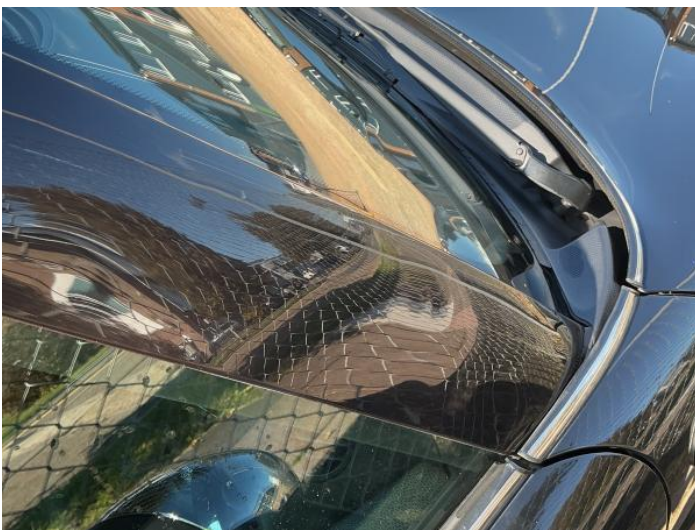
19: A Post os  
Dented  
Over 30mm

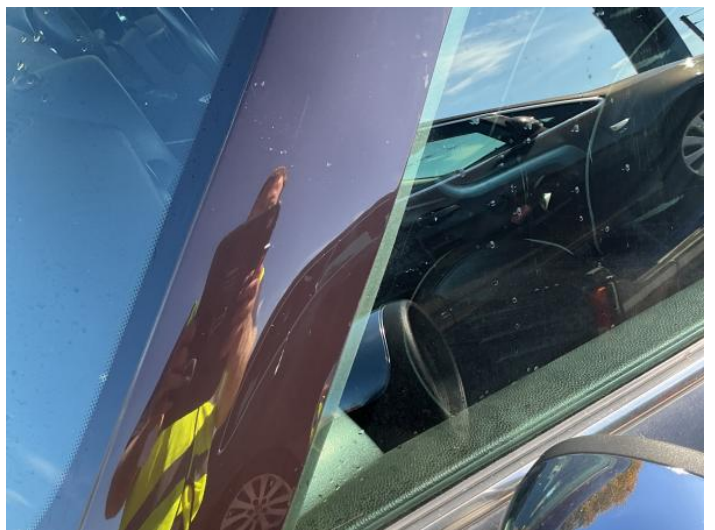
20: A Post ns  
Dented  
Over 30mm
