# VEHICLE INSPECTION REPORT

AF59TMX

## Toyota Avensis 2.0 D-4D T4 5dr

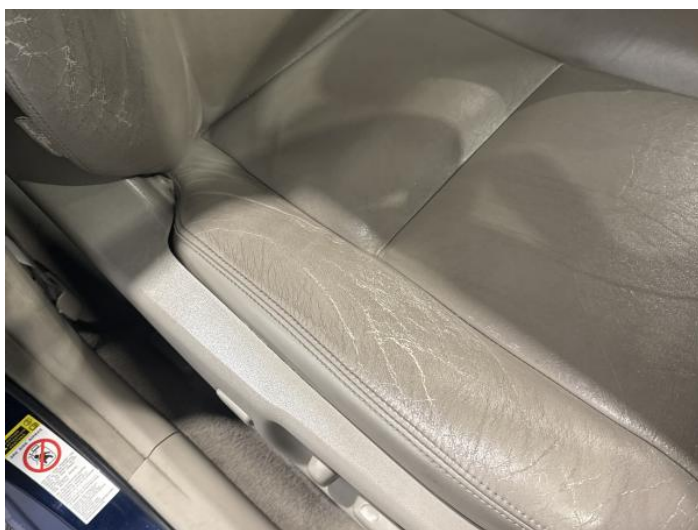
1: Seat Base Cover osf  
Scuffed  
Over 25mm

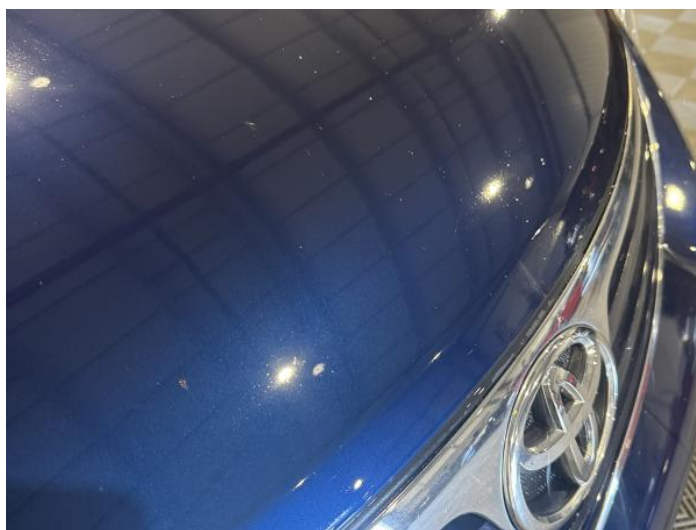
2: Bonnet  
Chipped  
Multiple Chips

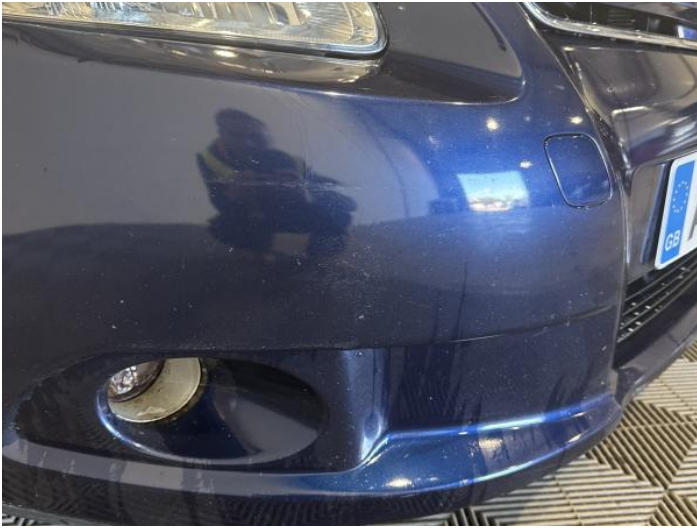
3: Bumper Front  
Dented  
With Paint Damage

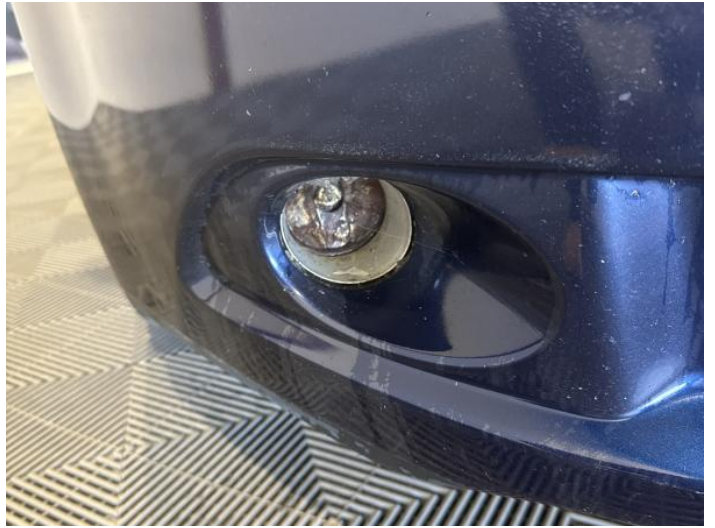
4: Fogdriving Lamp osf  
Broken  
Replace

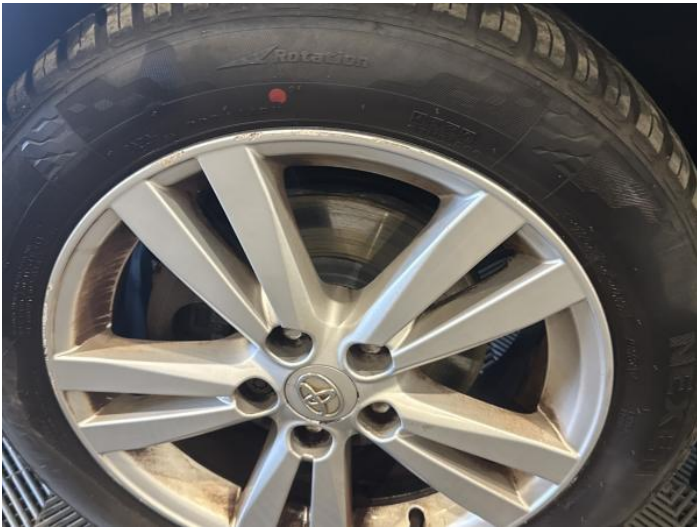
5: Wheel nsf  
Scratched  
Over 50mm

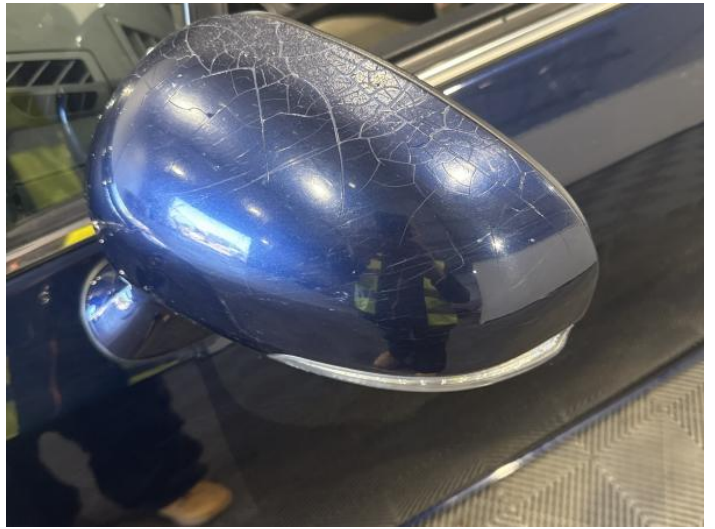
6: Door Mirror Assy nsf  
Scratched (Painted)  
Over 25mm Thru Paint

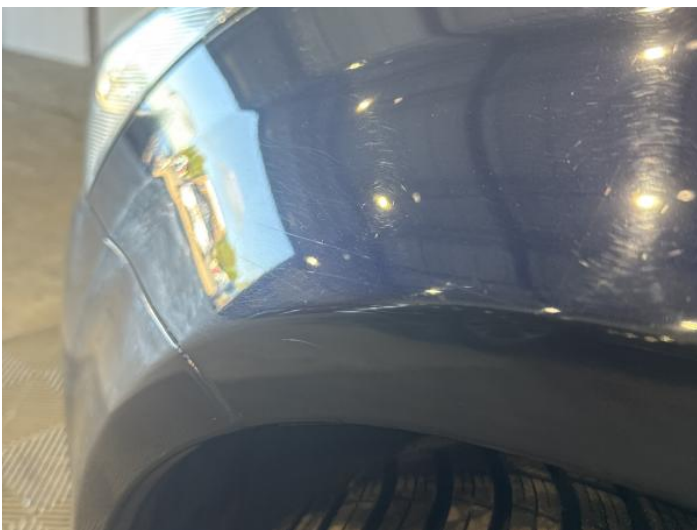
7: Wing nsf  
Scratched  
UpTo 25mm Thru Paint

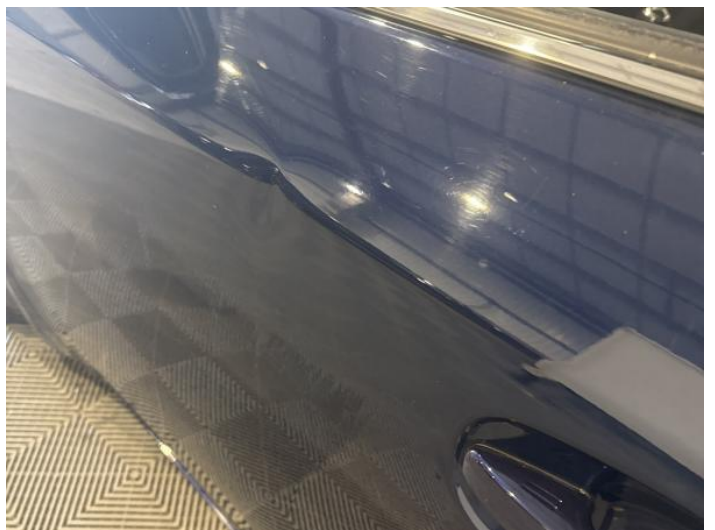
8: Door nsf  
Dented  
Over 30mm

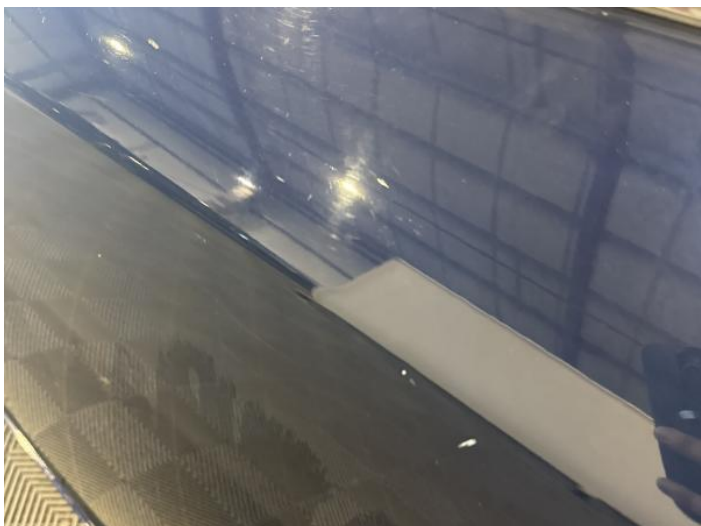
9: Door nsr  
Scratched  
Over 25mm Thru Paint

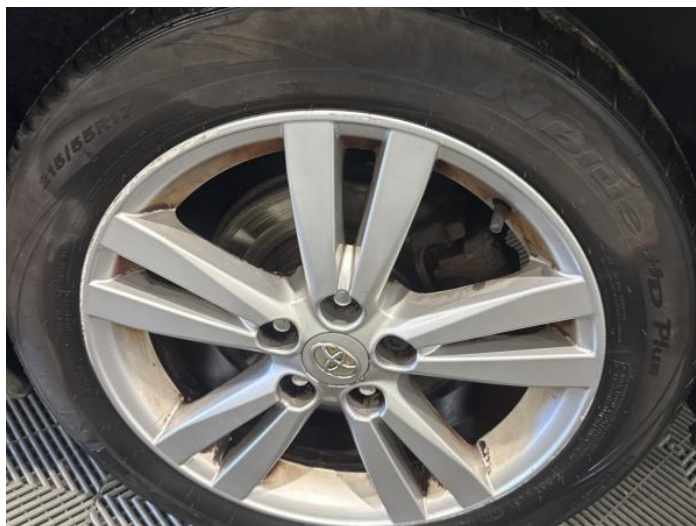
10: Wheel nsr  
Scratched  
Over 50mm

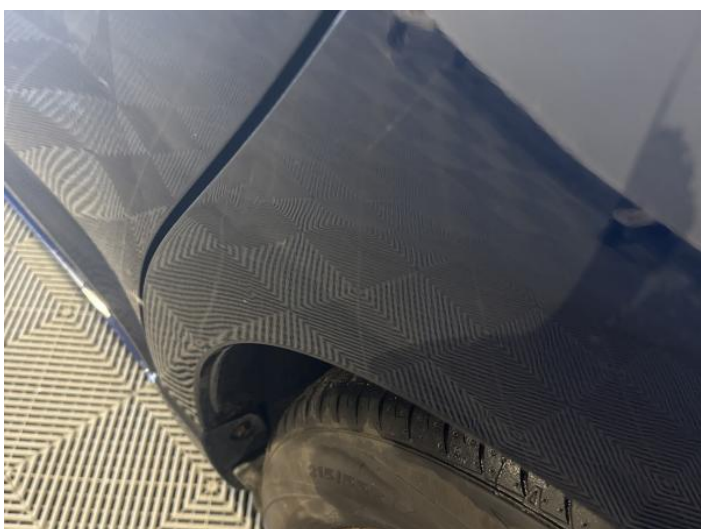
11: Qtr Panel nsr  
Dented  
Between 10mm + 30mm

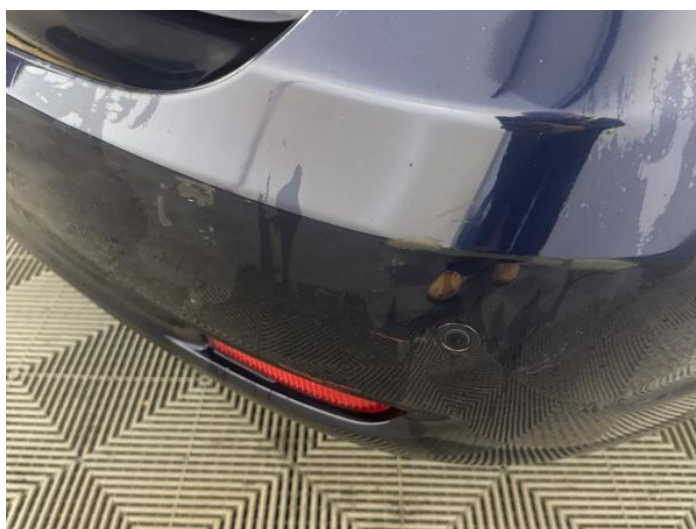
12: Bumper Rear  
Scratched  
Over 100mm Thru Paint

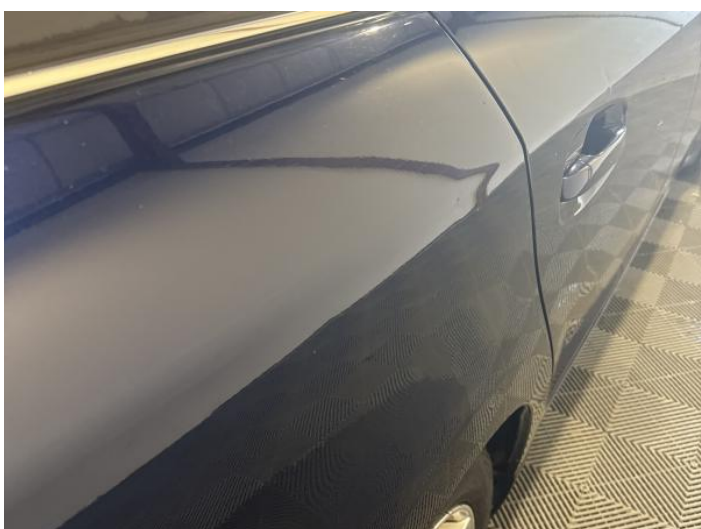
13: Qtr Panel osr  
Dented  
Over 30mm

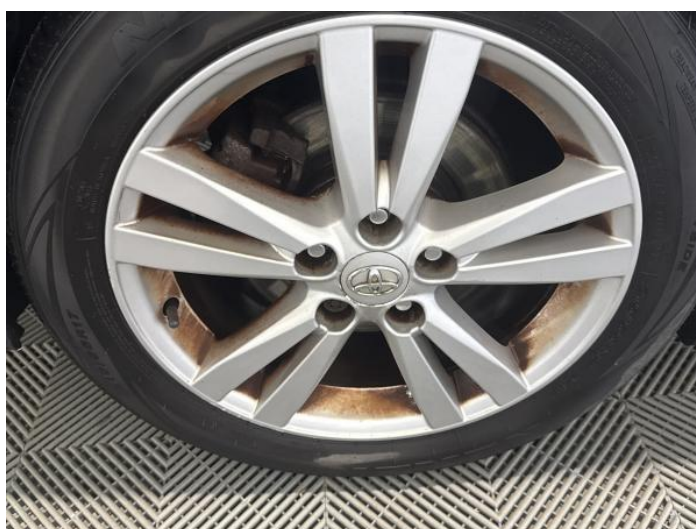
14: Wheel osr  
Scratched  
Up To 50mm

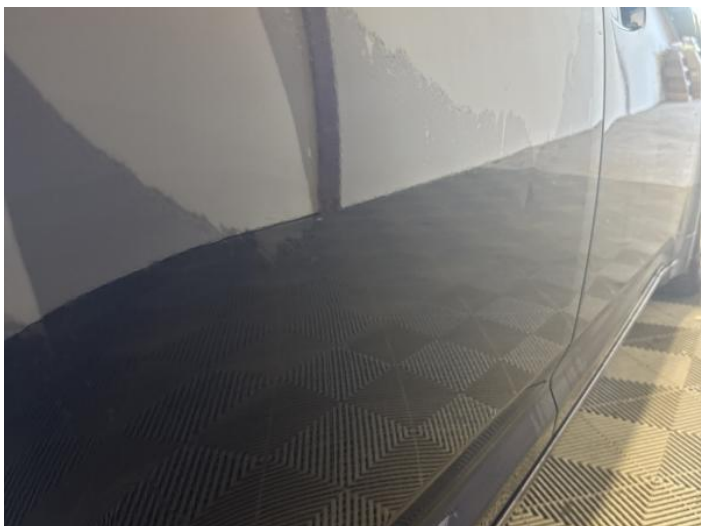
15: Door osr  
Dented  
Over 30mm

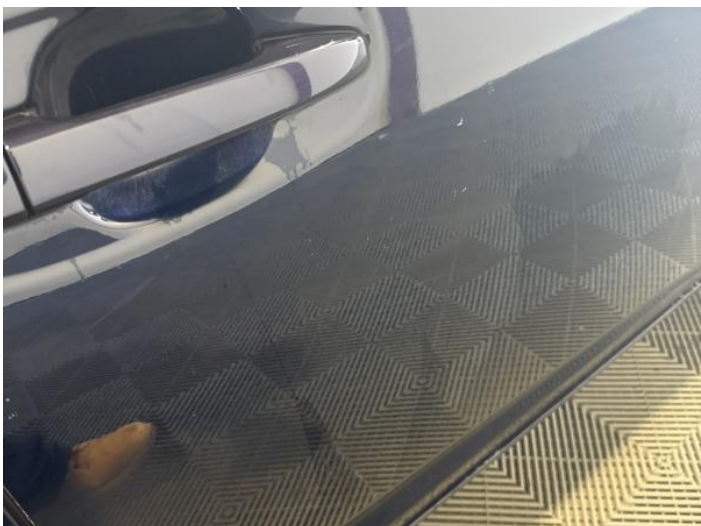
16: Door nsf  
Scratched  
Over 25mm Thru Paint

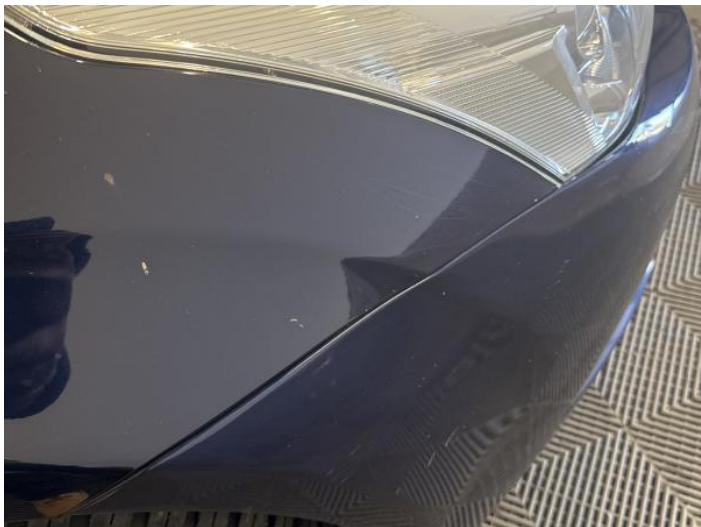
17: Wing osf  
Scratched  
Over 25mm Thru Paint

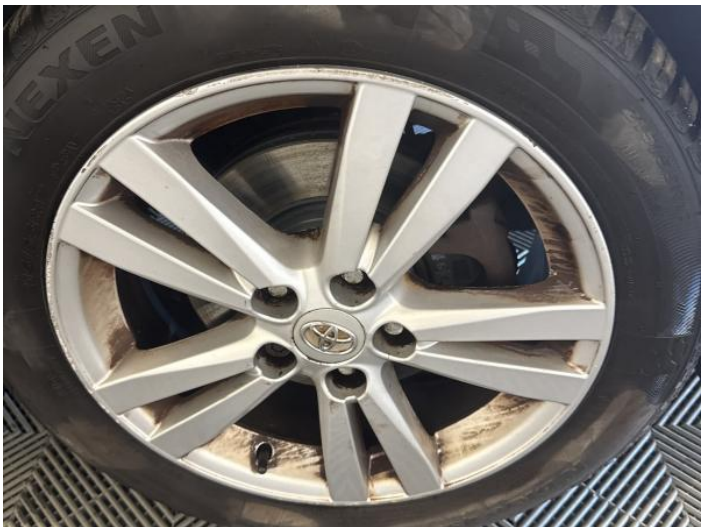
18: Wheel osf  
Scratched  
Over 50mm
