Vehicle Inspection Report

Reg:
 GL70LWW

VIN:
 6FPPXXMJ2PLY37059

Appraised By: Eastbourne Car Auctions

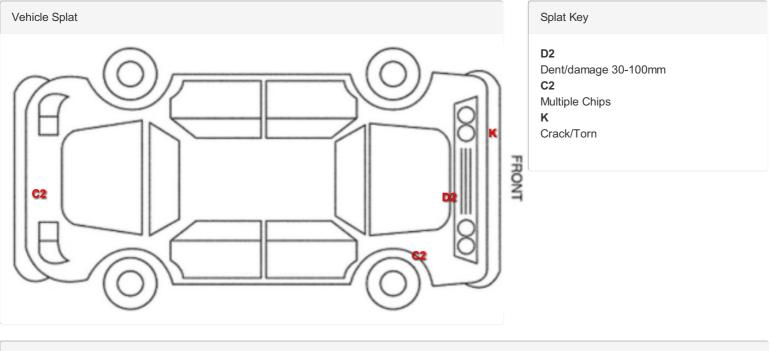
Component						
Wing osf						
Wing osf						
Door osf						
Door osf						
Door osr						
Door osr						
Qtr Panel osr						
Tailgate						
Door nsr						
Bumper Front						
Bonnet						
Screen Front

1 To 5 Over 25mm Not Thru Paint Over 25mm Not Thru Paint Edge Chip Over 25mm Not Thru Paint Edge Chip Over 25mm Not Thru Paint 1 To 5 Over 25mm Not Thru Paint UpTo 25mm With Paint Damage UpTo 10mm

dpf light on, front bumper out of line

Smart Repair Machine Polish Machine Polish Smart Repair Machine Polish Smart Repair Machine Polish Smart Repair Machine Polish Repair and Refinish Repair and Refinish Smart Repair
