## VEHICLE INSPECTION REPORT

LL64LNM

### Porsche Panamera 3.0 [300] V6 Diesel 4dr Tiptronic S

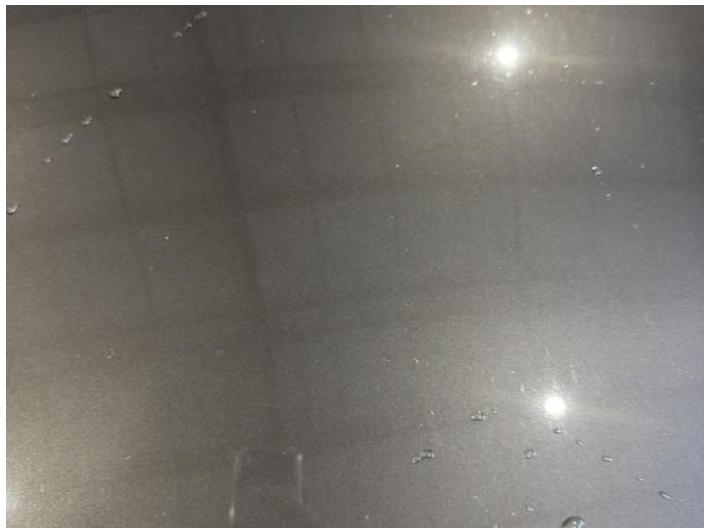
1: Bonnet  
Chipped  
1 To 5

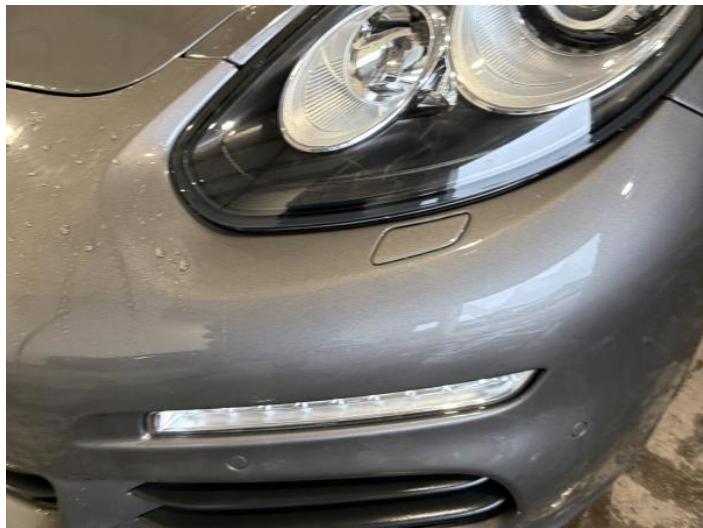
2: Bumper Front  
Chipped  
Multiple Chips

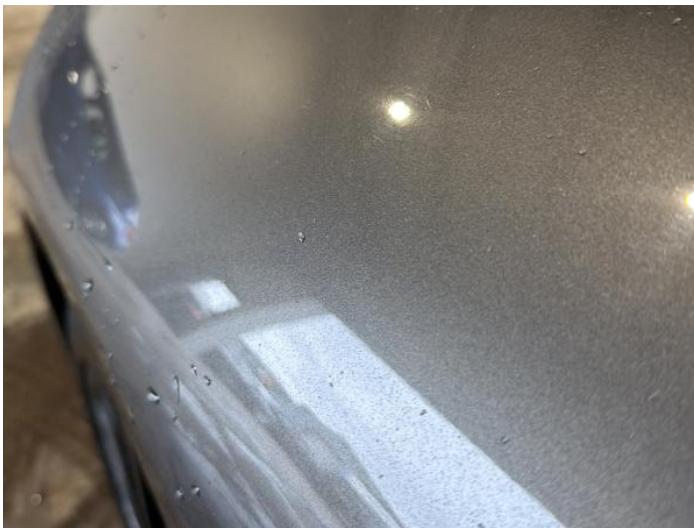
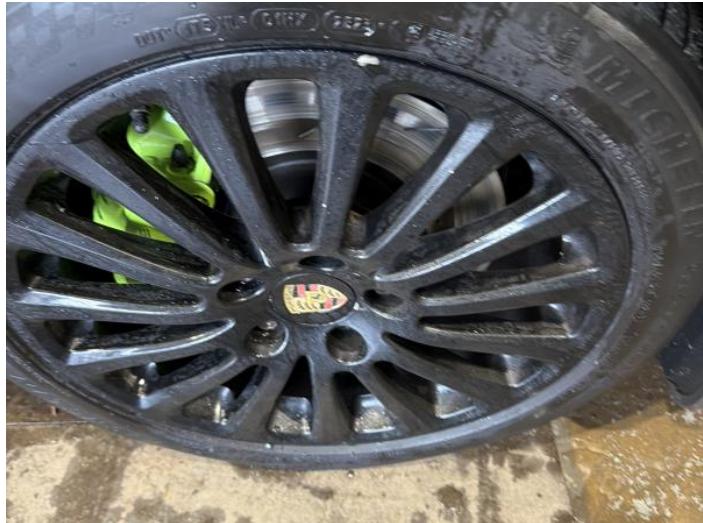
4: Wheel nsf  
Scratched  
Over 50mm

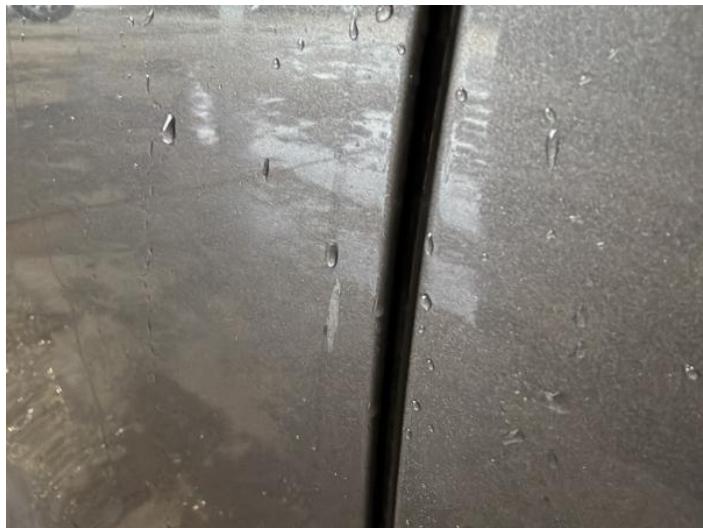
5: Wing nsf  
Dented  
2 Or Less UpTo 10mm

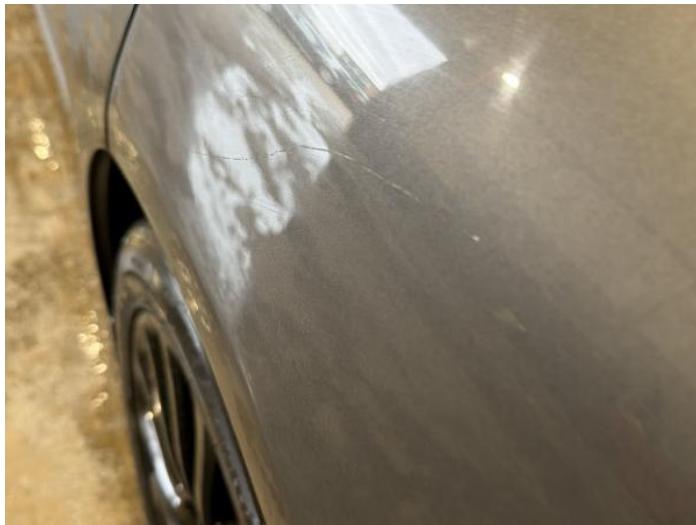
9: Qtr Panel nsr  
Dented  
Over 2 UpTo 10mm

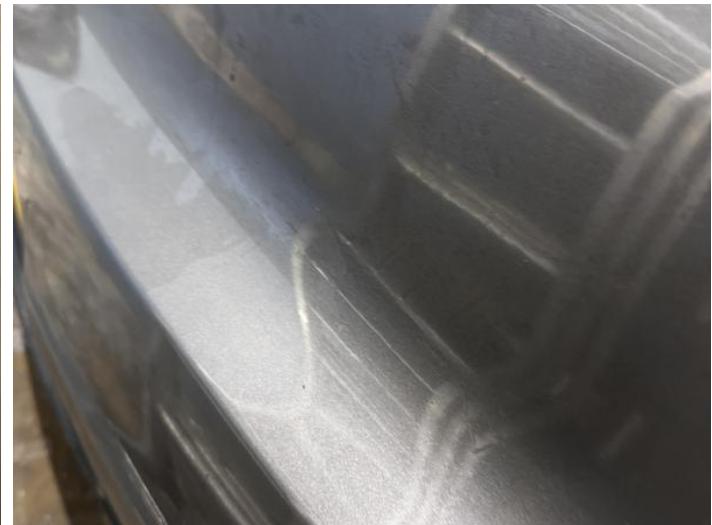
10: Bumper Rear  
Chipped  
Multiple Chips

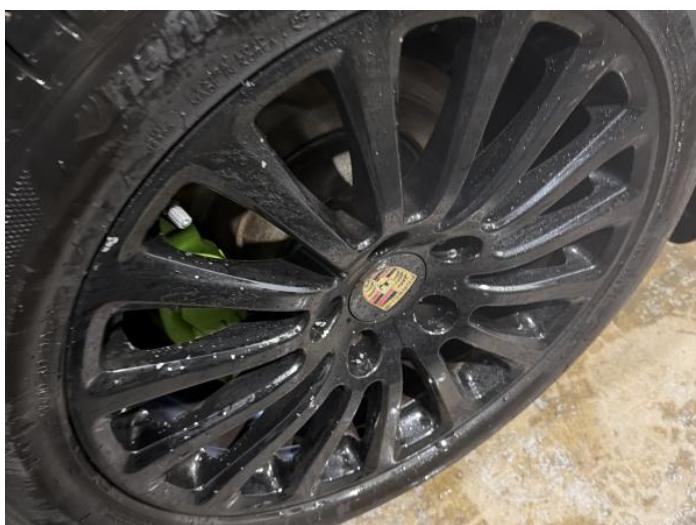
13: Wheel osr  
Scratched  
Up To 50mm

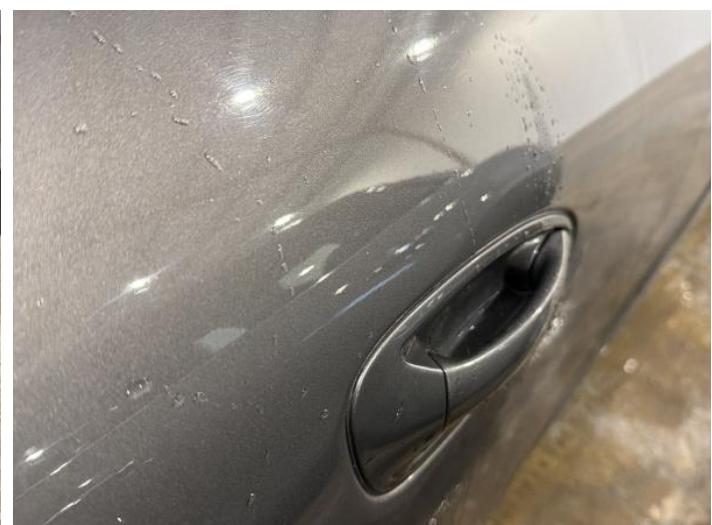
14: Door osr  
Poor Previous Repair  
Poor Paint

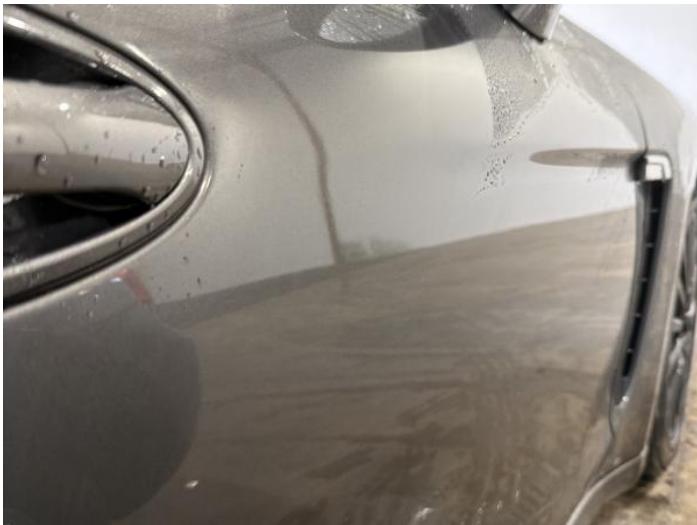
15: Door osf  
Chipped  
1 To 5

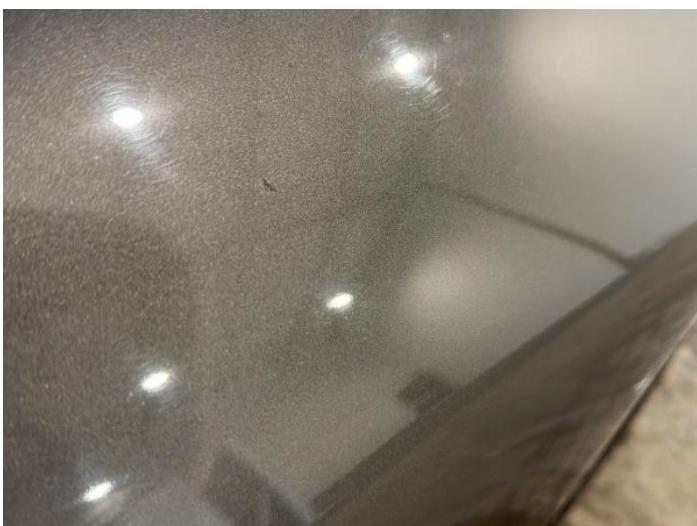
17: Wing osf  
Chipped  
1 To 5

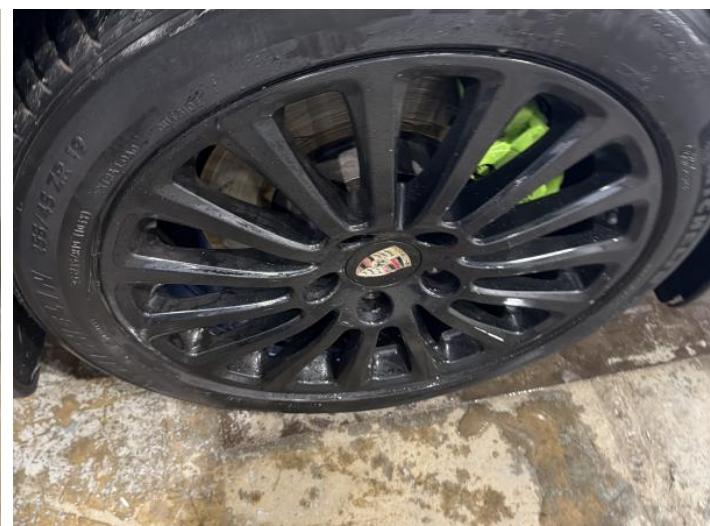
18: Wheel osf  
Scratched  
Up To 50mm
